# Technical Service Bulletin

<b>Subject:</b>  <b>GRINDING NOISE FROM REAR BRAKES</b>	<b>Bulletin No.:</b> 04-007/20
	<b>Last Issued:</b> 11/09/2020

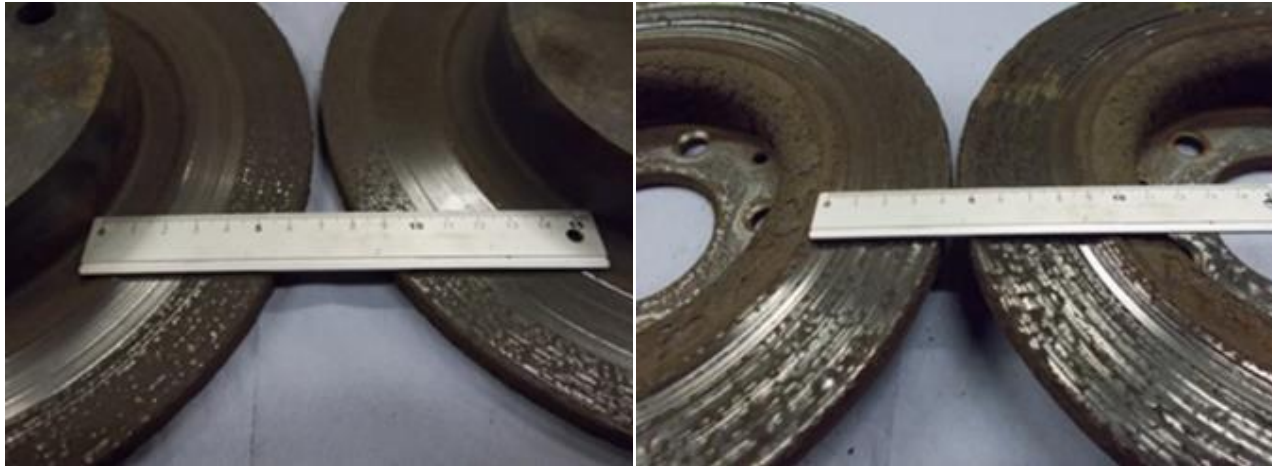
Some vehicles equipped with electric parking brake (EPB) may exhibit a grinding noise from the rear brakes when braking. This may be caused by the rear brake pads not having the capability to remove the rust from the rear brake discs. The red rust accumulated on the discs is exposed to high temperatures during braking, and consequently the rust turns black. As the black rust is too hard to be removed by the brake pads, the rust progress is accelerated, resulting in the grinding noise.

Outer Side

Inner Side

To eliminate this concern, the brake pad material has been changed in order to improve the rust-removing

capability.
