# Technical Service Bulletin

<b>Subject:</b> <b>DTC U2050:55 STORED AFTER REPLACING OR REPROGRAMMING TCU</b>	<b>Bulletin No.:</b> 09-013/20
	<b>Last Issued:</b> 11/17/2020

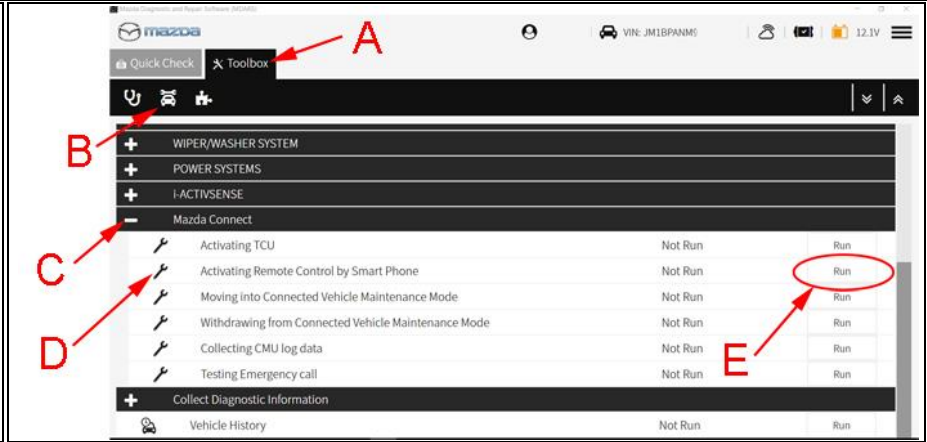
3b. Select the following:  
A. Toolbox  
B. Work support icon  
C. Mazda Connect  
D. Activating Remote Control by Smart Phone  
E. RUN.

3c. Follow the on-screen instructions.

1. If TCU is not being replaced, ignore "Complete installation of new TCU" (a).
2. Battery voltage must be 14-14.5V (b). (see SA-063/20)
