# Technical product information

<b>Topic</b>	New Continental GT - New Continental GTC and Bentayga Driver/Passenger door power latch creak on close
<b>Market area</b>	Bentley: worldwide (2WBE),Hongkong-Macau (5HK)
<b>Brand</b>	Bentley
<b>Transaction No.</b>	2052394/10
<b>Level</b>	EH
<b>Status</b>	Approval
<b>Release date</b>

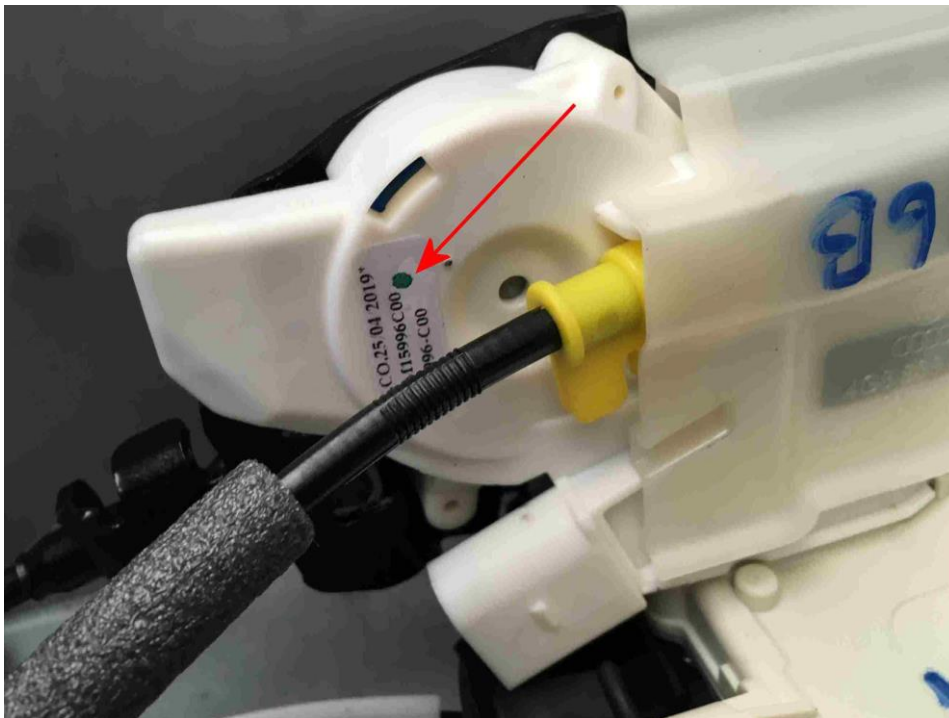
Driver or Passenger door creak during the power latch "Close" function

- 1) Obtain a clear video recording of the issue (save the video as it may be required for analysis)
  - 2) Replace the applicable door latch - Refer to Rep.Gr 57
  - 4) Open a Non technical/For information only DISS query - Attach a photo of the door latch label as shown in Figure 1
- IMPORTANT: If a green paint dot is evident on the label, please ensure the dot is clearly visible within the photograph
- Should the green dot not be evident a photograph of the latch label is still required
  - Attach the previously recorded video to the open query, the query can now be submitted
