INSTRUCTION TO SERVICE

ITS: 59076	
SECTION:	273 Exterior Lights
WRITTEN BY:	Mike Pearson
SUBJECT:	Replace specified street and curbside front headlamps

ITS59076

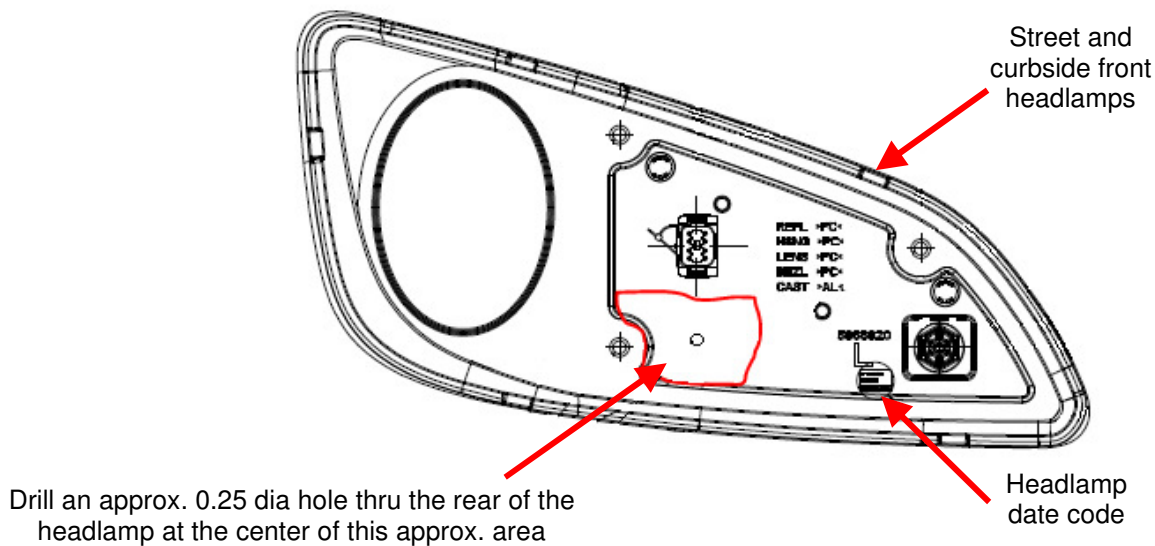
Figure 1: Headlamp Date Code and Hole Locations, Typ for CS & SS

3. Inspect the date stamp on the existing curbside and street side headlamps, an inspection mirror may be needed to view the date stamp location, see Figure 1 for date stamp location.

4. If the headlamp date stamp is between 26-June-2019 and 14-October-2020 the headlamp will need to be replaced as per Steps 5 thru 8, **document and discard the headlamp as per Step 12**. If the headlamp date stamp is not between 26-June-2019 and 14-October-2020 the headlamp is not to be replaced.

5. Disconnect tie back the harness from the headlamp being replaced.
6. Remove and save the existing headlamp mounting hardware.
7. Remove the existing headlamp and install the new curbside headlamp p/n 621840 and/or street side headlamp p/n 621841 depending on date stamp using the existing hardware from Step 6, torque hardware to 40-50 in*lbs. Headlamp modules are to be centered in the pockets in the front mask to ensure that there is no contact between the headlamp and the panel.

11. Turn the main battery disconnect switch to the "ON" position.
12. Removed headlamps, failed or not must have the headlamp date code documented for each claim (headlamp) to be accepted, as well as an approx. 1/4" dia hole is to be drilled thru the rear of the headlamp to an approx. depth of 1/2". The date code and hole can be located as shown;
