Technical product information

| Topic | Engine overheating - Warning on the DIP - V8 Kovomo |
| Brand | Bentley |
| Transaction No. | 2061369/1 |

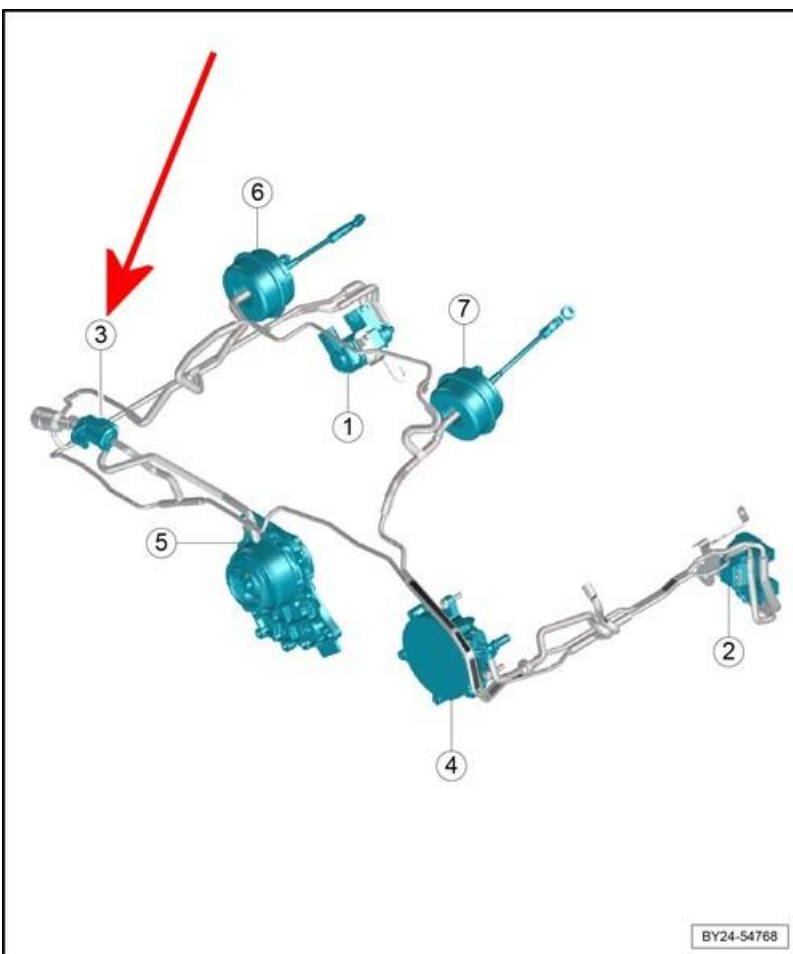
Figure 1 Shows the Bentayga Solenoid (Arrow)

When the solenoid is at fault (sticking open) the vacuum supply is constant, this allows the sleeve to stay in position around the impeller which leads to the symptoms described within the Customer statement/Workshop findings section of this TPI

1) Check and confirm the solenoid valve is sticking open and supplying a constant vacuum

Should the symptom be as described and there is no issues with the vacuum system other than a constant vacuum being supplied to the coolant pump the solenoid is at fault and must be replaced

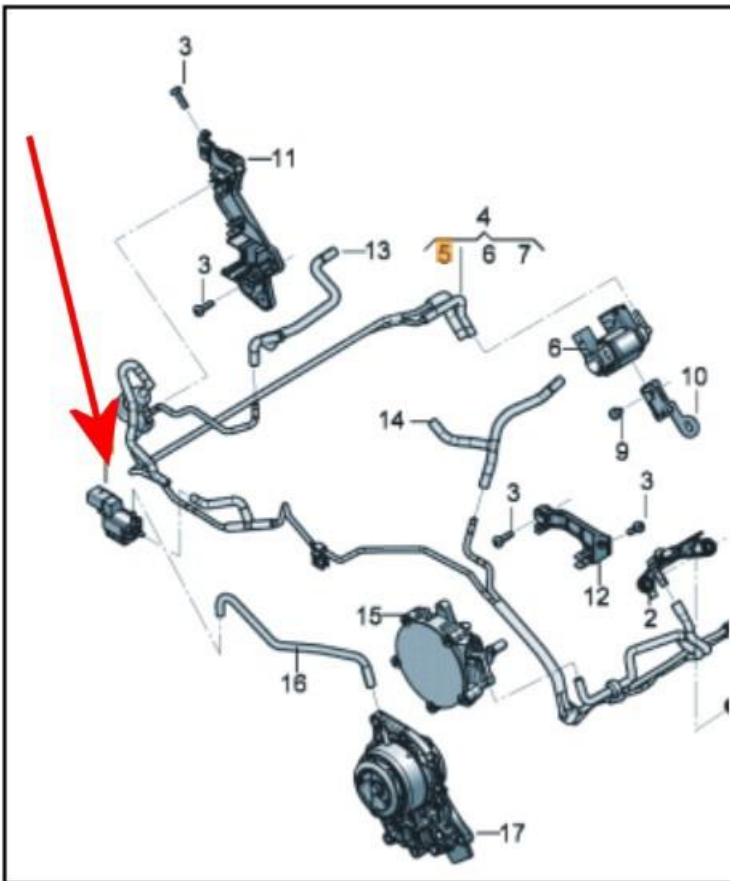
Figure 2 Shows the New Continental GT/ GTC and Flying Spur solenoid (Arrow)
