## Technical product information

| <b>Topic</b> | Transmission communication DTC's (Numerous) - V8 Kovomo engine |

### New Continental GT and New Continental GTC - V8 Kovomo

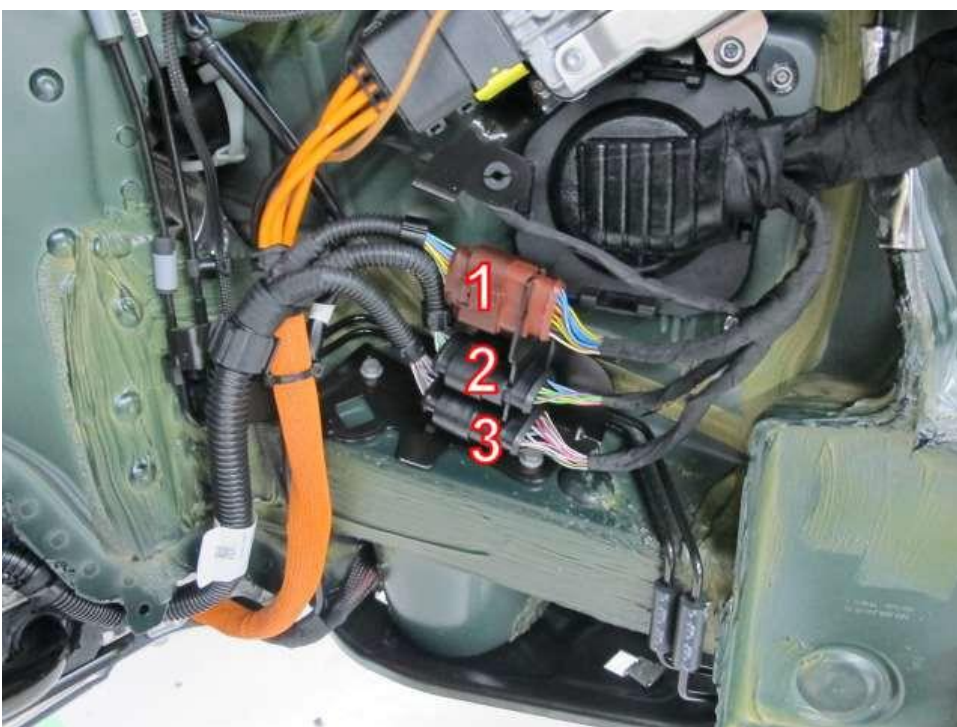
Loose pins within the transmission link harness to the Mechatronic unit for dual clutch gearbox -J743- connections can lead to various transmission communication and hardware based DTC's

- Referring to Figure 2 - Disconnect the three connectors shown

2) Once disconnected carry out pin/terminal grab checks on all three male and female connections

- In the event the main vehicle harness pins are not to specification the applicable pins should be replaced
- Should any issues be found with the transmission link harness and/or pins – the harness should be replaced
- In the event the pins are to specification or the applicable repairs have been done (for example – Harness replacement or pin replacement) - Reconnect all three connectors (Figure 2) and proceed to Step 3
