Service Alert

Subject: DTC U2050:55 STORED AFTER REPLACING OR REPROGRAMMING BCM	Service Alert No.: SA-003/20
	Last Issued: 11/06/2020

2019-2020 Mazda3
2020 CX-30

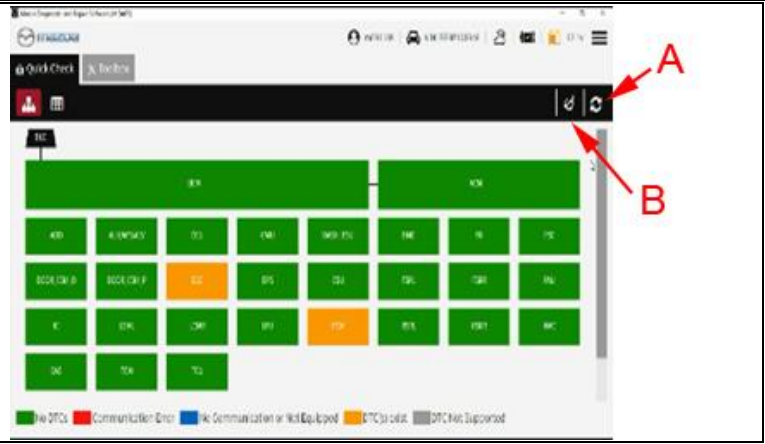
CAUTION: If the engine is not started, DTC P2610 is stored and cannot be erased.

6. Select Quick Check (A), then start the engine and select the DTC Clear icon (B).
