Service Alert

CX-30 SERVICE CAUTIONS FOR NEW AND REVISED FEATURES

Service Alert No.: SA-013/20

2020-2021CX-30

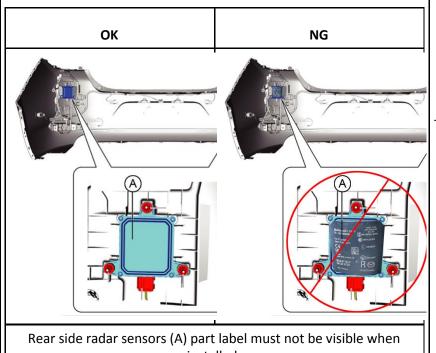
Blind Spot Monitoring (BSM) System

- 1. BSM system indicates vehicle on the opposite side.
- 2. i-ACTIVSENSE indicator ring will not turn green
- 3. Rear Cross Traffic Alert (RCTA) does not work
- 4. Rear side radar sensor aiming may fail
- 5. TPMS DTC(s) stored

This may be caused by BSM rear side radar sensor(s) installed facing the wrong direction.

installed.

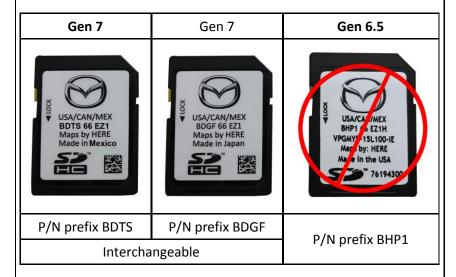
The 2020 CX-30 7th generation (Gen 7) infotainment system is not equipped with factory installed navigation system, however, it is available as a dealer installed accessory.

NOTE: Gen 6.5 Navi SD card with part number prefix BHP1 (CX-3) installed in the Gen 7 2020 CX-30 will not function.

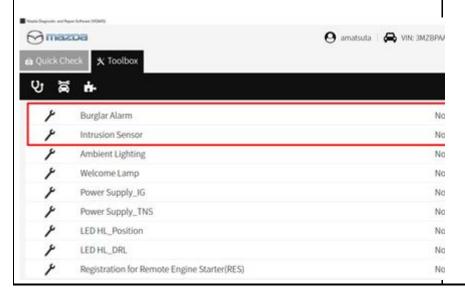
The CX-30 is not equipped with a Theft-Deterrent System. **CAUTION**: DO NOT use MDARS to enable:

The CX-30 does not have the necessary Theft-Deterrent System hardware to function if enabled using MDARS, and MDARS cannot disable the Theft-Deterrent System after it has been enabled. The following DTC's may be stored if the burglar alarm or intrusion sensor are enabled:

- 1. B109F:87 Intrusion Sensor Module
- 2. B2002:87 On Board Charger DC/DC Low Voltage Side Contact Hotline if the Theft-Deterrent System has been accidently enabled.
