Service Alert

Subject: CONNECTED VEHICLE SYMPTOM TROUBLESHOOTING	Service Alert No.: SA-031/20
	Last Issued: 11/06/2020

2019-2021 Mazda3
2020-2021 CX-30
2021 CX-5
2021 CX-9

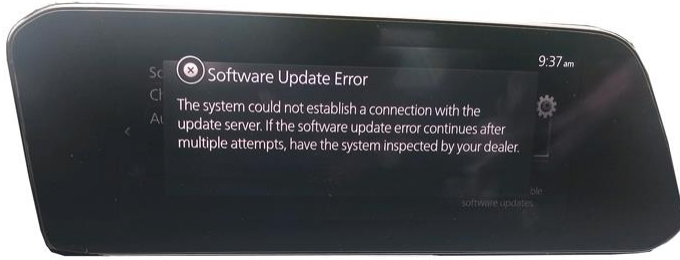
Confirm the customer's phone and vehicle have good to strong reception during the concern as shown in the table below.

Indication	Explanation
	Radio waves are not being received. Move to a location with good reception.
	Weak reception.
	Good Reception
	Strong reception.
	Currently conducting an operation check of the communication unit. If this condition continues, consult an Authorized Mazda Dealer.
	<ol style="list-style-type: none"> 1. The Telematics Communication Unit (TCU) is unsubscribed 2. Connected Service contract has ended 3. TCU has not been initialized, go to SA-010/20

- If the reception is weak, move the vehicle to a location where the reception is good to strong as shown in the table, then try to get the Authorization Code and/or operate the remote functions before proceeding to the Repair Procedure if there is still an issue.
- If the reception is good to strong, proceed to the Repair Procedure.

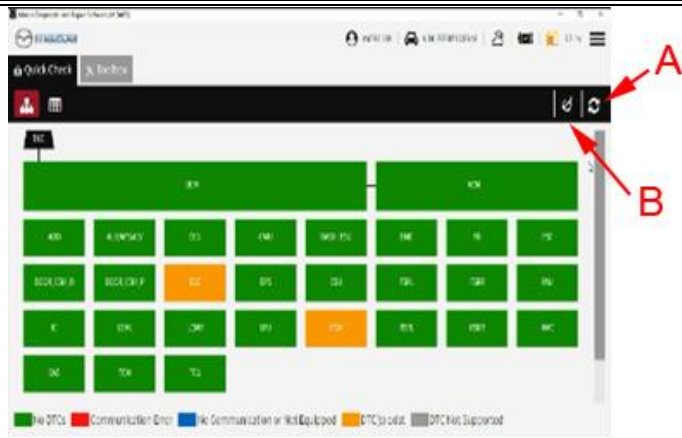
CAUTION: If the engine is not started, DTC P2610 is stored and cannot be erased.

5. Select Quick Check (A), then start the engine and select the DTC Clear icon (B).
