Service Alert

Subject: CRACKED REAR DIFFERENTIAL	Service Alert No.: SA-047/20
	Last Issued: 11/18/2020

2017-2020 CX-3 AWD
2017-2020 CX-5 AWD
2017-2020 CX-9 AWD
2020 CX-30 AWD

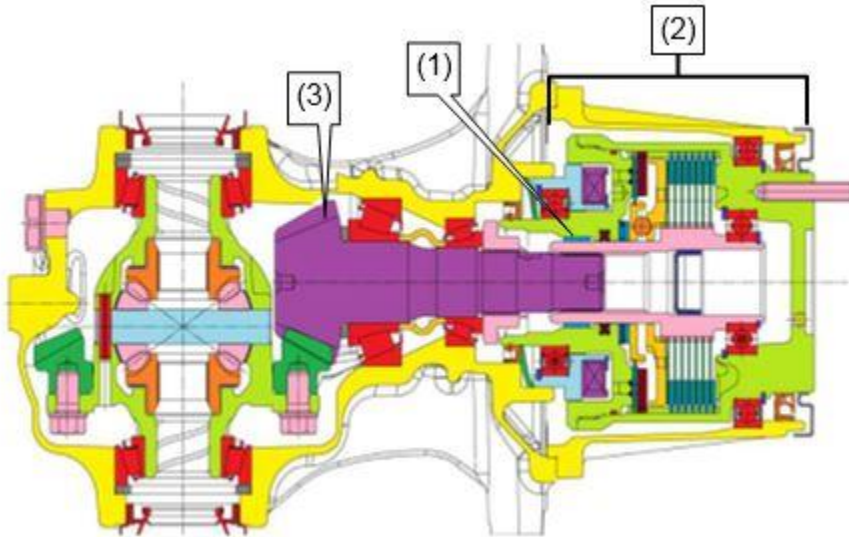
This concern is caused when the sliding bearing (1) in the coupling (2) is seized and causes the coupling component to fit loosely. The pinion shaft head (3) then contacts the differential case and causes a crack.

1. Be sure to release the Electric Parking Brake (EPB) before starting the vehicle. If a vehicle is started aggressively with the EPB applied, higher torque and slippage may occur in the coupling component causing damage to the sliding bearing.

2. When unloading a vehicle from a trailer, a) be sure that all tire straps/bands are removed and b) avoid aggressive starting to prevent coupling slippage, which is caused by a large difference of rotation between the front and rear wheels.
