**TITLE: Manual Service Disconnect Replacement****Type: Customer Satisfaction Campaign****Year: 2020****Applicability: MY20 Revero GT****System: Electric Drive****Market Region: All****Sequence: 01**

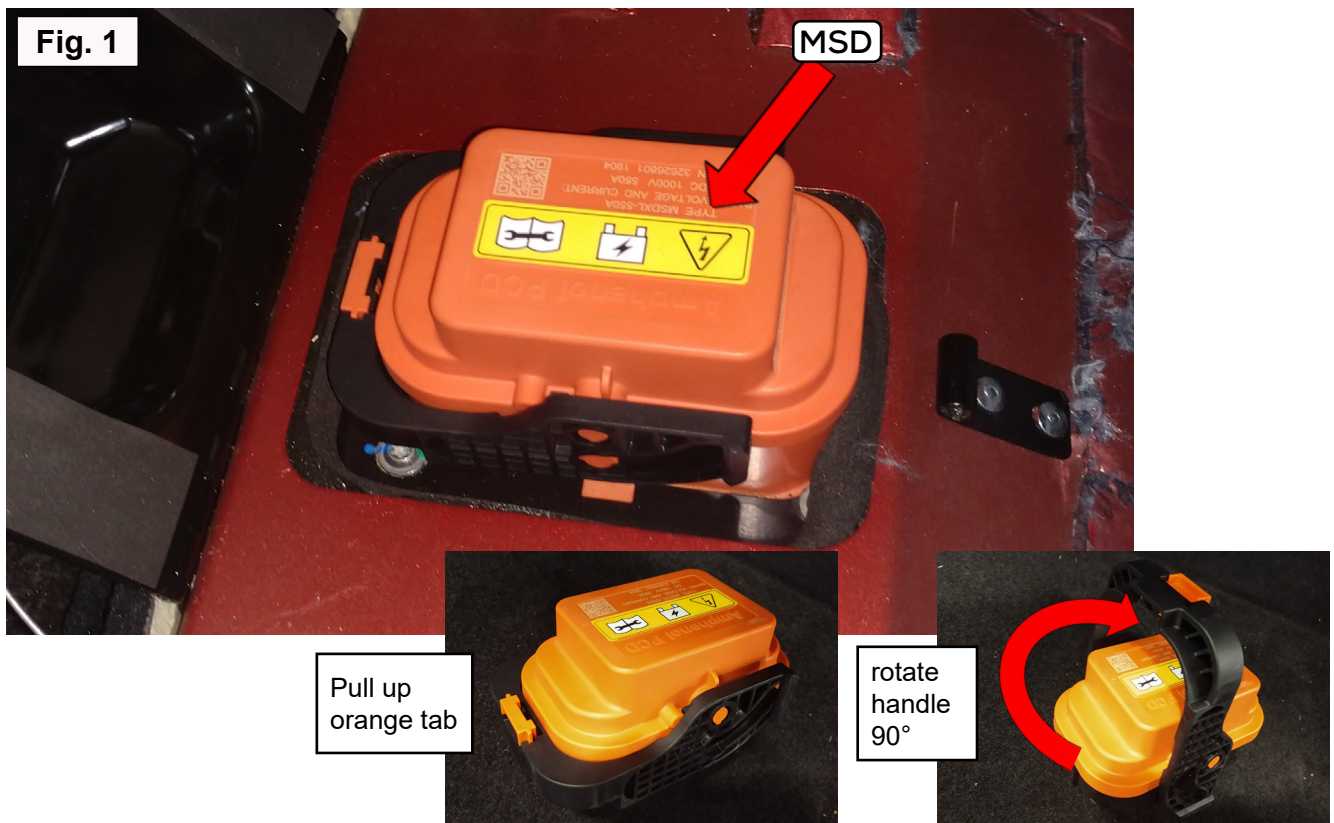
**Purpose:** There is a specification change in the Manual Service Disconnect (MSD). Replace the current installed unit in the vehicles listed on the following page.

The new MSD has a 400A rating.

Disconnect the 12-Volt, remove the fuse #21 (BECM fuse) then remove the MSD, found under the rear LH (driver) side seat cushion. Replace with the new MSD, part number C131118006302, reinsert fuse #21, and reconnect the 12-volt.

Destroy the original MSD – with the MSD removed, drill a hole into the warning sticker.
