SERVICE INFORMATION BULLETIN

SUBJECT: Rear Frame and Stabilizer Bar Bracket

Mounting Bolt- Design Changes

NUMBER: <u>12-296-20R</u>

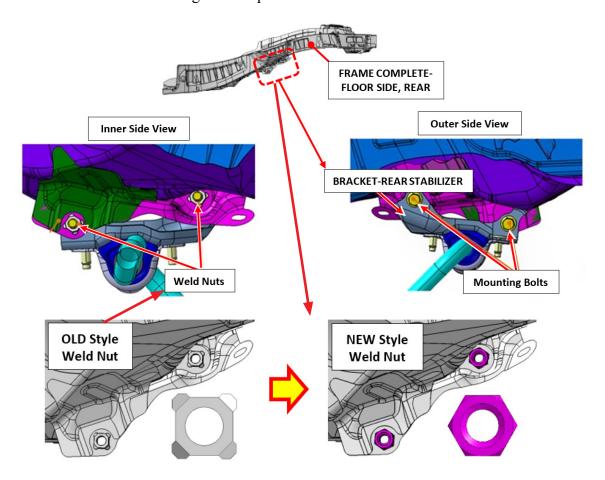
- The new Flange Bolts listed in the table on pg. 1 are **NOT** compatible with weld nuts used in the original frames. **Using the new-style Flange Bolts on the original frames will damage the weld nuts.**
- The original Flange Bolts (p.n. 010108200) are reusable and readily available if needed.
- The new Flange Bolts (p.n. 20058FL010) have a special lubricant applied to their threads and are now One-Time use items.
- There have been no changes to the part numbers of the stabilizer bar brackets.
