## Articles Contained in this Issue

CODE	ARTICLE.....	PAGE
(00)	STIS New Releases .....	7
(01)	QMR of the Month .....	1-2
(01)	QMR of the Month Award Presentations.....	2
<b>Tech Tips Greatest Tips</b>		
(16)	TORQUE CONVERTER RELEARN.....	3
(03)	Front Differential Failure After Transmission R&R .....	4
(03)	Binding/Sound While Turning.....	4-5
(07)	Electrical Connector & Pin Discrepancy .....	5
(15)	Starlink App Soft Key Grayed Out.....	6

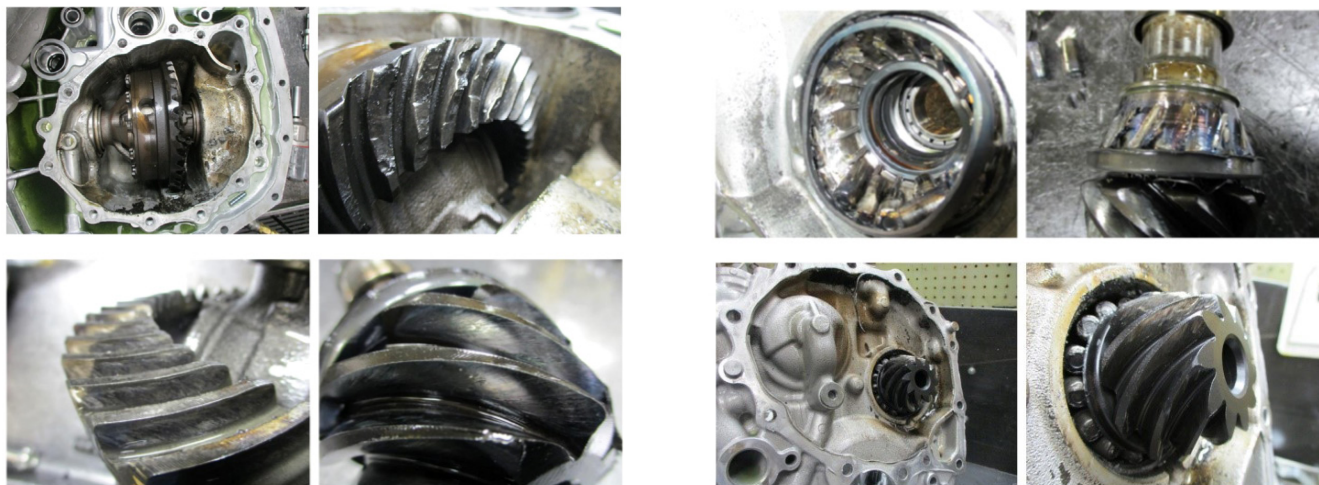
Techline has been made aware of an increased number of front differential failures due to improper fluid levels after transmission replacement.

It is **CRITICAL** to always remember to fill and confirm the proper level of front differential fluid when servicing all transmissions. Low differential fluid will lead to a failure of the ring and pinion gears, related roller bearings and eventually cause catastrophic damage to the transmission.

Damaged ring gear

DAMAGED PINION GEAR BEARING ROLLER CAGE

Retailers **MUST** fill the front differential and the transmission with proper fluids. These fluids **DO NOT** intermix.

Always review the appropriate Service Manual for specific procedures, proper fluid types and levels. STIS>Service Diagnostics (select model and year) > Transmission/Transaxle > Continuously Variable Transmission > Differential Gear Oil > Adjustment. All returned transmissions with clear findings of improper fluid levels will be debited for the full claim amount.

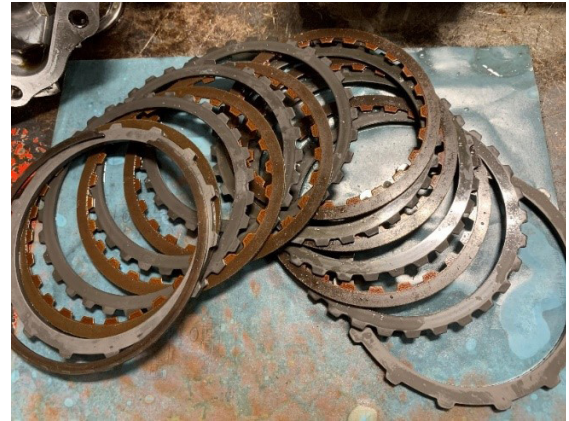
Figure 1: Visually "ok" clutches and plates

As a reminder the, transfer clutches and friction Plates can visually look good as shown in Figure 1 but, grooving or notches in the drum can still be seen. In this case, the marking in the drum is visible and is an indication that torque bind has occurred. The inside and outside of the drum should be inspected for marking. Running a fingernail across the marks replacement of all three during inspection should be completed (clutches, friction plates and drum). The marks provide a place where the clutches and plates will stick resulting in binding and in some cases, a sound.

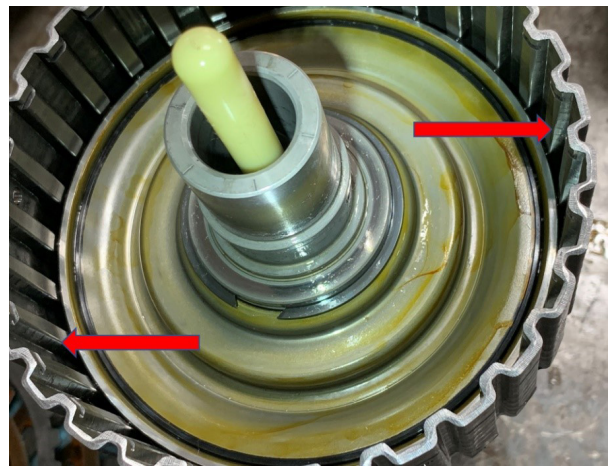
Figure 2: "Witness marks" on inside of Clutch Drum

Transfer Clutches should be inspected for wear and discoloration after eliminating other items that can cause a bind/sound (e.g.: tires, transfer pressure, speed sensors, FWD mode). Transfer Clutch friction plates should be inspected for “heat markings” and discoloration. The Transfer Clutch Drum should be inspected for grooving “witness marks” as shown in Figure 2 below indicated with the red arrows.

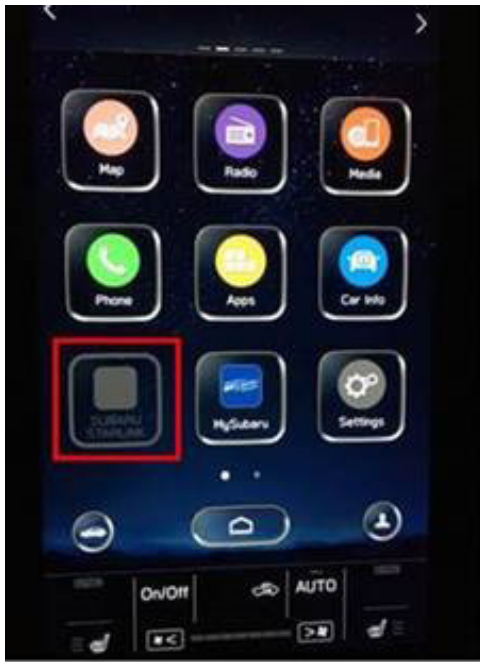
Techline continues to receive reports regarding customer concerns with their STARLINK App soft key being grayed out on their CID display. If this is found to be the case, please note this is a normal operating characteristic. The STARLINK App soft key will be grayed out until a phone equipped with the Subaru STARLINK App is paired. Once a phone is successfully paired, the STARLINK App logo will illuminate and be selectable. The images below show both scenarios.

**(Unpaired/ Grayed out)**

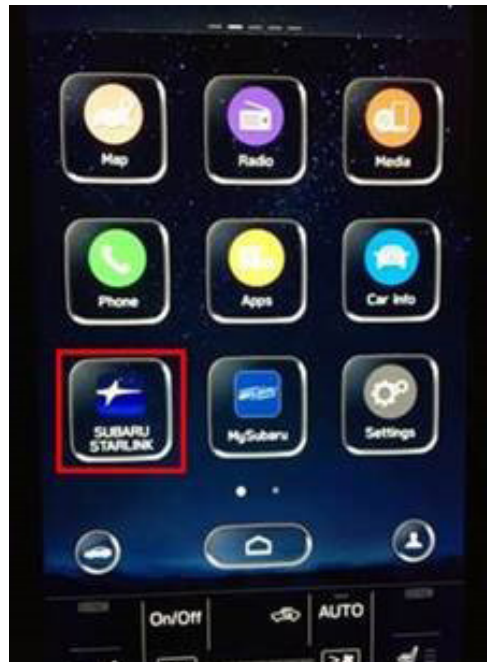
**(Paired/Illuminated)**
