Washer Bottle Field Repair**Applicability:** MY2018-2019 Revero**Market Region:** All

PURPOSE: This bulletin outlines a field fix for cracked and leaking washer bottles. Washer bottles are to be replaced with new items when available.

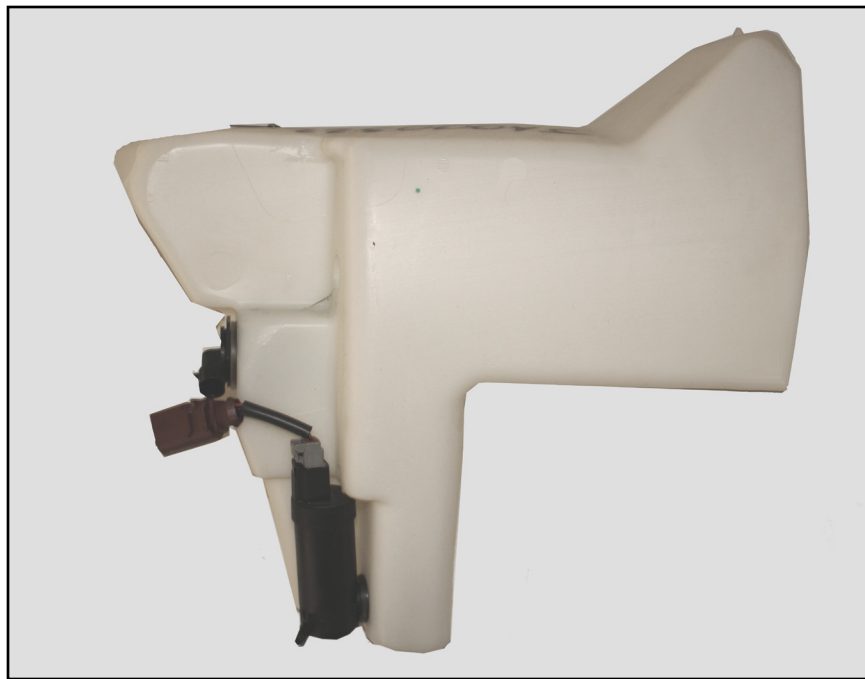
Fig 1a

When presented with a washer bottle leak, removal and replacements is advised. If an assembly is not available please remove and perform the repair described here.

The procedure will require a soldering iron or plastic welding tools. These tools are readily available and are to be sourced locally.

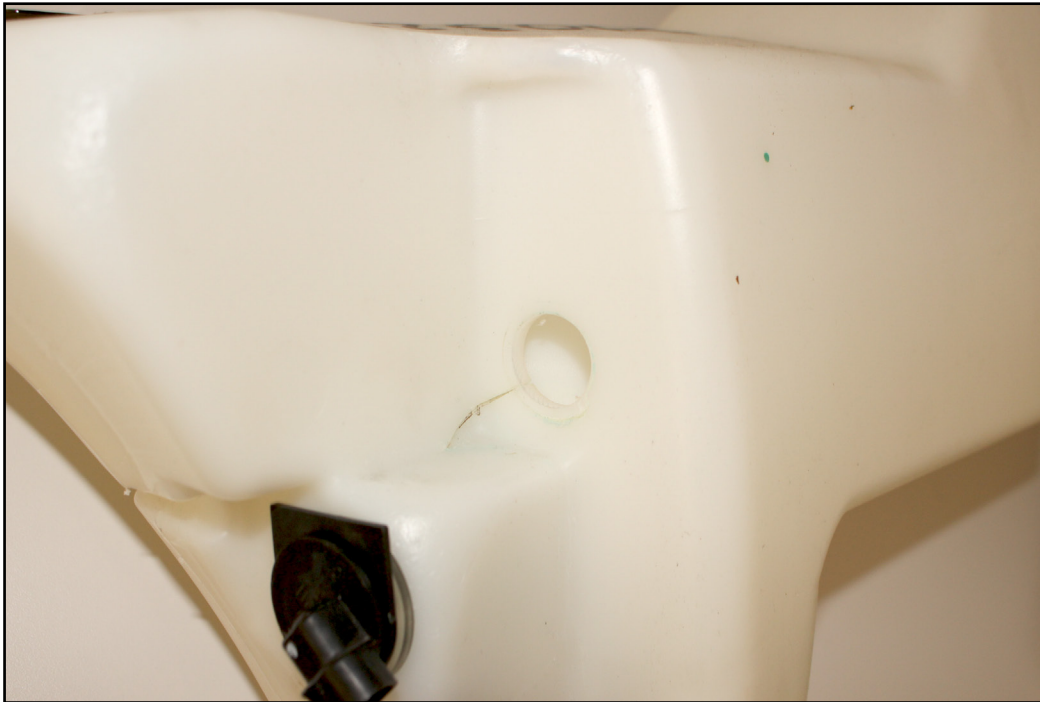
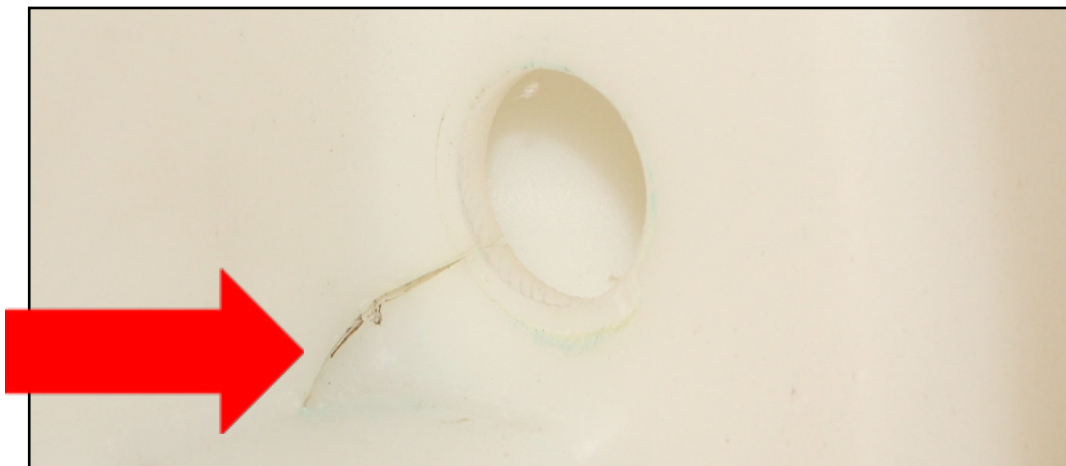
Fig 2a

The severity of the crack may prevent this type of fix. Deformation of the pump mounting location or a defect that is too wide to be repaired will require replacement with a suitable assembly. As shown in (Fig 2a and 2b) this is a repairable defect.

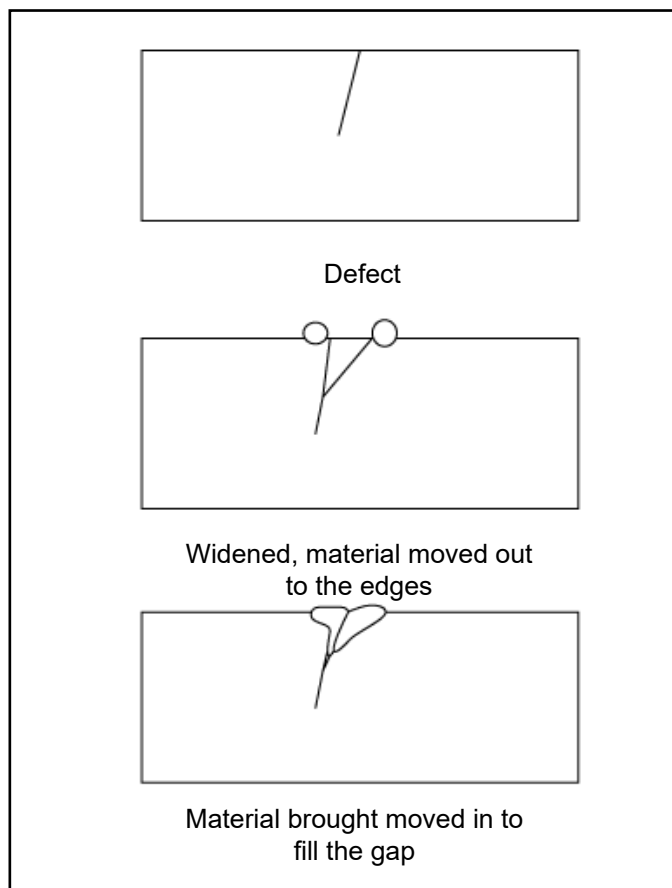
Fig 3a

Below in (Fig 3a) is a graphic representation of the process

With an available soldering iron or suitable plastic welding tool, heat the cracked area and melt material to widen the crack.

The width should not be greater than the tool tip.

This should be opened up in a wedge shape, so it is wider with excess material collected at the top edge of the crack.

The penetration should be about 70% of the washer bottle walls thickness.

The idea is to apply heat to the edges being joined in order to melt the plastic until it is liquid enough to blend the edges together.
