SERVICE BULLETIN

APPLICABILITY: 2017-18MY Impreza
 2018MY Crosstrek
 2018MY Legacy and Outback
 2018MY BRZ*

NUMBER: 15-211-17R
DATE: 06/13/17
REVISED: 11/23/20

SUBJECT: Reprogramming File Availability for Additional Optimization of Harman Gen 3 Audio and Navigation Head Units

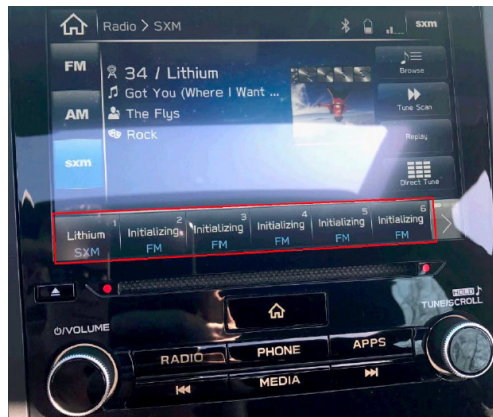
- 1- Radio station presets disappear (touch screen buttons return to “Initializing”).

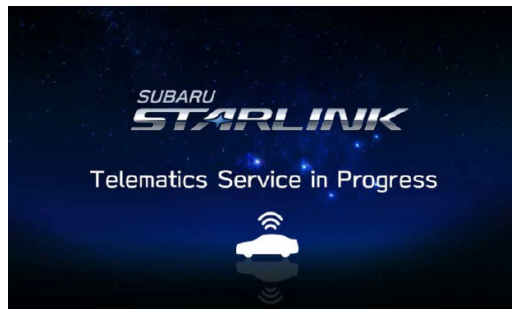
- 2- STARLINK “Telematics Service in Progress” screen freezes.
