SERVICE INFORMATION BULLETIN

APPLICABILITY: 2020MY Legacy & Outback

SUBJECT: Denso CP1 BASE (Dual 7" Display Screen)
Erratic Operation

NUMBER: 15-273-20

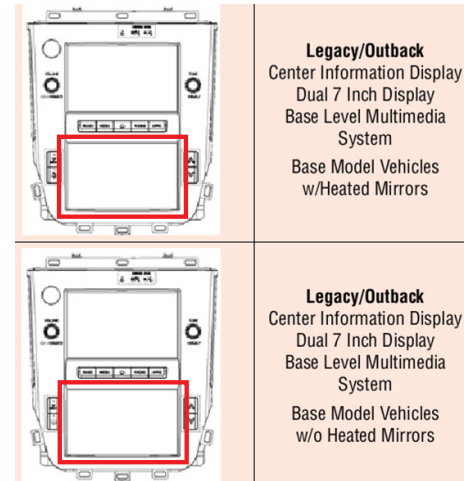
This Service Information Bulletin addresses isolated customer concerns regarding the pictured CP1 BASE Model Center Information Display (CID) LOWER 7-inch display screen flashing, not responding to touch inputs and / or shutting off intermittently.

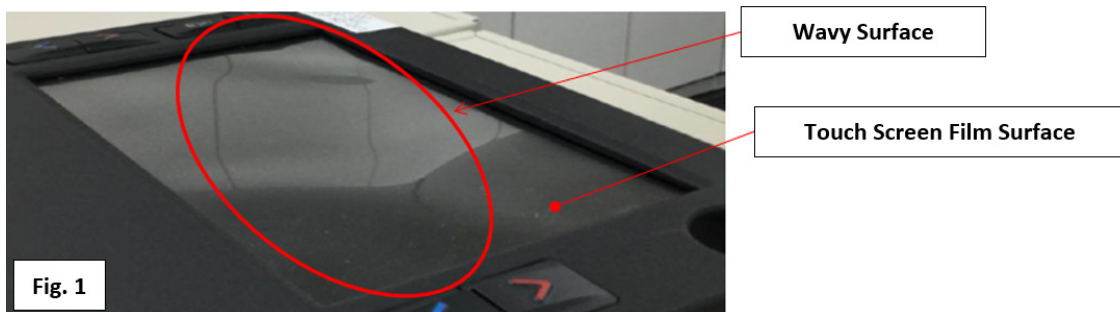
Check for any deformation or waviness of the touch screen surface. Inspect the surface condition diagonally with light reflecting on it at various angles. Is any waviness visible as shown in **Fig. 1** below?

- **If YES:** Replace the CID **display component** because the surface of the touch screen is deformed.
- **If NO:** Proceed to **Step 2**.

NOTE: In the event the CID requires replacement, the new unit **INCLUDES** a new surrounding trim panel and new control buttons as a ready to install assembly.

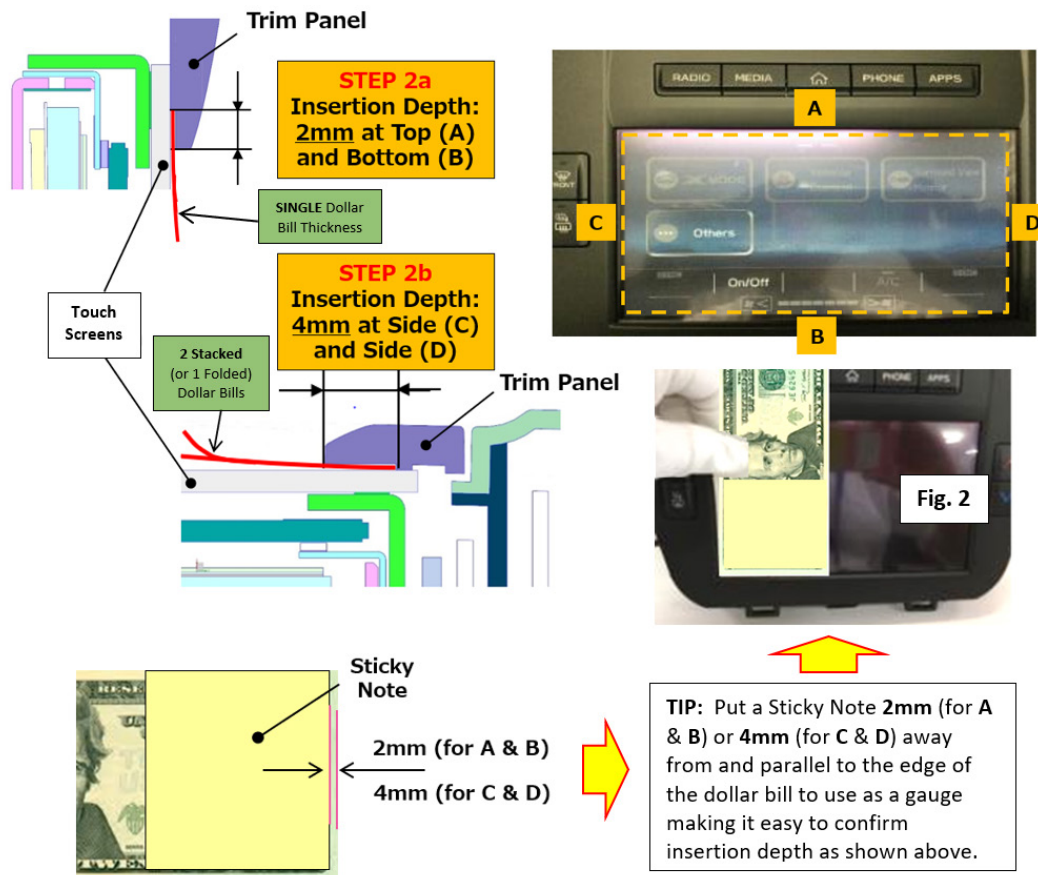
Steps 2a & 2b: Inspect for deformation of the lower touch screen, the surrounding trim panel and for any foreign material trapped in between them. Use the illustrations below as a guide.

- **2a:** Insert a (preferably a crisp, new) dollar bill into the gaps between the touch screen and the surrounding trim panel along the top (**A**) and bottom (**B**) as shown in the **Fig. 2** example below. The dollar bill should be able to be inserted **2mm** into the full width of both the top and bottom gaps.
- **2b:** Insert a dollar bill folded in half (to provide 2 thicknesses) into the gaps between the touch screen and the surrounding trim panel along the sides (**C**) & (**D**). The folded dollar bill should be able to be inserted **4mm** into the side gaps from top to bottom.

IMPORTANT: All 4 of these measurement checks must be done **TWICE**.

- If the dollar bill can be inserted into the gap **2mm** on the **Top** and **Bottom** and **4mm** on **BOTH** sides, there is no deformation of the touch screen or surrounding trim panel. Proceed to **Step 4**.
- If the dollar bill cannot be inserted, replace the CID because the surrounding trim panel and / or touch screen are likely deformed.

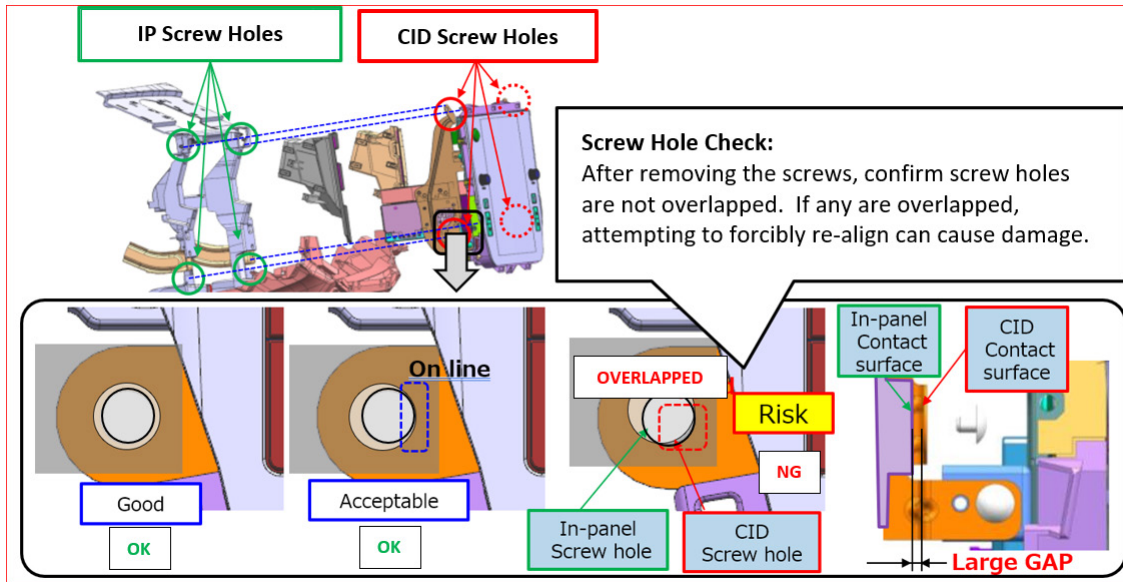
Step 4: Check condition of the retaining screw holes and contact surfaces between the instrument panel (IP) and CID after removing the screws.

- Inspect the screw holes of the IP and the bracket following the illustrations below. If the screw hole(s) are overlapped, **CAREFULLY** re-align to Acceptable or “**OK**” as shown below.
- Inspect the gap between contact surfaces of the IP and the bracket following the illustration below. If a gap exists between the two contact surfaces, **CAREFULLY** adjust the seating / alignment by changing the tightening order of the retaining screws.

TIP: If there is too much mis-alignment, **CAREFULLY** loosen the other three screws, let things settle, then try tightening them again in a different order to see if the alignment improves before installing the final screw or, loosen them all, let things settle then tighten again but in stages so any one hole is not too far offset (beyond **OK**).

- **If YES:** The condition persists, replace the CID.
- **If NO:** The condition no longer persists. Operate the unit for an extended period to confirm a successful repair.
