Technical product information

Topic	Transmission communication DTC's (Numerous) - W12 engine
Market area	Bentley: worldwide (2WBE)
Brand	Bentley
Transaction No.	2059068/3
Level	EH
Status	Approval
Release date

New Continental GT and New Continental GTC - W12 engine

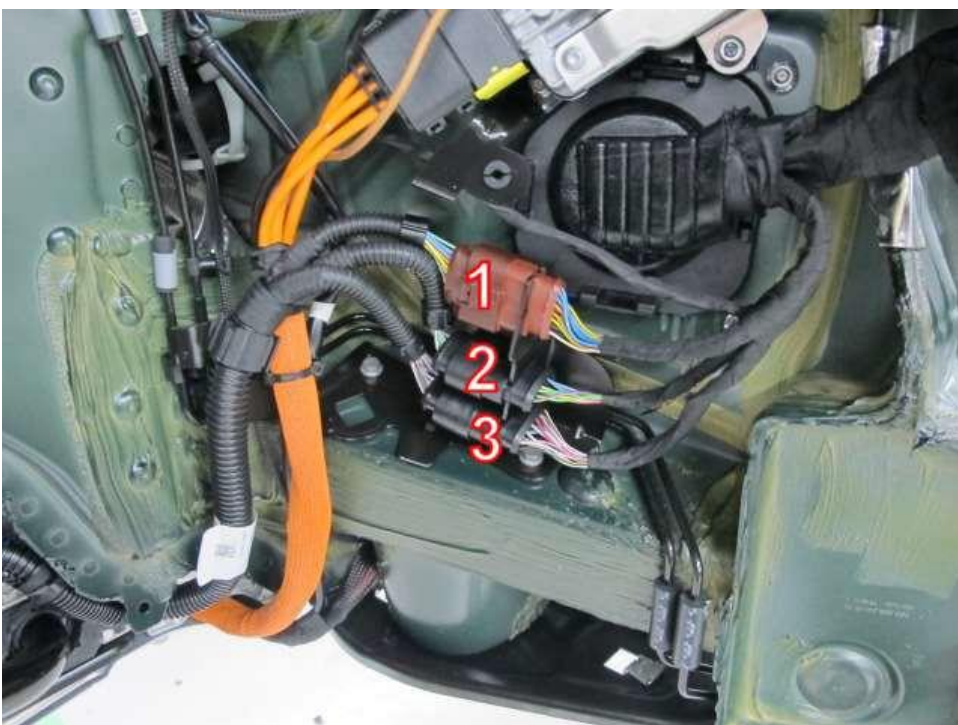
Loose pins within the transmission link harness to the Mechatronic unit for dual clutch gearbox -J743- connections can lead to various transmission communication and hardware based DTC's

- Referring to Figure 2 - Disconnect the three connectors shown

2) Once disconnected carry out pin/terminal grab checks on all three male and female connections

- In the event the main vehicle harness pins are not to specification the applicable pins should be replaced
- Should any issues be found with the transmission link harness and/or pins – the harness should be replaced
- In the event the pins are to specification or the applicable repairs have been done (for example – Harness replacement or pin replacement)
 - Reconnect all three connectors

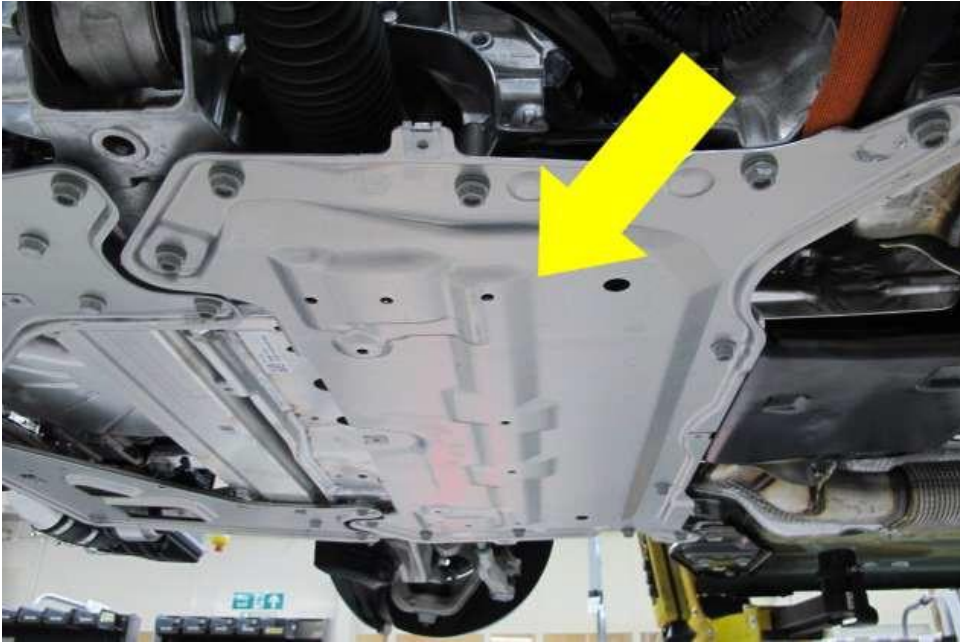
Figure 3

3) Remove the rear subframe support – Rep.Gr 40 (Figure 3)

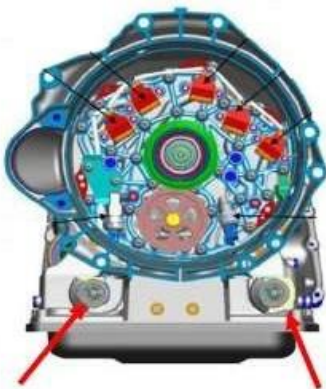
Figure 4

4) Disconnect the connections (Figure 4 - Arrows) from the Mechatronic unit for dual clutch gearbox -J743-

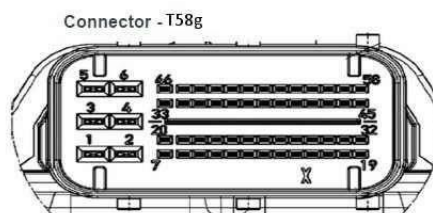
- Referring to the applicable currentflow diagram and Figure 5 and 6- Carry out resistance and pin/terminal grab checks on all disconnected connections from the T58g connector to T20az and T20ay on the harness.

Connector T58g	Connector T20az	Resistance
PIN 1	co PIN 4	0.4
PIN 3	co PIN 2	0.2
PIN 4	co PIN 3	0.5
PIN 6	co PIN 1	0.4
PIN 9	co PIN 8	0.4
PIN 10	co PIN 6	0.1
PIN 11	co PIN 10	0.3
PIN 12	co PIN 20	0.3
PIN 13	co PIN 13	0.5
PIN 16	co PIN 17	0.4
PIN 22	co PIN 5	0.4
PIN 23	co PIN 7	0.4
PIN 24	co PIN 9	0.4
PIN 25	co PIN 11	0.4
PIN 26	co PIN 12	0.4
PIN 27	co PIN 14	0.4
PIN 29	co PIN 16	0.5

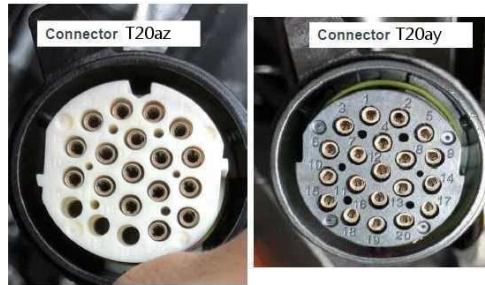
Figure 6

Connector T58g	Connector T20ay	Resistance
PIN 1	PIN 5	0.4
PIN 14	PIN 1	0.4
PIN 21	PIN 20	0.4
PIN 34	PIN 18	0.3
PIN 36	PIN 3	0.3
PIN 37	PIN 2	0.4
PIN 38	PIN 4	0.4
PIN 41	PIN 9	0.4
PIN 42	PIN 13	0.5
PIN 43	PIN 10	0.4
PIN 44	PIN 15	0.4
PIN 46	PIN 17	0.4
PIN 48	PIN 19	0.5
PIN 49	PIN 16	0.4
PIN 50	PIN 6	0.4
PIN 51	PIN 7	0.4
PIN 52	PIN 8	0.4
PIN 54	PIN 11	0.4
PIN 56	PIN 12	0.4
PIN 58	PIN 14	0.4

Connector T58g	Power supply	Resistance
PIN 2	Ground	0.2
PIN 5	Fuse box SK or SP (20A)	0.2
PIN 55	TV48	0.3

When conducting the T58g resistance checks from pin 5 to the relevant fuse (Refer to the applicable Wiring diagram) please ensure the correct fuse board is located

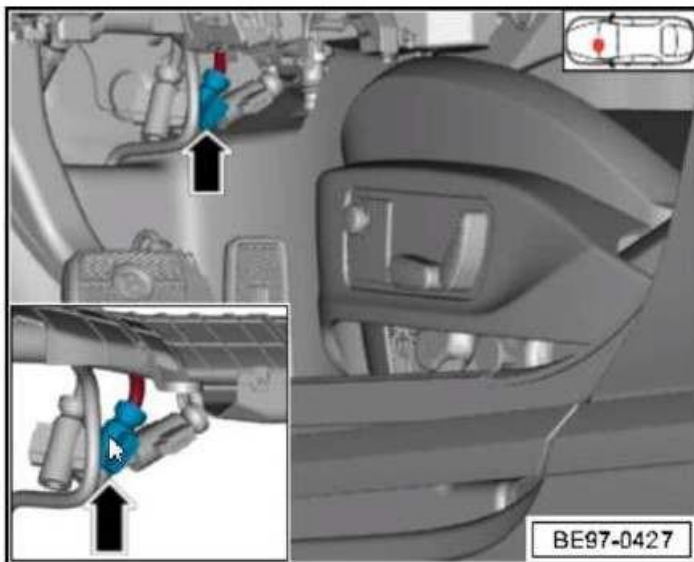
Figure 7

Connector TV48 (Figure 7) MUST also be disconnected when conducting the pin 55 to TV48 resistance check TIP: once the check has been done reconnect TV48
