Subject: PSB E274: PACCAR MX-13 Engine Model Year 2019-2020 Oil Filter Cap Replacement

## Technical Information Bulletin

### E274

PACCAR MX-13 EPA17 EMY2019-2020 Oil Filter Cap Replacement

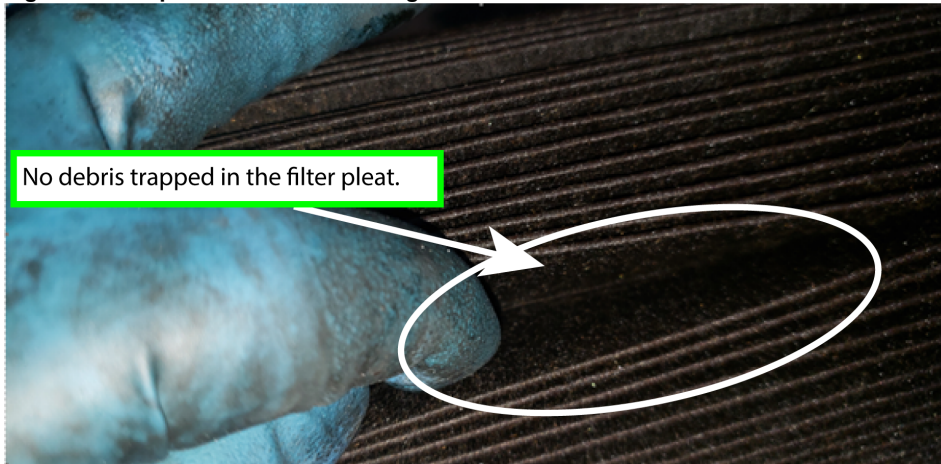
Figure 2 Example of a filter with no significant debris

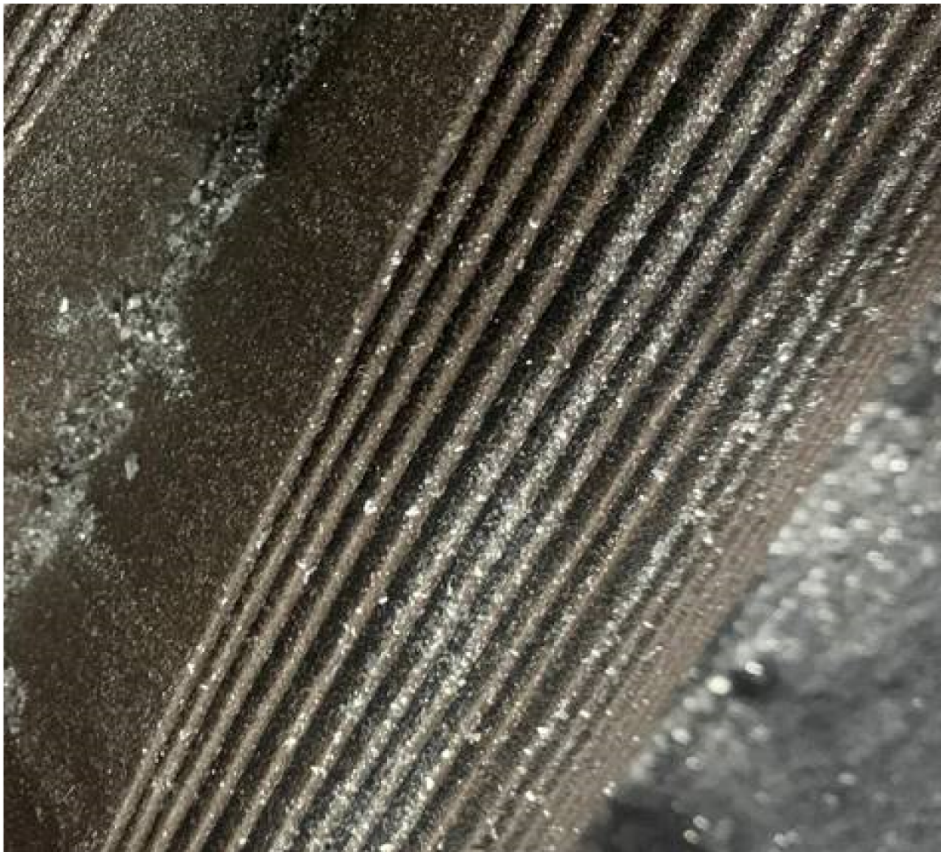
Figure 3 Example of a filter with significant debris

Large debris trapped in the filter pleat.

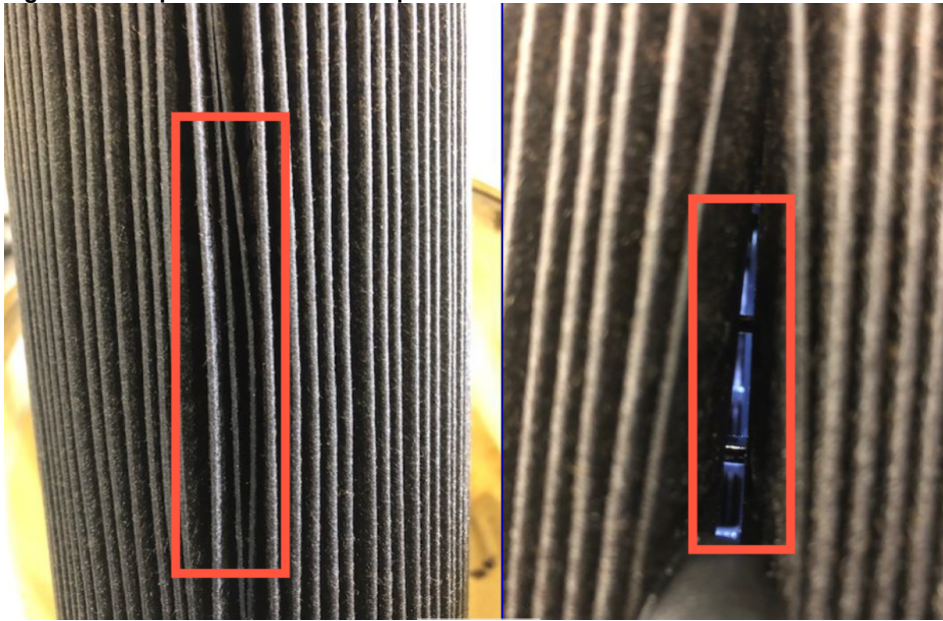
**Figure 4 Example of a filter with a separated seam**

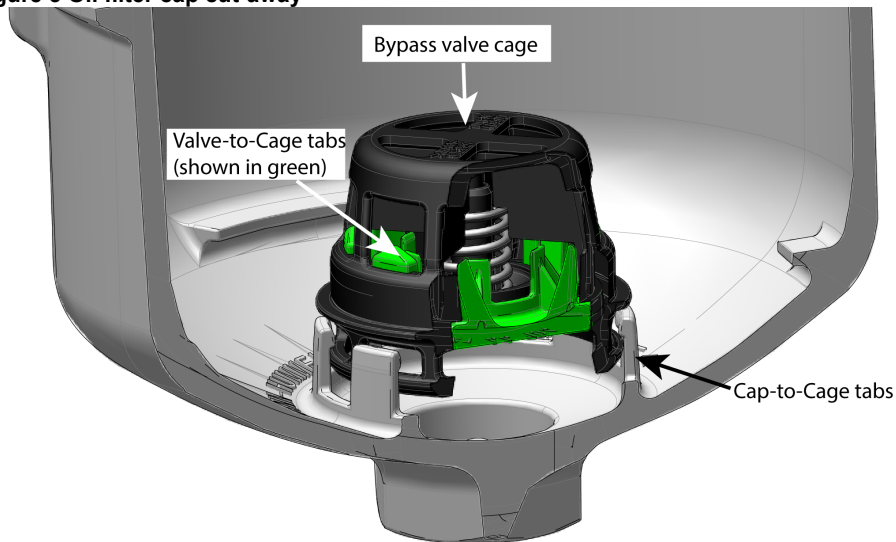
4. Inspect the retaining tabs that hold the bypass valve cage to the filter cap and the tabs that hold the bypass valve to the cage. If any of them are broken, take clear photos.
- Tip: Ensure the camera flash is on or use a flashlight to illuminate the bypass valve.

**Figure 5 Oil filter cap cut-away**

5. If there are no issues found, install the new oil filter cap with the original oil filter.
6. If broken bypass valve tabs are found or significant debris is found in the filter pleats, start a TCS365 case and await instructions from the VSC. Provide the following information in the case:
- If tabs are broken
  - If significant debris was found in the filter pleats
  - If a separated seam is found. In addition, take an oil sample and return the oil sample and filter to PTC.
  - If a damaged pleat is found. In addition, take an oil sample and return the oil sample and filter to PTC.
  - Attach photos

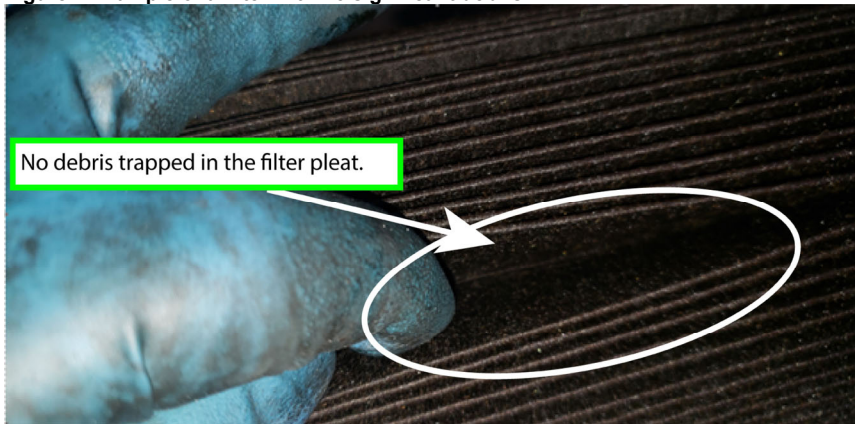
**Figure 2 Example of a filter with no significant debris**

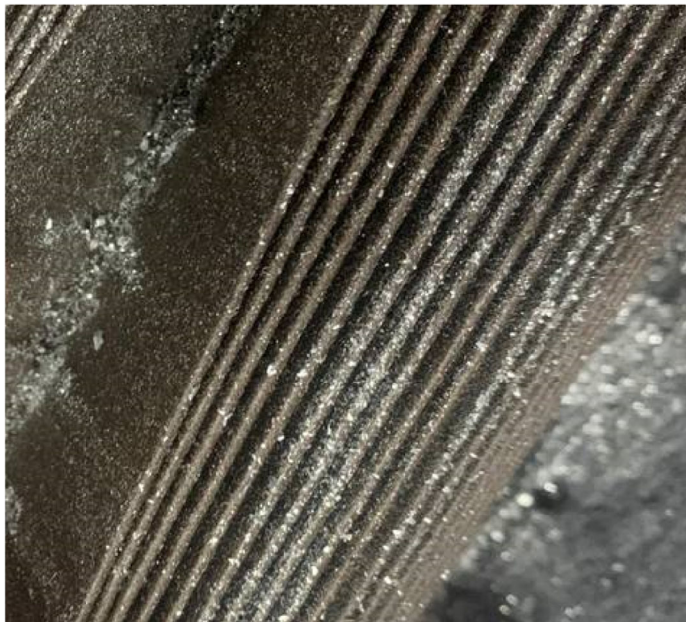
**Figure 3 Example of a filter with significant debris**

Large debris trapped in the filter pleat.

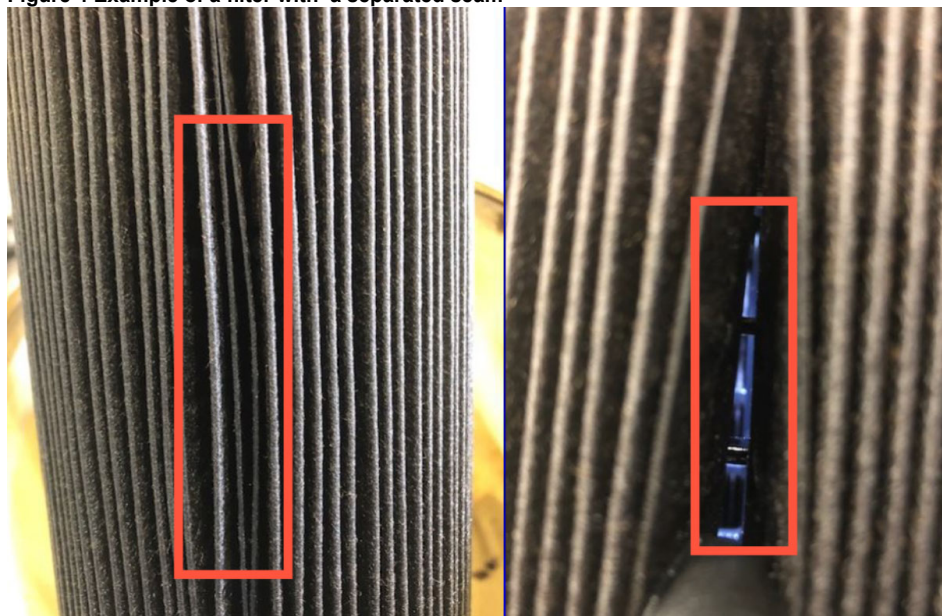
Figure 4 Example of a filter with a separated seam

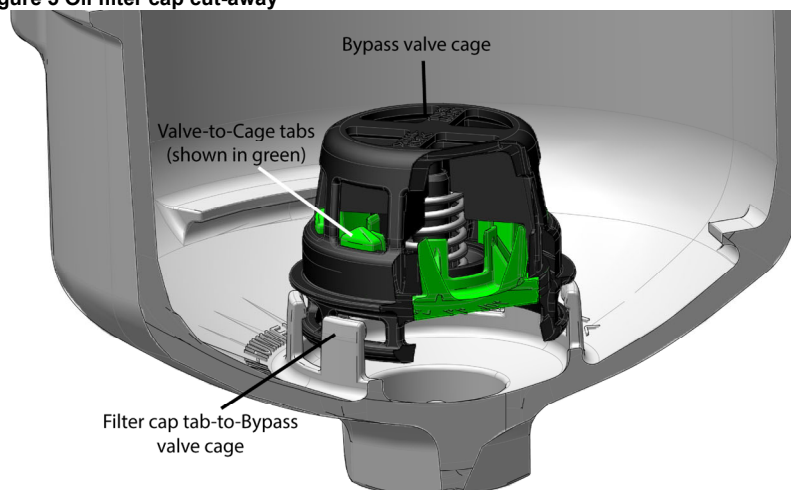
4. Inspect the retaining tabs that hold the bypass valve cage to the filter cap and the tabs that hold the bypass valve to the cage. If any of them are broken, take clear photos.
  - Tip: Ensure the camera flash is on or use a flashlight to illuminate the bypass valve.

Figure 5 Oil filter cap cut-away

5. If there are no issues found, install the new oil filter cap with the original oil filter.
6. If broken bypass valve tabs are found or significant debris is found in the filter pleats, start a TCS365 case and await instructions from the VSC. Provide the following information in the case:
  - If tabs are broken
  - If significant debris was found in the filter pleats
  - If a separated seam is found. In addition, take an oil sample and return the oil sample and filter to PTC.
  - If a damaged pleat is found. In addition, take an oil sample and return the oil sample and filter to PTC.
  - Attach photos
