Service Bulletin

01-079

HVAC Intermittently Stops Blowing Cold Air

Technical Information Bulletin

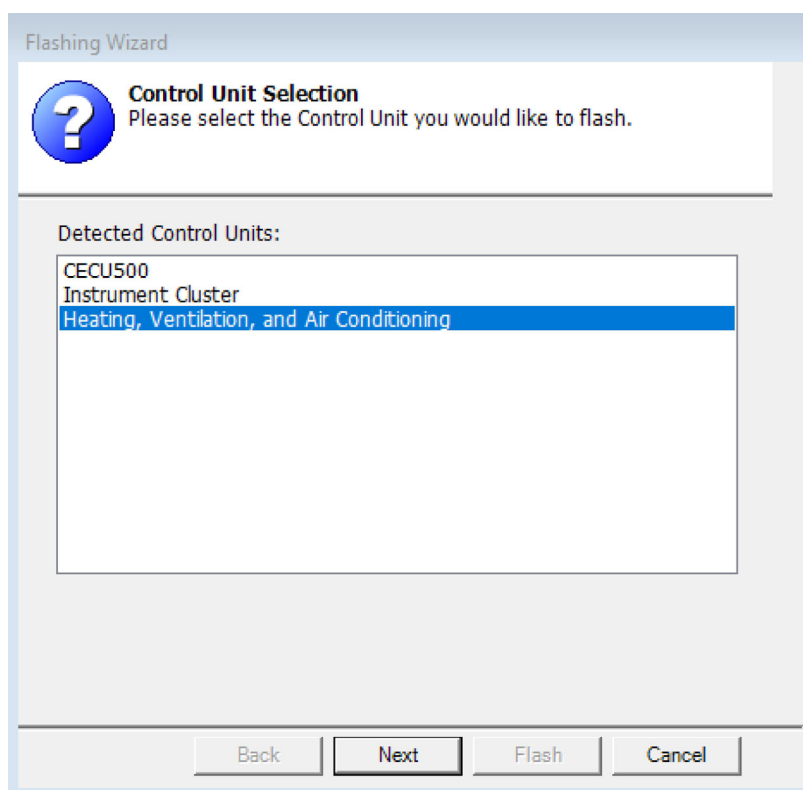
1. Ensure ESA is up-to-date.
2. Connect ESA to the chassis.
3. Update the HVAC Controller software to the latest available version. In ESA, click Tools | Flashing, then select Heating, Ventilation, and Air Conditioning from the Flashing Wizard window.

4. Select the most current software version from the Version Selection window.
5. Click Flash to update the software.
6. Disconnect ESA.

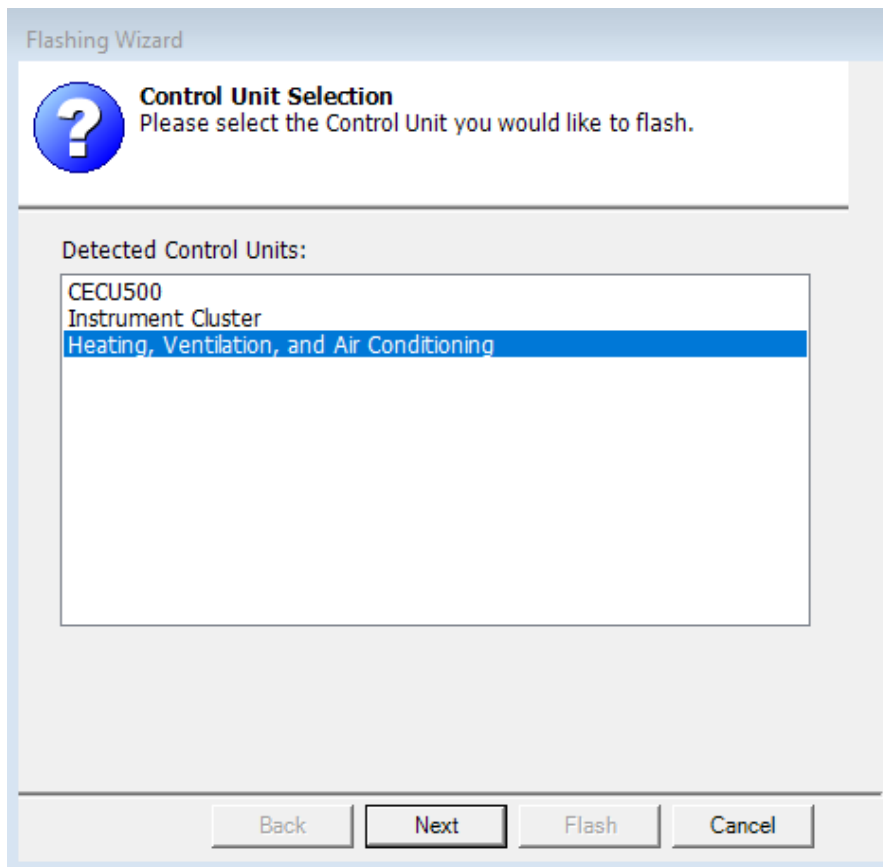
1. Ensure ESA is up-to-date.
2. Connect ESA to the chassis.
3. Update the HVAC Controller software to the latest available version. In ESA, click Tools | Flashing, then select Heating, Ventilation, and Air Conditioning from the Flashing Wizard window.

4. Select the most current software version from the Version Selection window.
5. Click Flash to update the software.
6. Disconnect ESA.
