Technical product information

Topic	New Flying Spur - Flying "B" Mascot
Market area	Bentley: worldwide (2WBE)
Brand	Bentley
Transaction No.	2058354/3
Level	EH
Status	Approval
Release date

New Flying Spur

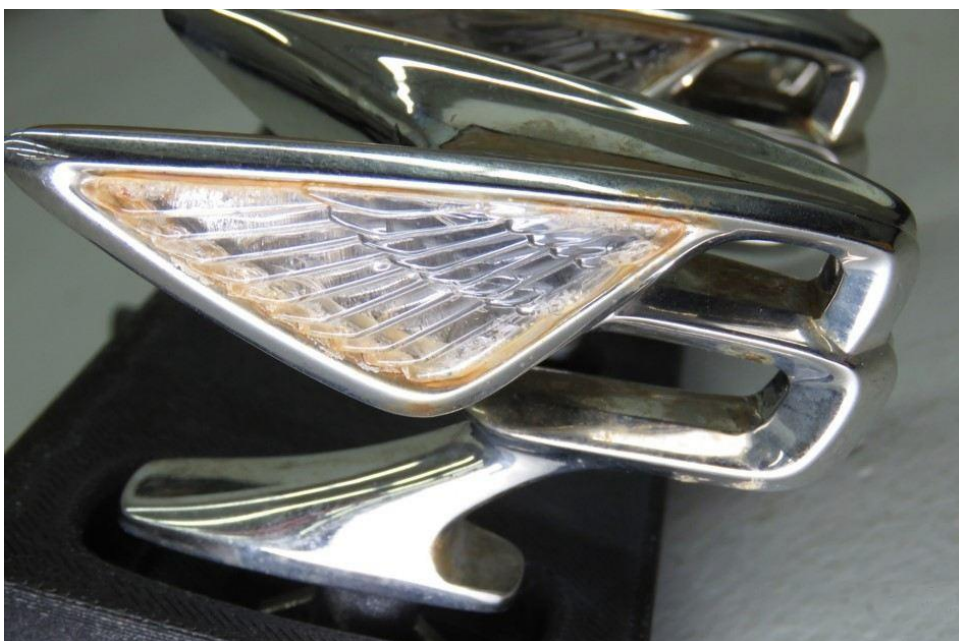
Figure 1

Corrosion – Damage codes 0001 and 0002

Description	Damage Code	Solution	Information
Corrosion beneath "clear" section of Flying "B" wings.	0001	Replace Flying "B" elevating assembly.	Figure 1.
Corrosion on edges of Flying "B" wings.	0002	Remove corrosion using metal polish. If corrosion cannot be removed successfully or there is a repeat complaint of corrosion, replace Flying "B" elevating assembly.	Figure 2. Care must be taken not to damage paint on Radiator Shell.
Functionality Slow operation / vibrates / fail to deploy / fail to stow / bounces back.	0017	Apply "Tri-Flow" lubricant. If the concern is still present after applying the lubricant, raise a DISS query and seek advice.	Figure 5. See <i>Functionality – Damage Codes 0017 and 0020 below.</i>

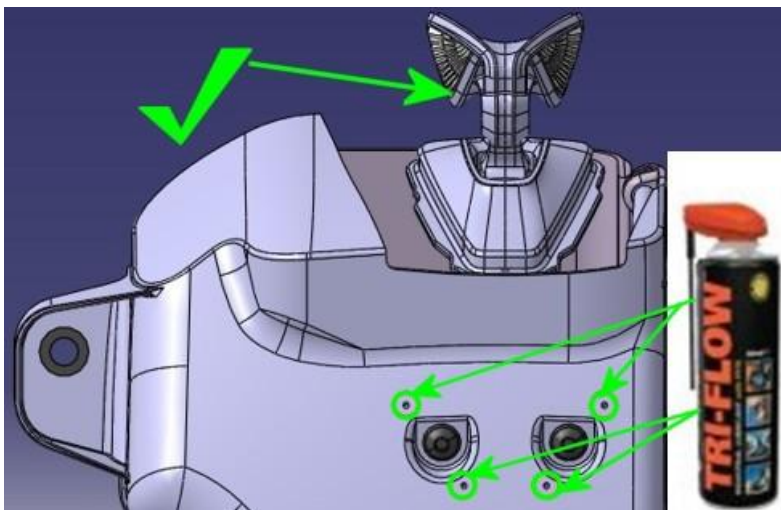
Figure 5

Functionality Noise during operation.	0020	Apply "Tri-Flow" lubricant. If the concern is still present after applying the lubricant, raise a DISS query and seek advice.	Figure 5. <i>See Functionality – Damage Codes 0017 and 0020 below.</i>
Surface Finish Surface - visual damage.	0030	Remove light surface damage using metal polish – if damage cannot be successfully removed replace Flying "B" elevating assembly.	Care must be taken not to damage paint on Radiator Shell.
Electrical fault - fail to deploy / fail to stow, wings do not illuminate or "flicker" when illuminated.	0040	If Diagnostic Trouble codes are stored in 8108 – Control Unit For Hood Ornament -follow <i>Guided Fault Finding</i> paths to determine root cause. Check condition of electrical connector and connections. If no fault found replace Flying "B" elevating assembly.	Figure 6.
Surface Finish – black painted variant. Insufficient paint adhesion.	0067	Replace Flying "B" elevating assembly.	Figure 7. Black variant only.

Referring to Figure 5- Ensuring the Flying "B" is revealed - Using the precision spray nozzle, lubricate the Flying "B" mechanism, apply "Tri-Flow" industrial lubricant into the four holes shown, the lubricant should be dispensed for two seconds at each location - Figure 5.

Conceal and reveal the Flying "B" five times to distribute the lubricant.

Remove any excess lubricant with a clean dry wipe.

If the complaint is still present, conceal the Flying "B" and repeat the lubrication process.

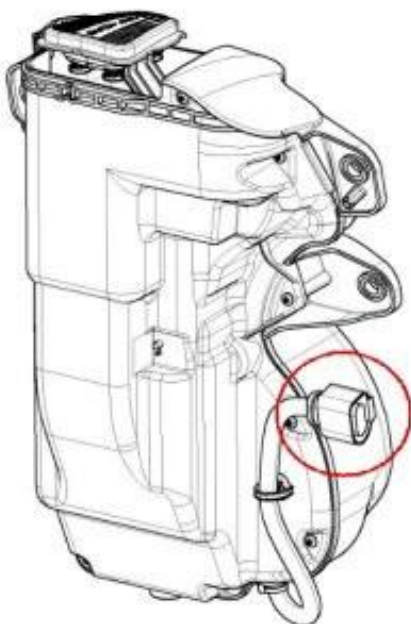
Figure 6

[Electrical fault – Damage code 0040](#)

Check condition of electrical connector and connections – Figure 6.
