Field campaign

Topic	Bank 1 - Intake manifold sensor replacement (SC 20/35)
Market area	Australia E04 Bentley rest Asia and Australia (6E04), United States E05 Bentley USA and rest America (6E05)
Brand	Bentley
Transaction No.	2061512/1
Campaign number	EB77
Note	
Type	
US code

Bank 1 Intake manifold sensor requires replacement

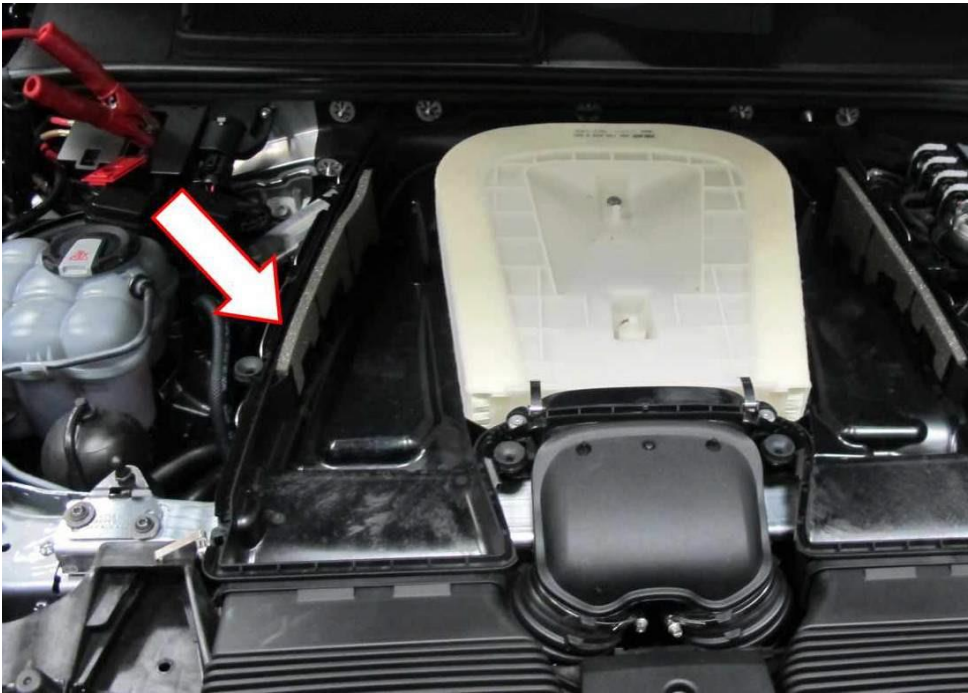
- Referring to Figure 1 (Arrow) Locate the sensor (Fitted to the Bank 1 Intake manifold)

For photographic purposes the Bank 1 sensor shown in Figure 1 was taken with the engine removed *NOTE: Engine removal is not required for this procedure although access to the sensor is tight*

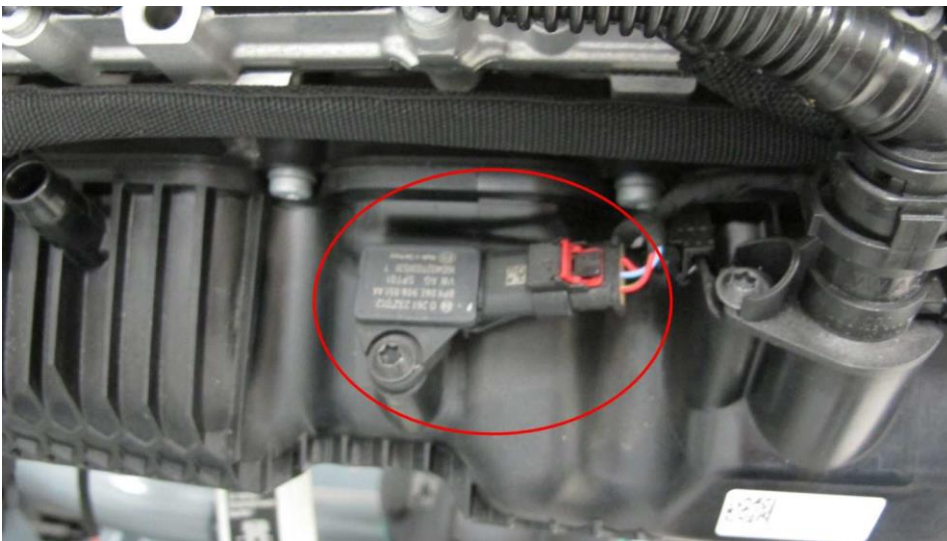
Figure 2

- Referring to Figure 2–Locate the sensor (Fitted to the bank 1–Intake manifold)

- Disconnect the electrical connection
 - Unscrew the sensor fixing (T20 Torx)
- 2) Remove the original sensor and discard
- Lightly lubricate the replacement sensor O-Ring with engine oil
 - Fit the new sensor into the Intake manifold
 - Torque tighten the fixing to 6 Nm
 - Reconnect the electrical connection
- 3) Referring to Rep. Gr 10–Refit the air filter element top cover and the right hand engine bay side cover
- Apply a yellow paint mark to the engine control module (Figure 3)

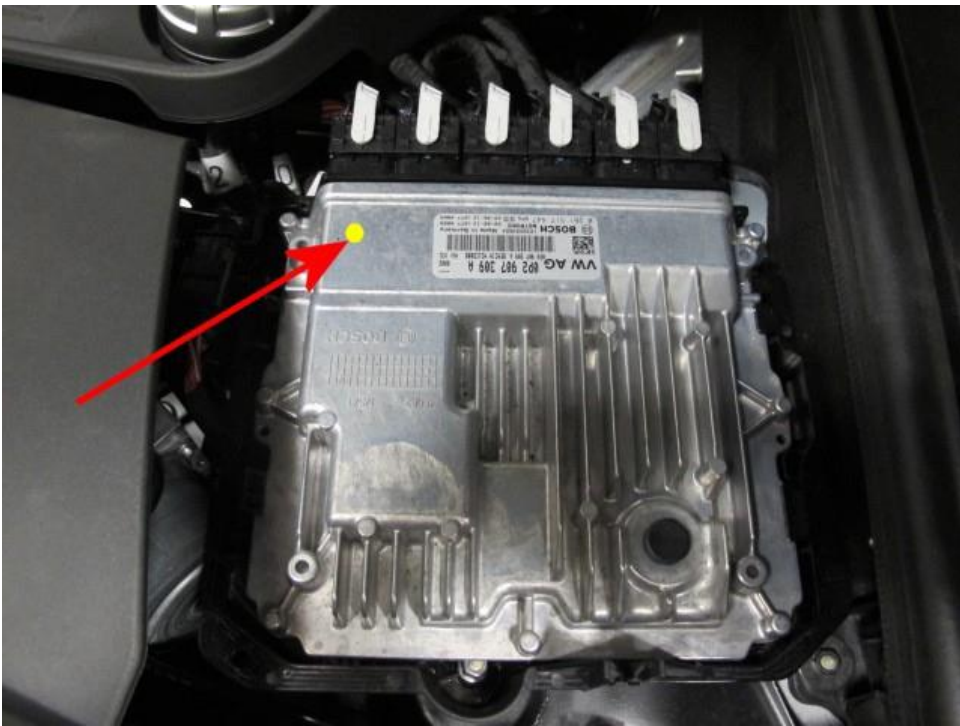
Figure 3

If the vehicle is not already listed as repaired in the "Repair history" (in Elsa Pro) check for the presence of a yellow paint mark on the engine control module (Figure 3)
