<b>HYUNDAI</b> <b>Technical Service Bulletin</b>	GROUP <b>Body</b>	NUMBER <b>20-BD-010H-2</b>
	DATE <b>November, 2020</b>	MODEL(S) <b>Accent (RB), Accent (HC) Elantra (MD/UD), Azera (HG), Sonata (LFa), Sonata Hybrid (LF HEV)</b>
<b>SUBJECT: TRUNK LATCH BASE REPLACEMENT</b>

This TSB supersedes 20-BD-010H-1 to include the 2018MY Sonata (LFa) and Sonata Hybrid (LF HEV).

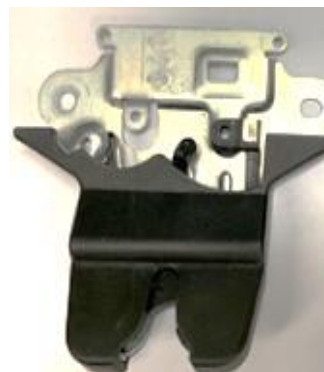
When reusing the actuator, do not contaminate the motor area.

3. Replace the trunk lid latch base and reuse the actuator.
