HYUNDAI Technical Service Bulletin	GROUP Body	NUMBER 20-BD-013H-1
	DATE November, 2020	MODEL(S) Sonata (DN8a)
SUBJECT: WINDOW NOISE REPAIR

Description: This bulletin describes the procedure to diagnose and repair a window exhibiting noise while lowering and raising.

Applicable Vehicles: Certain 2020MY Sonata (DN8a) vehicles produced from 10/22/19 – 6/11/20

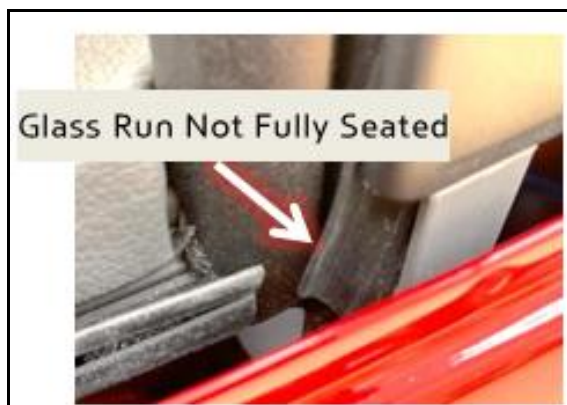
1. Inspect the glass run to determine if it is not seated.

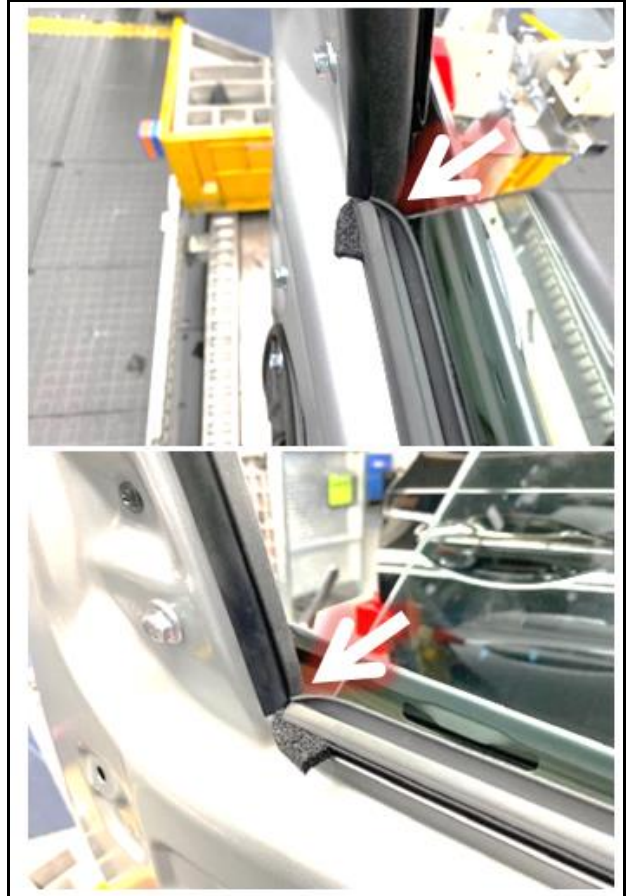
3. Inspect the belt molding and verify that the molding is fully seated and not underneath the glass run weather strip.

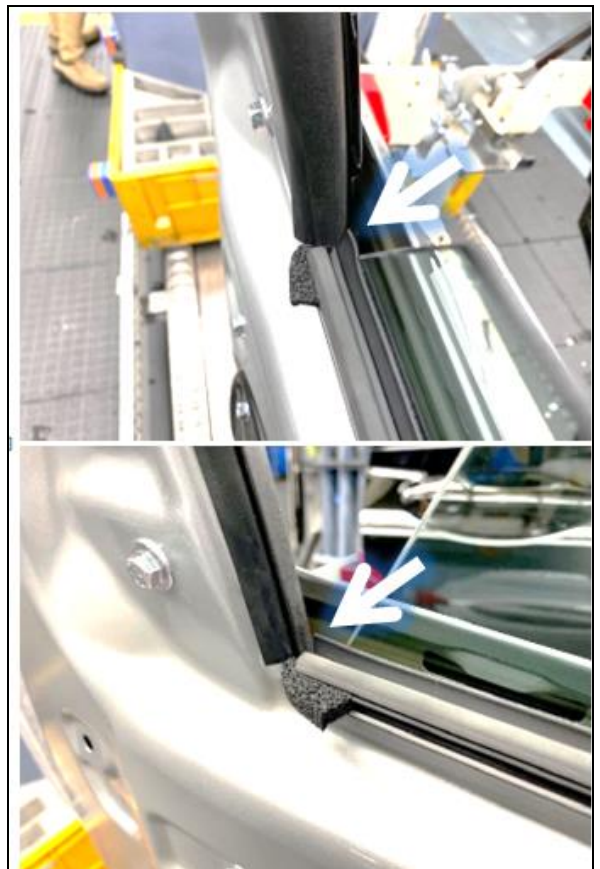
4. The belt molding should be aligned with the glass run weather strip.
