EL20-032

DTC B2724-23 AND/OR C1B56-04 STORED, AND/OR RAB ERROR MESSAGE OR WARNING

APPLIED VEHICLES: 2020-2021 QX50 (J55)

APPLIED SYSTEM: Rear Automatic Braking

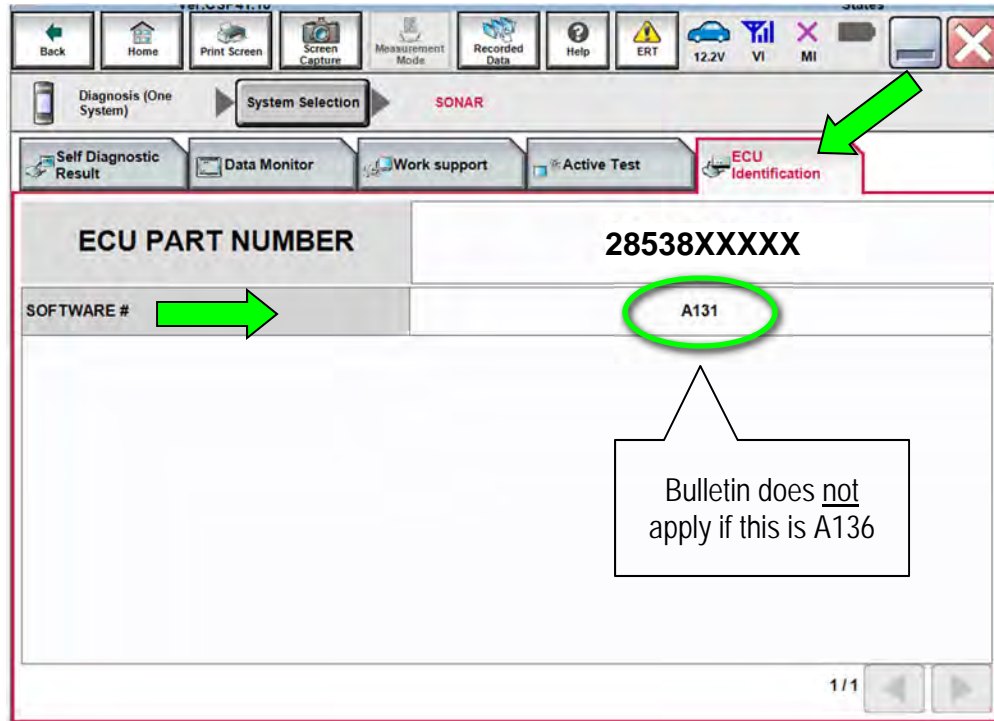
Figure 5

12. Select ECU Identification.
13. Confirm the SOFTWARE #. See Figure 5.
 - If the SOFTWARE # is A136, this bulletin does not apply. See the Electronic Service Manual (ESM) for further diagnostic information.
 - If the SOFTWARE # is not A136, proceed to step 14.

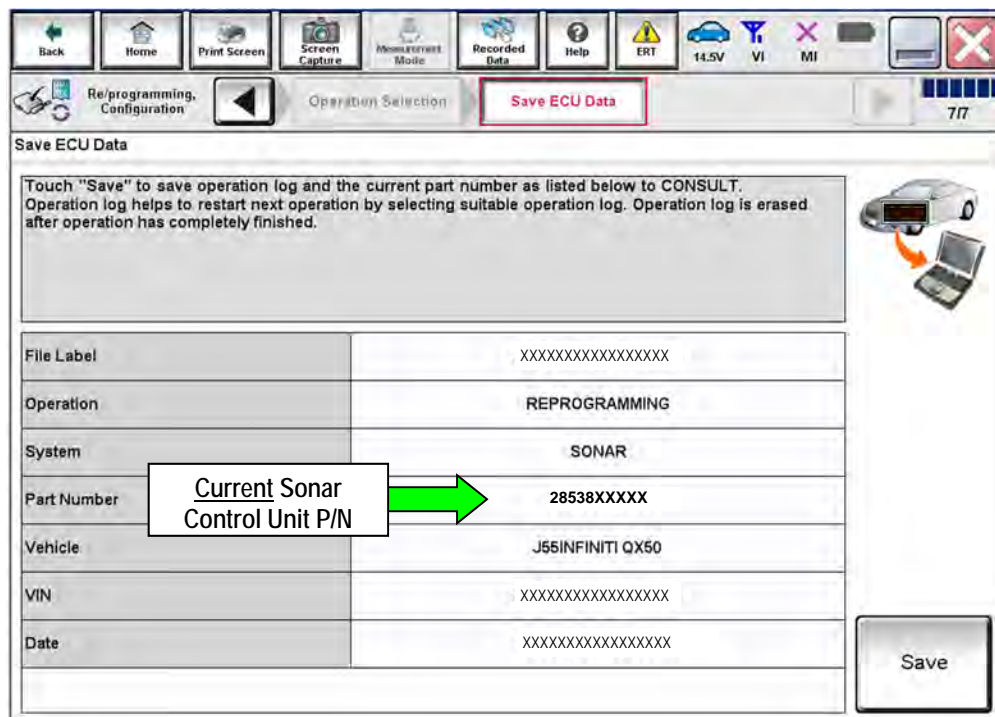
Figure 14

25. When you get to the screen shown in Figure 14, confirm that a reprogram is available as follows.

- A. Find the Sonar Control Unit Part Number and write it on the repair order.

- B. Compare the part number you wrote down to the part numbers in **Table A**.
- If there is a match, continue with the reprogramming procedure.
 - If there is not a match in **Table A**, this bulletin does not apply. See the ESM for further diagnostic information.

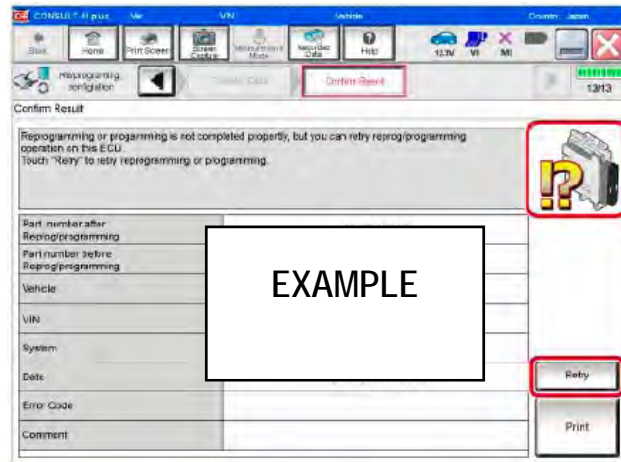
Figure 25

If reprogramming does not complete and the “!?” icon displays as shown in Figure 25:

- Check battery voltage (12.0 - 15.5 V).
- Ignition is ON, engine OFF.
- External Bluetooth® devices are OFF.
- **All electrical loads are OFF.**
- **Select retry and follow the on screen instructions.**
- “Retry” may not go through on first attempt and can be selected more than once.

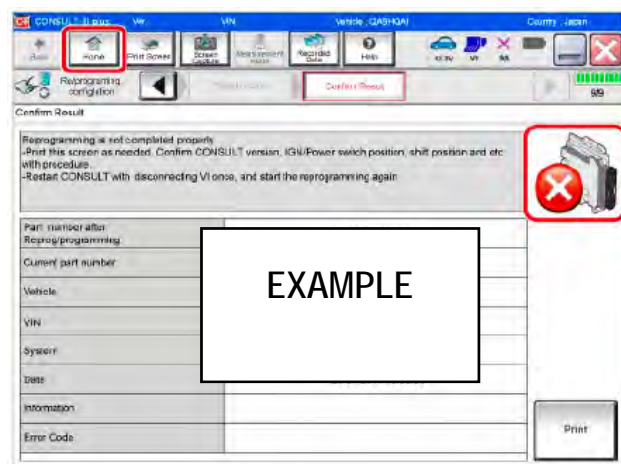
Figure 26

If reprogramming does not complete and the “X” icon displays as shown in Figure 26:

- Check battery voltage (12.0 - 15.5 V).
- CONSULT A/C adapter is plugged in.
- Ignition is ON, engine OFF.
- Transmission is in Park.
- All C-III plus / VI cables are securely connected.
- All C-III plus updates are installed.
- **Select Home, and restart the reprogram procedure from the beginning.**

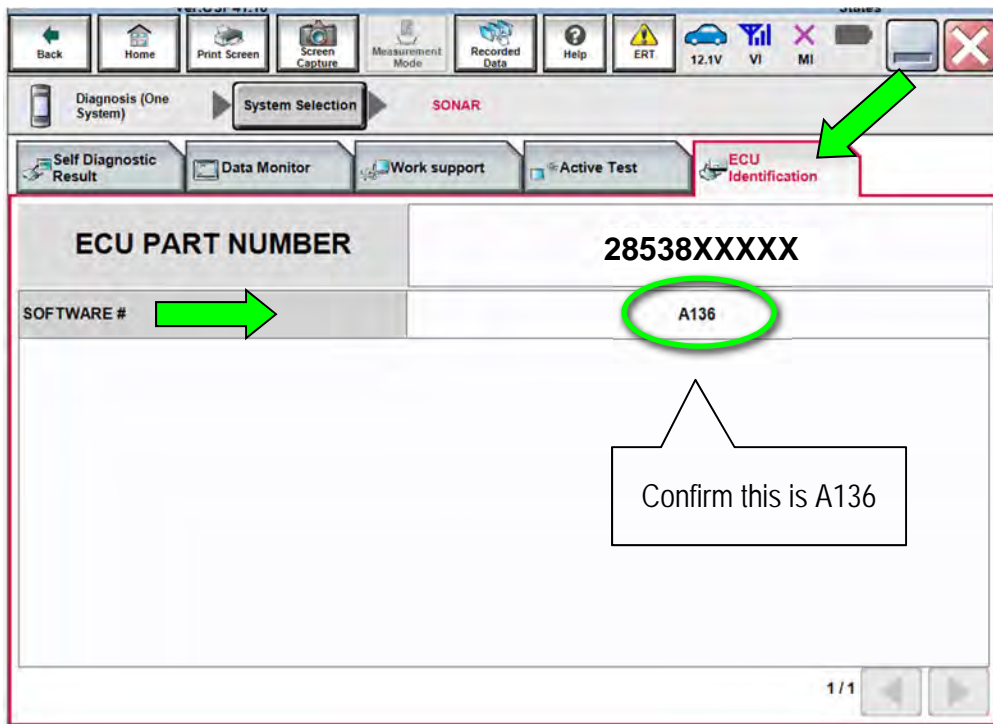
Figure 39

62. Confirm the SOFTWARE #. See Figure 39.

- If the SOFTWARE # is A136, proceed to step 63.
- If the SOFTWARE # is not A136, reprogramming did not successfully complete. Go back to step 15 on page 6 and perform the procedure again.

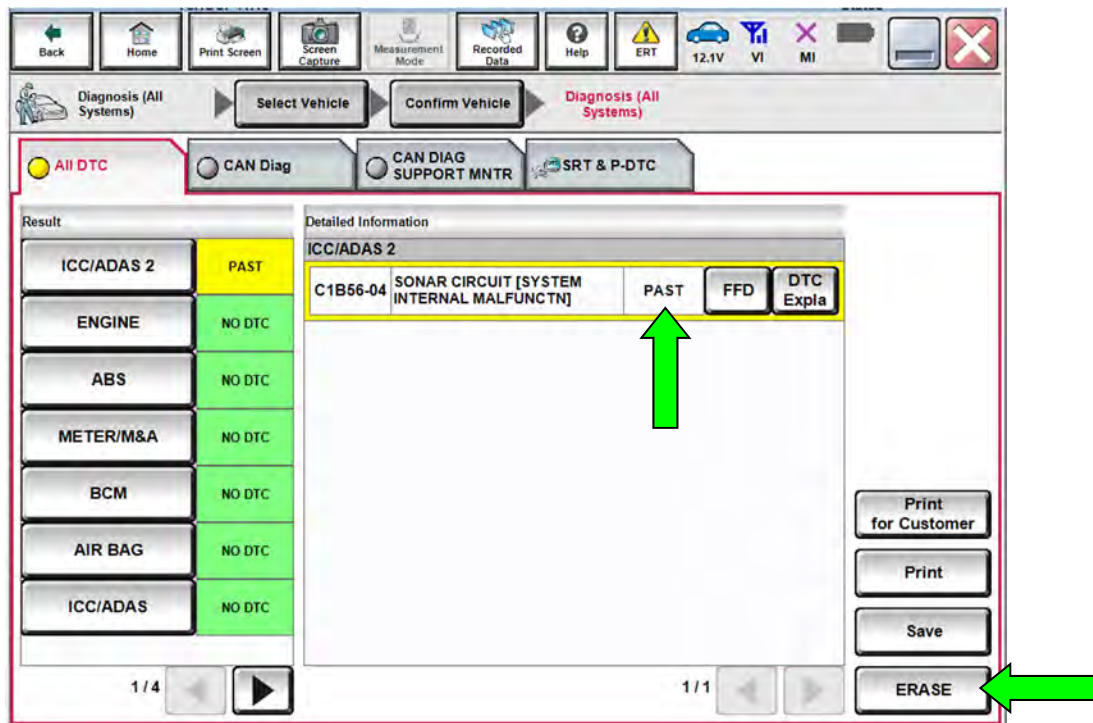
Figure 42

65. Select **Automatic Selection(VIN)**.
66. Select **Confirm**.
67. Select **Confirm**.
68. Turn the ignition OFF, then turn the ignition ON.
69. Confirm DTC C1B56-04 is displayed as **PAST** (not **CRNT**). See Figure 42.
70. Select **ERASE**.
