# SERVICE BULLETIN

EC17-033c

NTB17-113c

## 2017-2020 ROGUE SPORT; WHEN COLD, LONG CRANK TIME / ENGINE TURNS OFF / HESITATION / ROUGH IDLE / MISFIRE

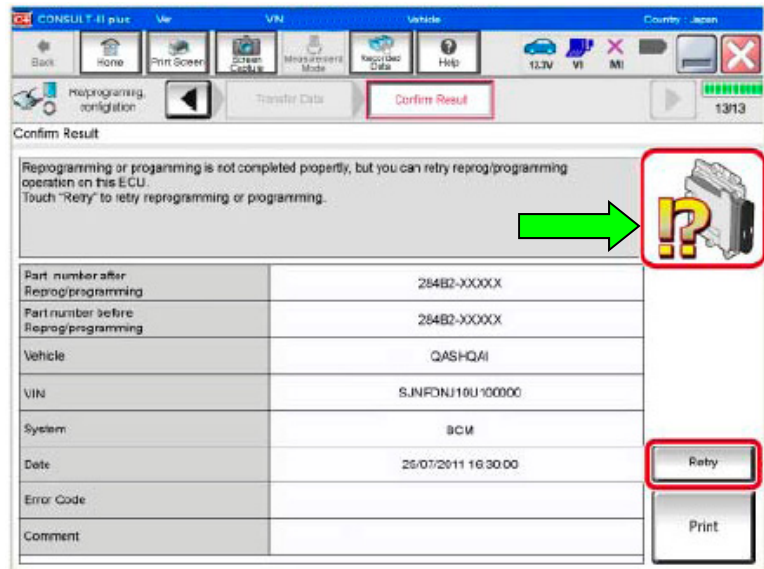
Figure 6

If reprogramming does not complete and the “!?” icon displays as shown in Figure 6:

- Check battery voltage (12.0–15.5 V).
- Ignition is ON, engine OFF.
- External Bluetooth® devices are OFF.
- All electrical loads are OFF.
- **Select retry and follow the on screen instructions.**
- “Retry” may not go through on first attempt and can be selected more than once.

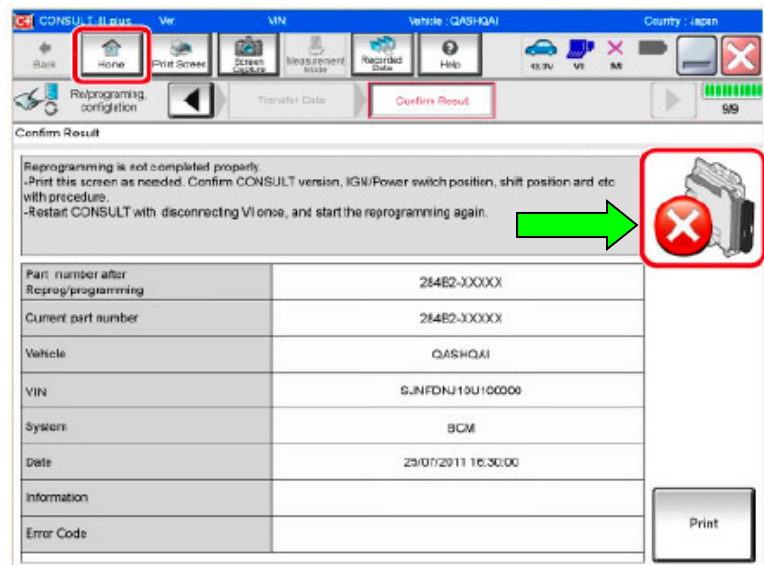
Figure 7

If reprogramming does not complete and the “X” icon displays as shown in Figure 7:

- Check battery voltage (12.0 – 15.5 V).
- CONSULT A/C adapter is plugged in.
- Ignition is ON, engine OFF.
- Transmission is in Park.
- All C-III plus / VI cables are securely connected.
- All C-III plus updates are installed.
- **Select Home, and restart the reprogram procedure from the beginning.**
