SERVICE BULLETIN

EL20-008b

NTB20-016b

RADIO INTERMITTENTLY REBOOTS DURING AUDIO PLAYBACK VIA BLUETOOTH CONNECTED IPHONE

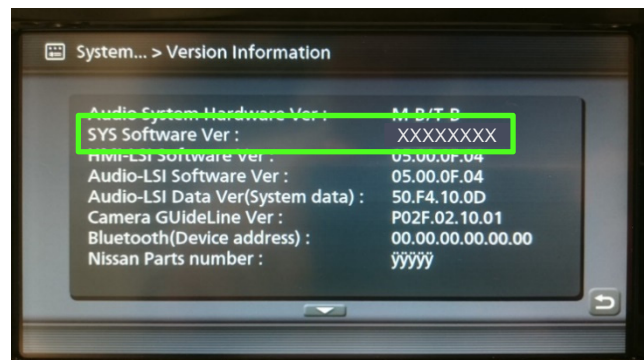
Figure 6

6. Select **Version Information**. Version information should display as shown in Figure 6.

- If the **SYS Software Version #** is less than the numbers shown below, turn the ignition OFF and continue to step 7 on page 4.
- If the **SYS Software Version #** is equal to or greater than the numbers shown below, no software update is needed. Go to ASIST for further diagnostic and repair information.

- For 2018-2019 Sentra, Versa Note and Versa Sedan: 80856035
- For 2020 Versa Sedan and 2018-2020 Kicks: 80851035
- For 2018-2020 NV: 80856235
- For 2018-2020 Frontier: 80856135

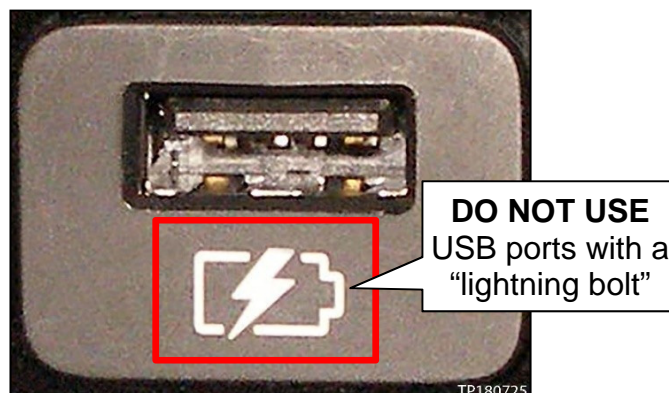
Figure 12

NOTICE Do not insert the USB drive into a charging port (Figure 12). If used, the update software and/or USB drive may become damaged. Only insert the USB drive in a USB media port.
