12/2/2020
CAL FTL 32-006

**Subject: Hendrickson Primaax EX 69,000 lb
Tri-Axle Rear Air Suspension Height-Control
Valve Relocation**

**Models Affected: Specific Freightliner M2 vehicles manufactured
between January 1, 2015 and June 4, 2020 equipped with a
Hendrickson Primaaz 69000 lb tri-axle rear air suspension**

NOTE: REVISED 12/2/2020: Step 8 drilling instructions expanded.

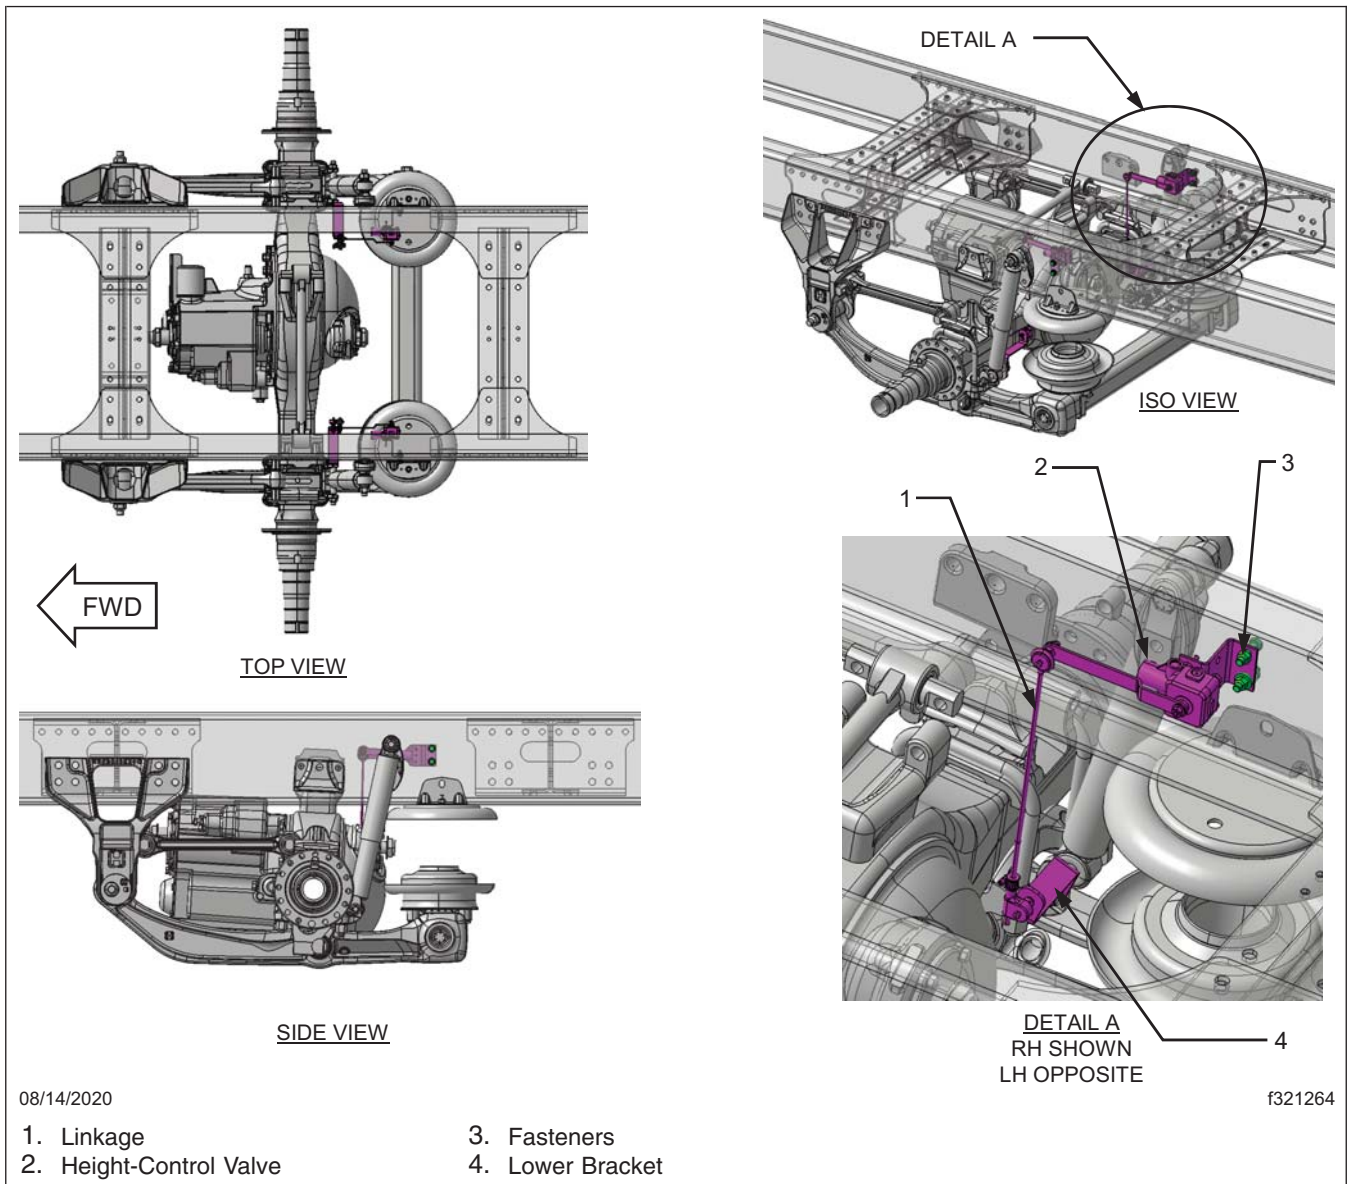
Fig. 1, Location of Height-Control Valves

The attached document provides work instructions for relocating the height-control valve downward 1.62 inches (41.3 mm) to prevent the linkage from protruding above the top flange of the frame when the suspension air is dumped.

1. Park the vehicle on a level surface, set the parking brakes, and *chock the tires*.
2. Put the transmission in neutral and build the air pressure to at least 100 psi. Shut down the engine.
3. Release the parking brakes.
4. Locate the height-control valves installed just rear of the mid-axle inside the left-hand and right-hand frame. See [Fig. 1](#).
