SS 1034831 Replacement Parts to Address Exhaust Brackets

Service Solution Title -- Replacement Parts to Address Exhaust Brackets or Clamp.

Applicable Vehicles--B2 TBB School Buses built between 2017 to 2020.

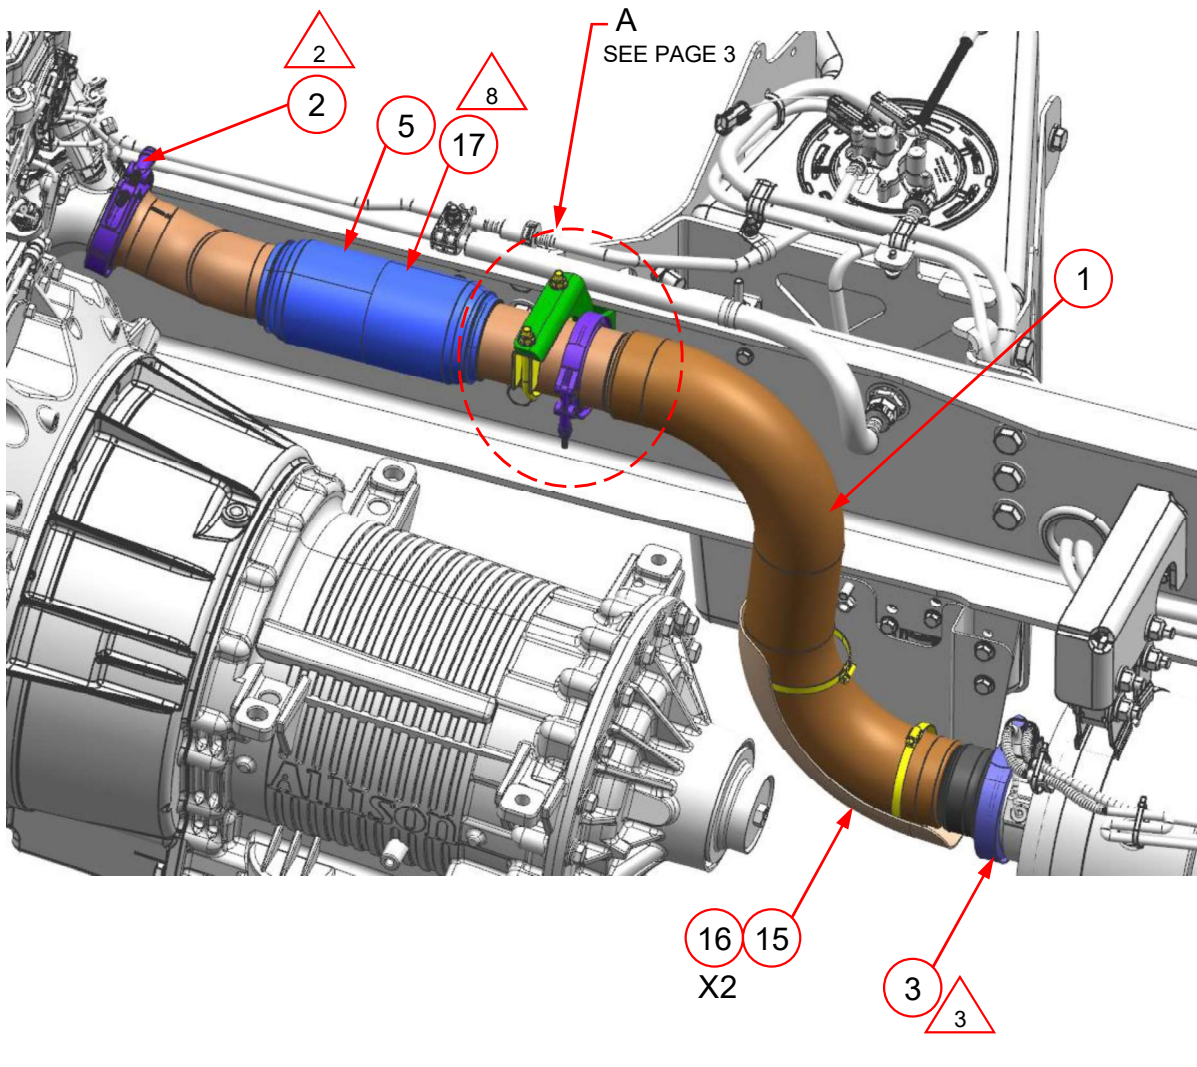
Symptoms--Exhaust pipe brackets and/or band clamp may fail.

Issue--Exhaust pipe brackets and/or band clamp may fail.

Solution--Exhaust pipe brackets and/or band clamp may fail. If either of the existing brackets or band clamp fails, the replacement parts will be the following using the attached Install drawing D04-35531-000.

Failure criteria	Replacement strategy	Additional parts to remove	Additional new parts
If 04-33140-000 fails	Replace with 04-35530-000	04-33141-000 and 04-20164-002	Saddle clamp 23-09289-001. TORQUE TO 23 FT-LBS, RANGE 20 -26 FT-LBS.
If 04-33141-000 fails	Replace with 04-35530-000	04-33140-000 and 04-20164-002	Saddle clamp 23-09289-001. TORQUE TO 23 FT-LBS, RANGE 20 -26 FT-LBS.
If 04-20164-002 Band clamp fails	Replace with saddle clamp 23-09289-001. TORQUE TO 23 FT-LBS, RANGE 20 -26 FT-LBS.	04-33141-000 and 04-33140-000	New bracket 04-35530-000.
