Preliminary Information

PIT5796 Drivers Memory Seat Does Not Adjust / Move To Its Full Travel

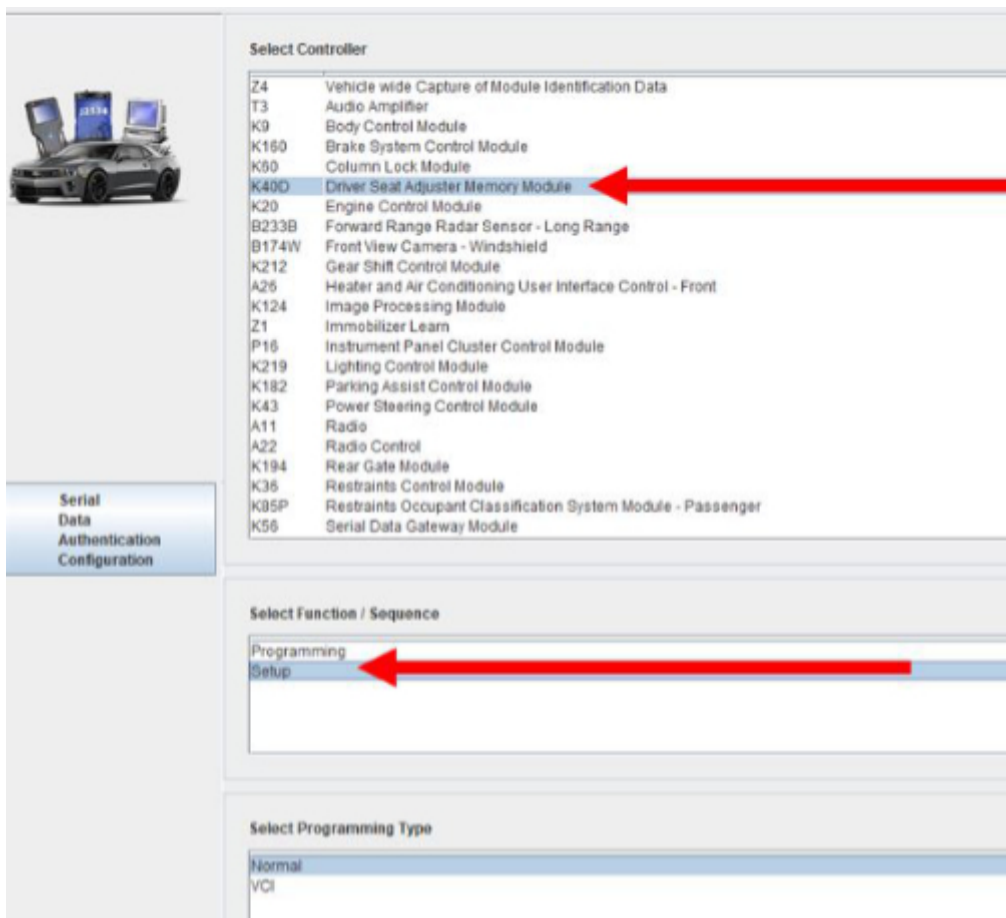
Involved Region or Country	North America
Condition	Some customers may comment that when they use the driver's power seat switch, the seat does not move to its full travel. Example, the driver's seat back will not fully recline or the seat will not move to the full rearward position.
Cause	This concern could be caused by a software issue with the K40D Driver's Seat Adjuster Memory Module.

To correct this concern, perform the SPS "setup" procedure, listed in Tis2Web, for the K40D Drivers Seat Adjuster Memory Module, shown below.
