PIP5765 Diagnostic Tip - Fuel Odor From Engine Compartment

Brand:	Model:	Model Years:	VIN:		Engine:	Transmissions:
			from	to		
Buick	Encore GX	2020 - 2021	All	All	1.3L (L3T)	All
Chevrolet	Trailblazer	2021	All	All	1.3L (L3T)	All

Involved Region or Country	North America
Condition	Fuel Odor From Engine Compartment
Cause	Fuel Leakage From Fuel Rail

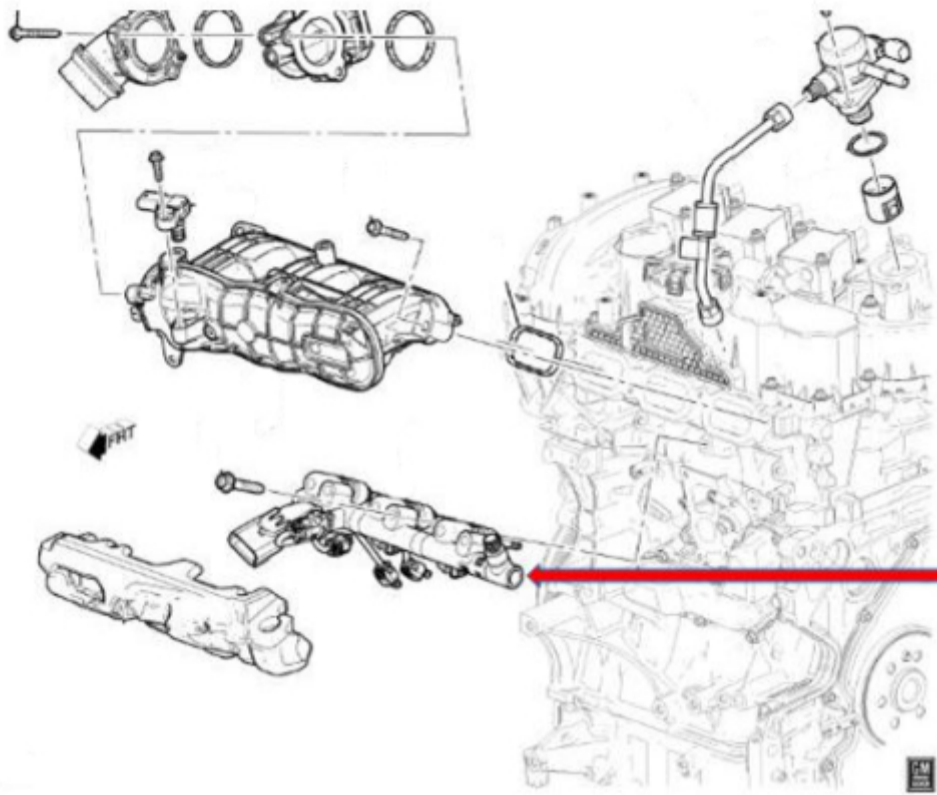
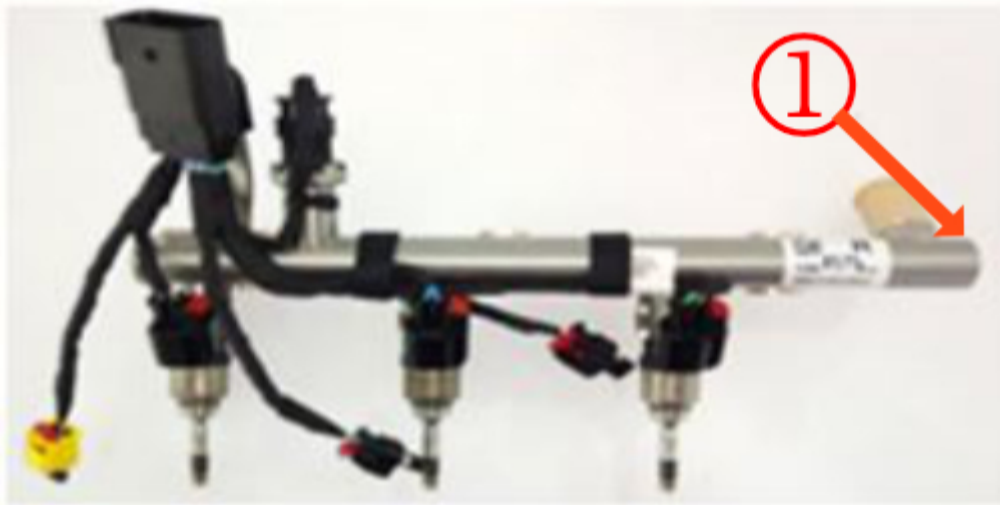
Inspect the Fuel Rail end cap at the location shown below for signs of dye or leakage.

Replace any fuel system component where leakage is found following all GSI service procedures and confirm the repair.
