Preliminary Information

PIT5404G Squeak Chirp Whistle Rattle Type Noise from Rear of Vehicle (Passive Exhaust Valve) or Buffeting Vibration Drone Exhaust Tone Change Body Pressure Booming (AFM Exhaust)

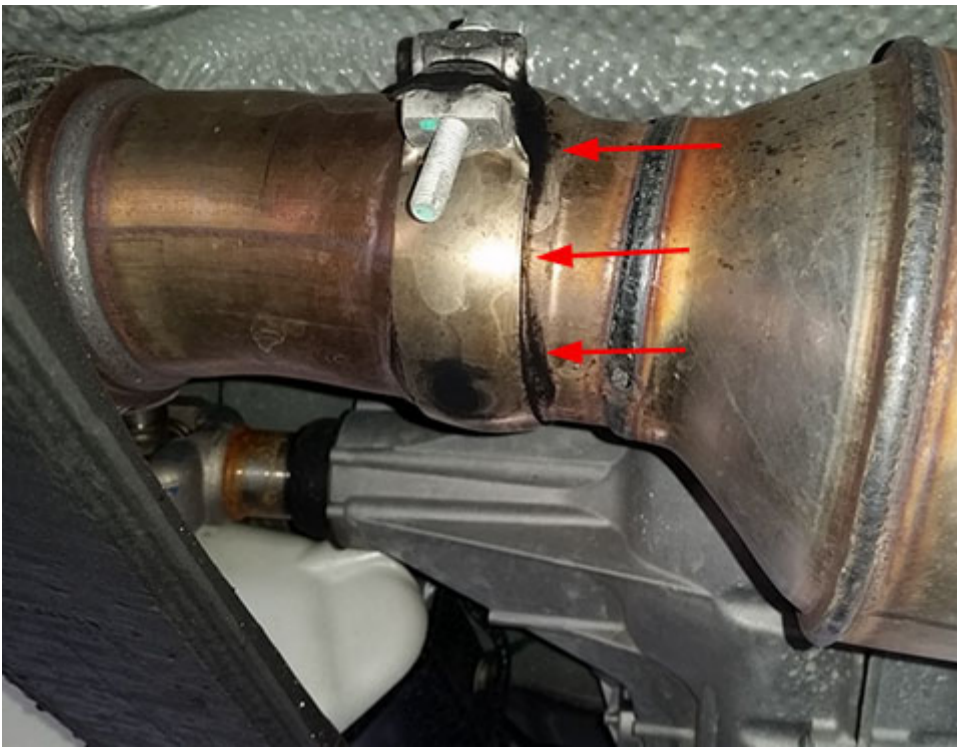
1. Ensure there are no leaks at the exhaust band (Norma) clamp joint. It has been found in some cases that a leak at the clamp joint could allow some level of exhaust tone change or exhaust vibration/drone type noise and/or buffeting vibration or body pressure booming to occur. Refer to latest version of [PIP5442](#).
