SERVICE BULLETIN

Reference number:	SB-43-1461	Issued: 15 December, 2020
Subject:	DBX Lift Process	
Model(s):	DBX	
VIN Range:	All	
Applicable to:	All Dealers	
Distribute to:	After Sales Manager Executive Manager Service Manager Sales Manager	Warranty Staff Technician(s) Parts Staff

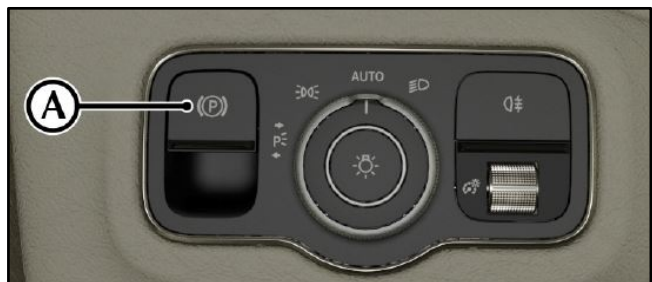
Figure 1

Aston Martin has found that the rear brake disc can move out of alignment with the rear hub when DBX is lifted on a vehicle lift. This is caused when the Electronic Park Brake (EPB) is applied and the transmission is in park (P) before the vehicle is lifted.

This can cause damage to the rear brake disc when a wheel is removed from the vehicle.

1. Release the EPB (A) (refer to Figure 1).

Note: Make sure the EPB symbol is not shown in the instrument cluster.
