SAFETY RECALL ACTION

Reference number:	RA-30-1471	Issued: 17 December, 2020
Subject:	Headliner Foam Block Installation	
Model(s):	DBX	
VIN range:	Refer to the separately published list of affected Vehicle Identification Numbers (VINs)	
Applicable to:	USA & Canada	
Distribute to:	After Sales Manager	Warranty Staff
	Service Manager	Technician(s)
	Sales Manager	Parts Staff

Reason for this Safety Recall Action (NHTSA Reference 20V-784)

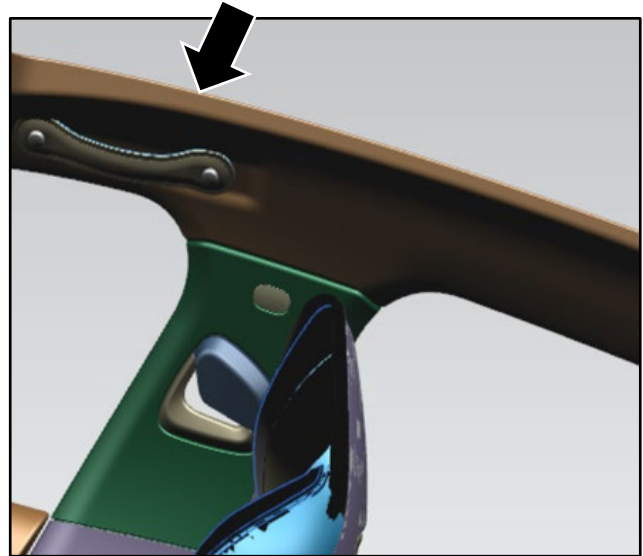
Figure 3

1. Find the headliner clipping point on the B pillar (refer to Figure 3).

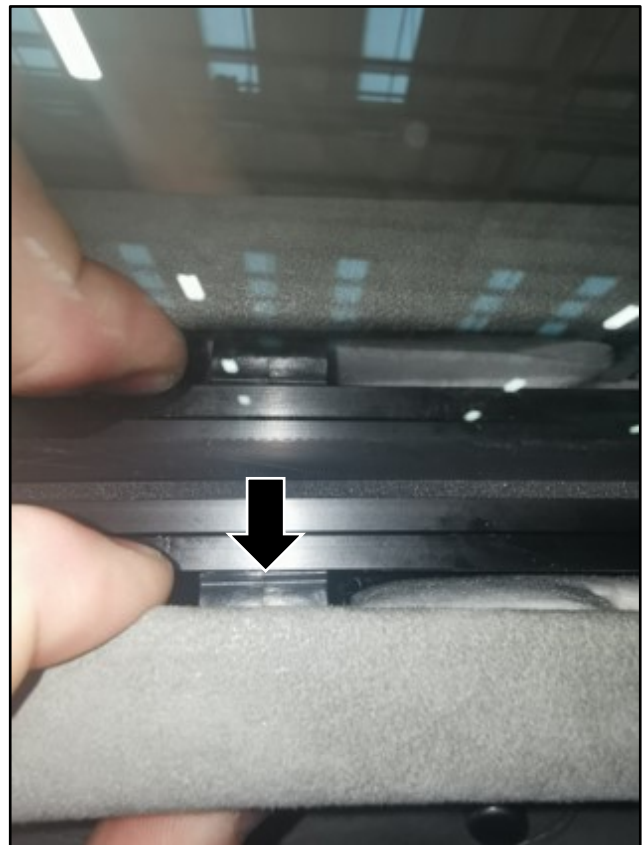
Figure 4

2. Carefully move the headliner down and push it back to disengage the clip (refer to Figure 4). This will let you access the recess for the headliner foam block.

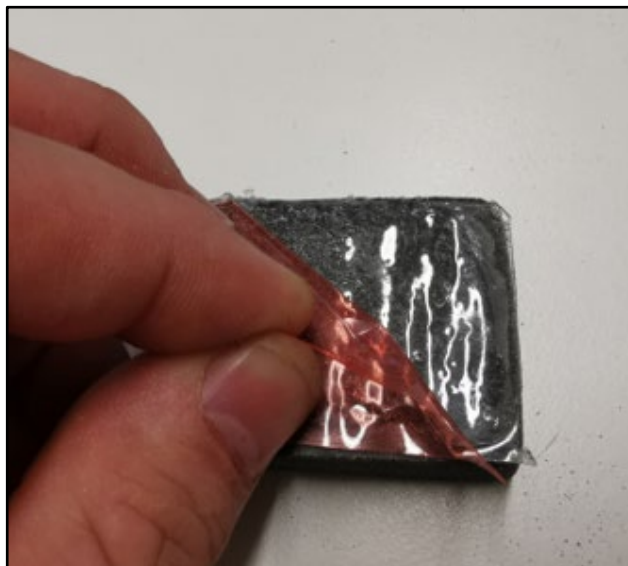
Figure 5

3. Remove the double-sided tape from the headliner foam block (refer to Figure 5).

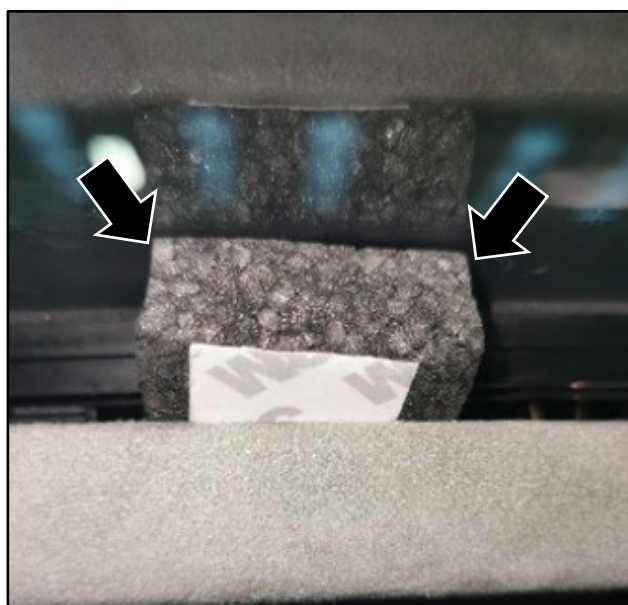
Figure 6

4. Put the headliner foam block into position between the roof rail and the headliner (refer to Figure 6).

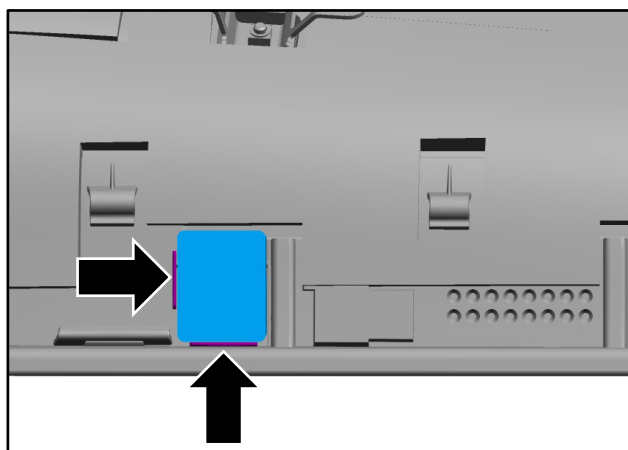
Figure 7

5. Install the headliner foam block on to the headliner assembly between the marks shown (refer to Figure 7).

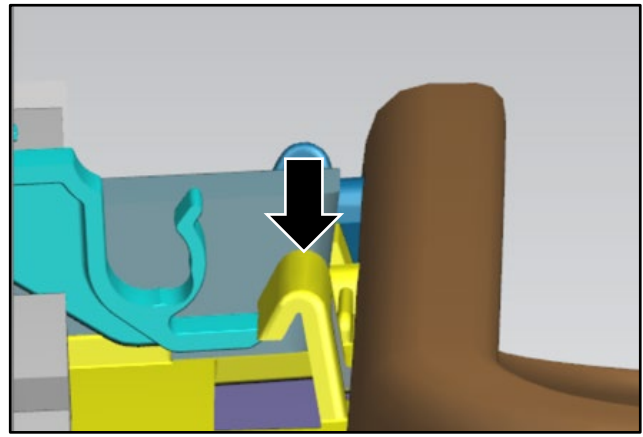
Figure 8

7. The headliner clip must be in the correct position before you install the headliner (refer to Figure 8).

Note: Take care when you install the headliner. The clips can be damaged if not in the position shown.

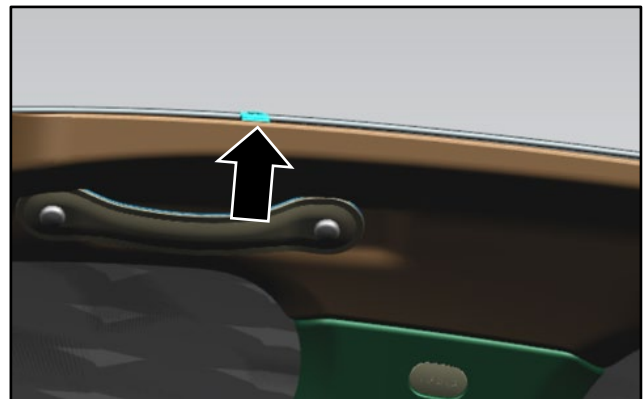
Figure 9

8. Install the headliner into position (refer to Figure 9). You will hear a click when the clip is engaged correctly.

Note: If you do not hear a click you must do steps 7 and 8 again.
