December 9, 2020

Version 1

Vehicle Cannot Be Refueled Completely

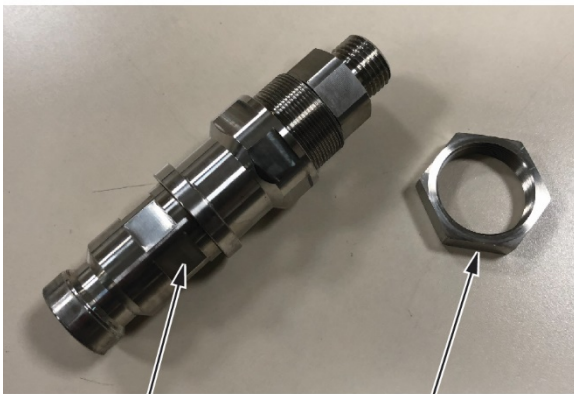
The hydrogen fuel fill receptacle does not conform to the SAE specifications of newer refueling nozzles.

12. Using a 32 mm socket, remove the nut from the rear of the fuel fill receptacle and remove the receptacle from the assembly.

RECEPTACLE
Remove.

NUT
Remove.
66 N.m (49 lb-ft)
