## Hissing noises and poor engine output when accelerating

| Topic number | LI09.41-N-071907 |
| Function group | 09.41 Charge air pipe/charge air cooling |
| Validity | Model 906 with engine 651 |

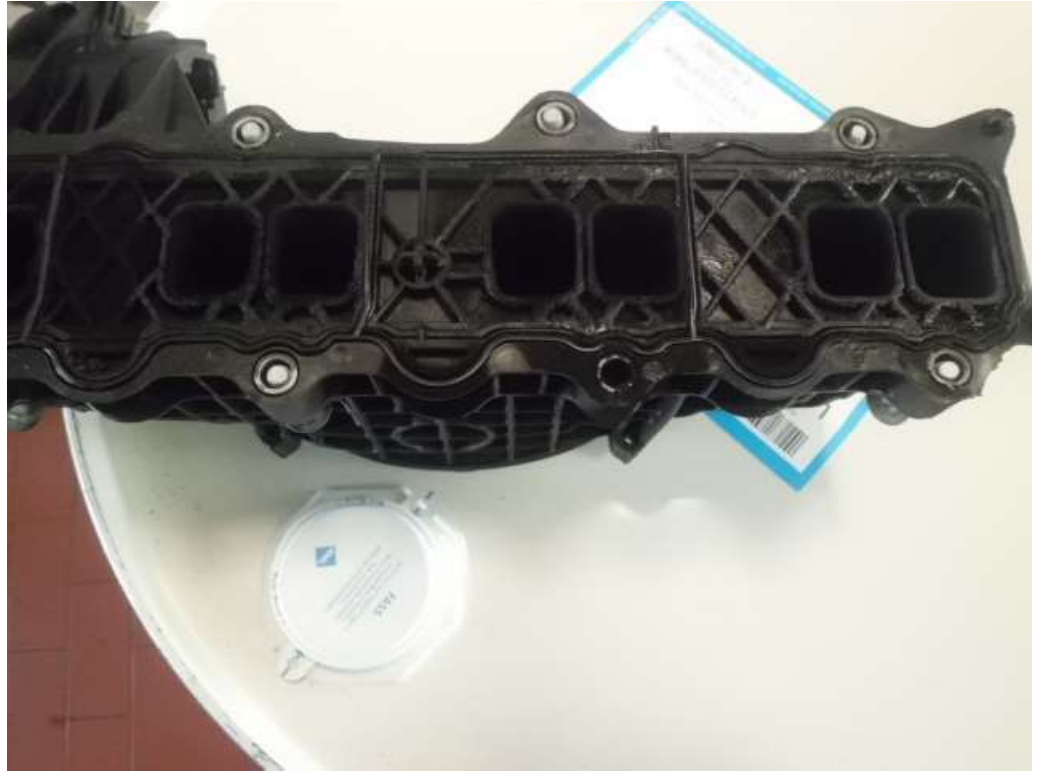
01.jpg:

One or more of the mounting screws of the charge-air distributor on the cylinder head could be loose or broken (see picture 01).

| Attachments | |
|---|---|
| 01.jpg | Missing mounting screw in charge-air distributor. |

1. Perform leak test of intake air system using leak tester (A000 588 18 21 00).

2. Remove the charge-air distributor (see AR09.41-D-1310WE for model 906).

5. Install the charge-air distributor (see AR09.41-D-1310WE for model 906).

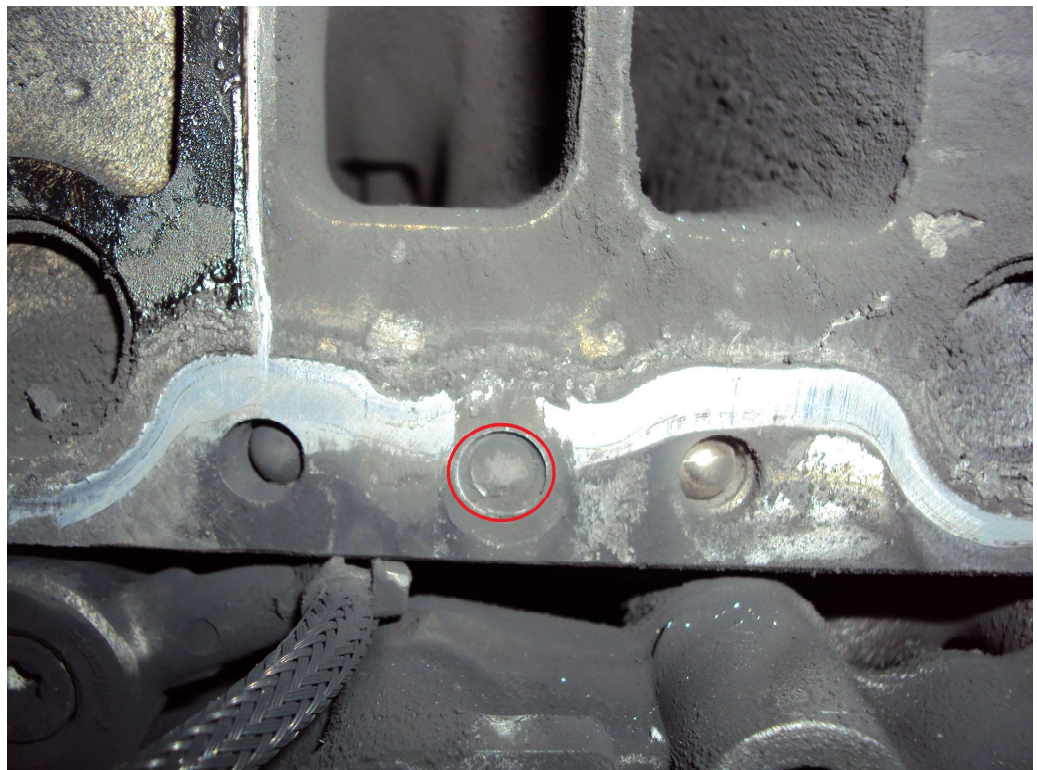
02.jpg:

4. Check the threaded holes for the charge-air distributor on the cylinder head for debris from the mounting screws (see picture 02).

| Attachments | |
|---|---|
| 02.jpg | Mounting screw debris in threaded hole of cylinder head. |

Information: Only do this if the mounting screws were broken. Any debris from mounting screws (see picture 02) must be properly removed from the threaded holes in the cylinder head.

Note: If any mounting screws are broken, all eight mounting screws must be replaced. The mounting screws with sleeves can be removed from and inserted into the charge-air distributor by hand (see picture 03). They are special stretch bolts. Consequently it is imperative that the screws listed in the parts table are used, otherwise repeat damage can occur.

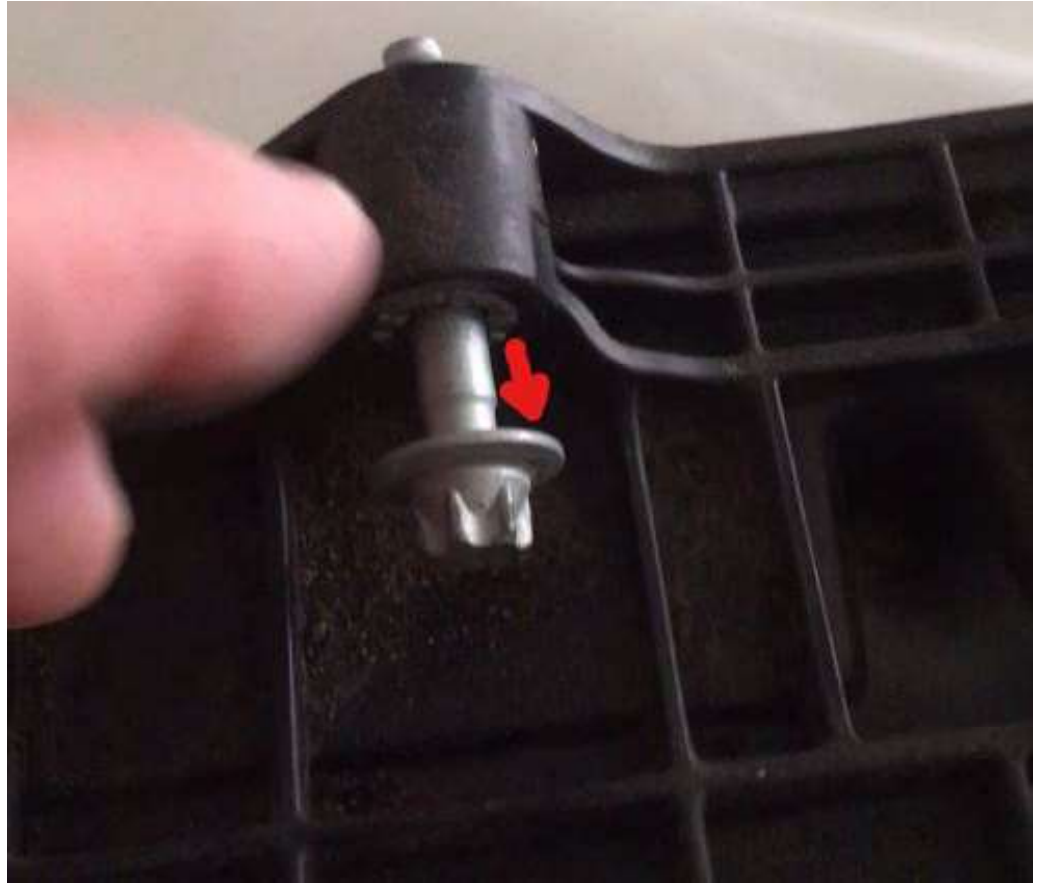
03.jpg:

| Attachments | |
|---|---|
| 03.jpg | Grip the screw head and pull the mounting screw with sleeve in the direction of the arrow out of the charge-air distributor. |

Information: When replacing the eight mounting screws, the old mounting screws with sleeves must be removed by hand from the charge-air distributor and the new mounting screws with sleeves must be inserted by hand into the charge-air distributor (see picture 03).
