Air recirculation flap malfunctions with fault code B10A207, B105C07, B109F07 and / or B113600 in ACC control units

Topic number	LI83.10-N-071291
Version	2
Function group	83.10 Ventilation
Date	11-20-2020
Validity	Model 907
Reason for change	Adding Information
Reason for block

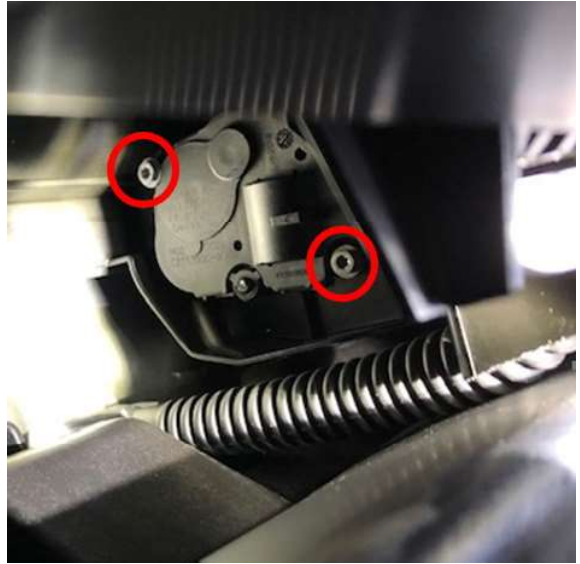
remedy 2 motor removal.
jpg:

During manufacturing process of heater case, stepper motors potentially installed in binding position onto linkage that may cause mechanical fault during actuation in unfavorable environmental conditions.

1. In control unit view N22/1, actuate each stepper motors with Xentry actuation
2. Locate actuator that is unresponsive to input
 - Pin point root cause without disassembly
3. Follow WIS to gain access to the unresponsive actuator
 1. Recirculation flap (AR83.10-D-2041TS)
 2. Blend air flap (AR83.10-D-2026TS)
 3. Distribution flap (AR83.10-D-2040TS)
4. "Disconnect electrical connector for stepper motor" - This will advertently perform a 'Hard Reset' on the motors
5. Remove diagnosed faulty stepper motor
6. Inspect linkage by hand for binding or harshness of movement (Replace if necessary)
7. Reinstall stepper motors (Complete torque of motors to case at 1.8Nm)
 - *** Follow correct torque to prevent new cause of binding of actuator motors***
8. Attempt to teach in Stepper motors using Xentry
 - If successful proceed to remedy 3
 - If unsuccessful Open PTSS case
