Service Bulletin

Bulletin No.: 19-NA-055

Subject: Accessory Front Floor Liner Warped, Bent Inward

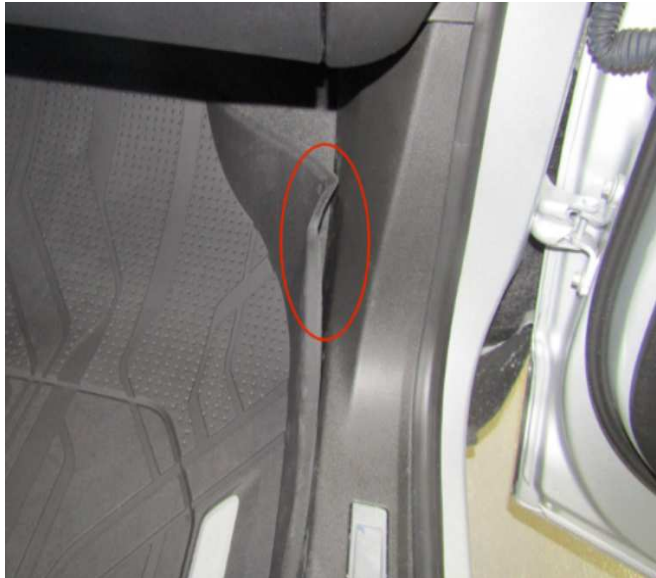
| Condition | <p style="text-align: right;">5280096</p> <p>Customer may comment on one, or both, front floor liners that being warped or bent inward.</p> |
| Cause | The cause of the condition may be a wire harness behind the garnish trim which pushes the trim inboard, creating a gap to the floor liner. |

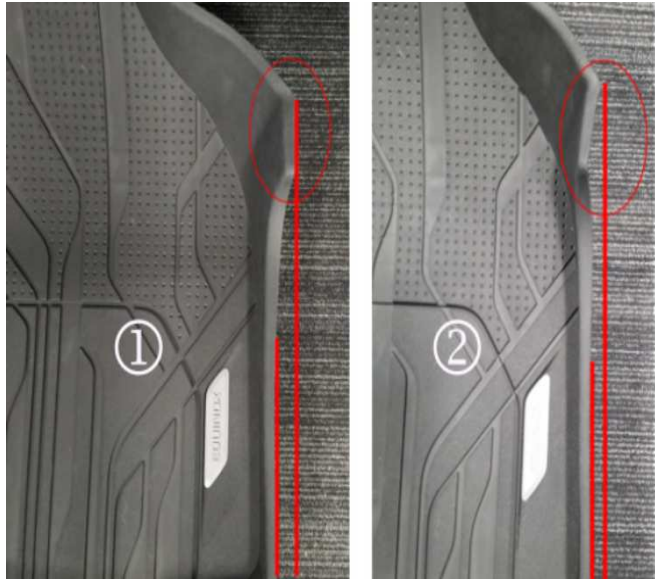
5280101

Note: Examples of a good (1) and bad (2) floor liner are shown in the graphic above.

First inspect the affected floor liner(s) to verify if it is a candidate for the trimming repair. Remove the floor liner(s) from the vehicle and lay flat on a clean surface:
