Service Bulletin

Bulletin No.: 20-NA-071

Subject: Service Engine Soon Lamp Illuminated and/or Service Power Brake Assist Message Displayed, with DTCs P0557 or P0558 Stored

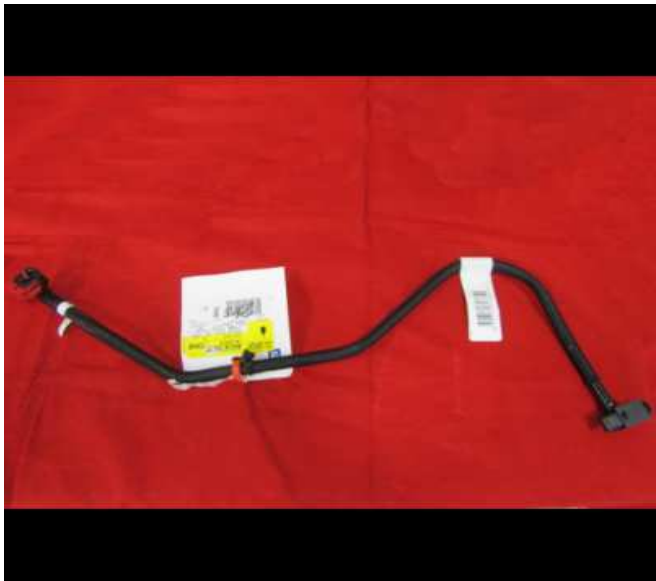
5549611

LFY Hose

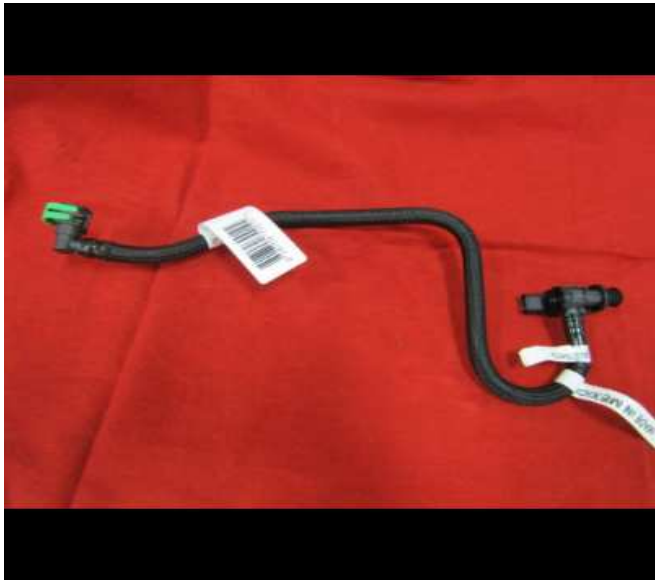
5549615

LGX Hose

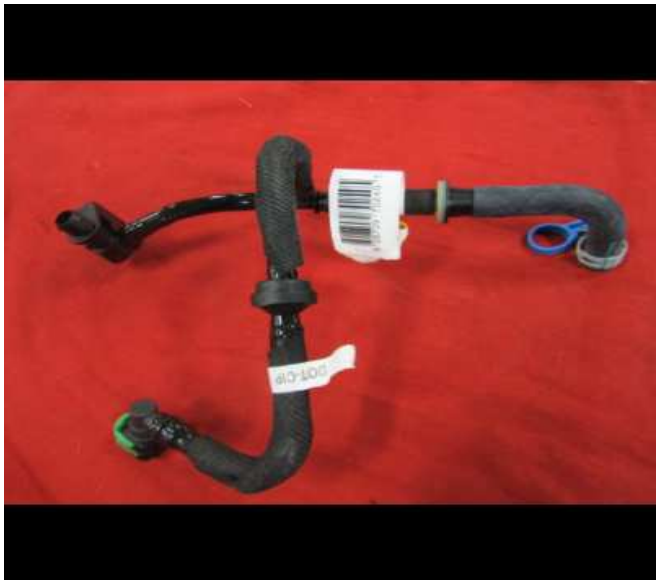
5549612

LCV Hose

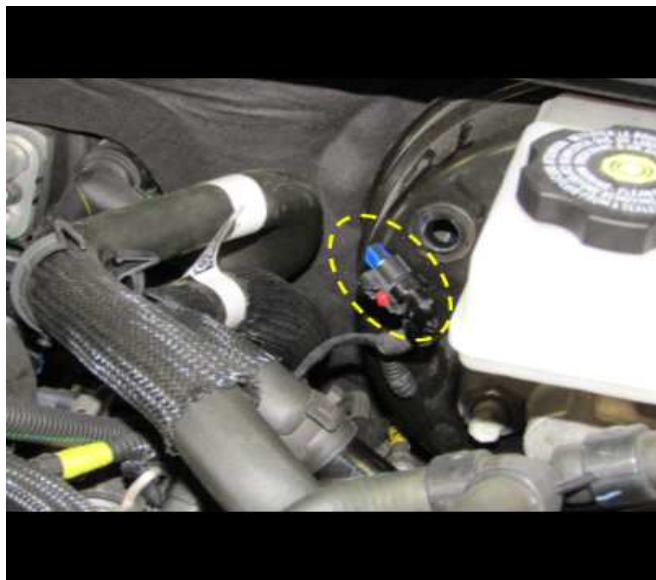
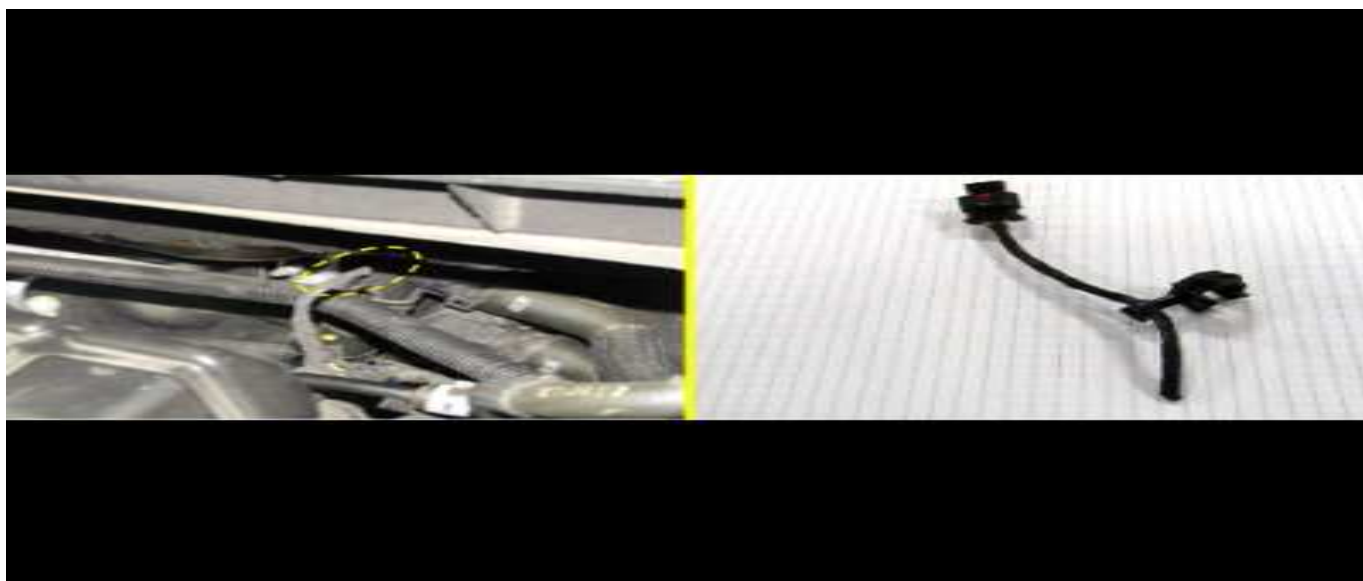
Note: The top graphic shows the LGX connector intact; the bottom one shows the LFY wiring already cut.

2. Locate the power brake booster vacuum sensor electrical connector. Fold conduit back and cut off connector, leaving approximately 5.0 cm (2.0 in) of wiring on the engine harness side.
3. Tape the cut wiring end to the engine harness. These wires will no longer be used.

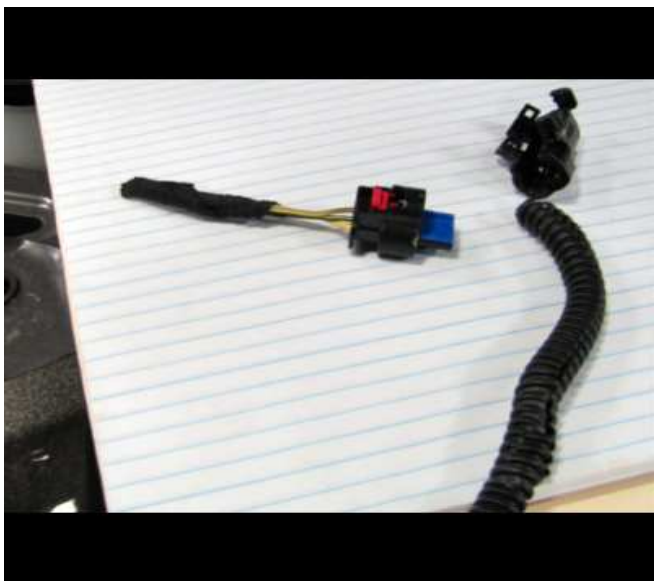
5549619

Note: Not all applications will have a cover on the connector.

4. Remove conduit and cover from the old connector.

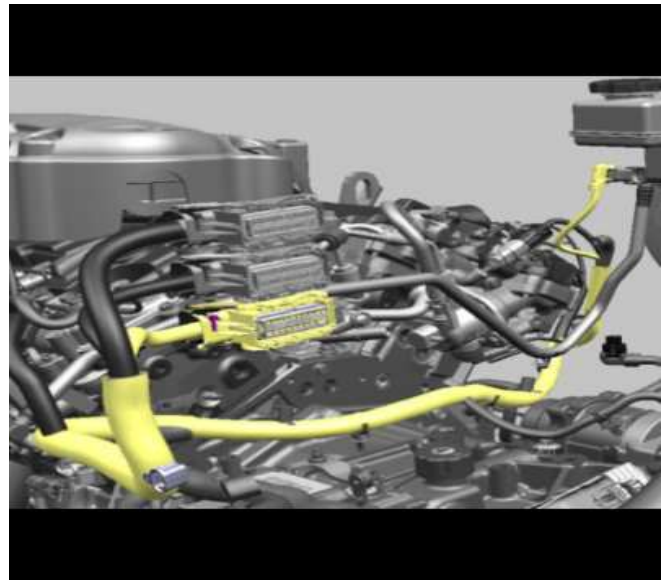
Note: The LFY harness routing is shown in the top graphic, the LGX routing is shown in the bottom math file. The routing for LCV is similar to the routing of the LGX.

10. Start routing the new harness alongside the engine harness.

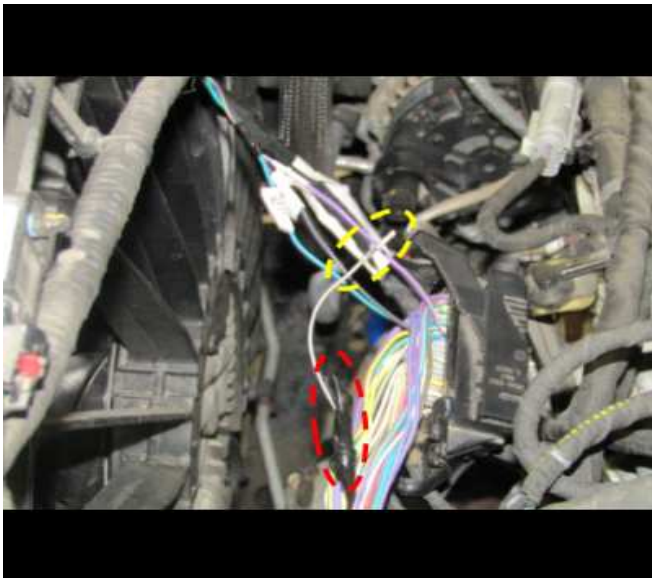
5549629

Note: In this step, do NOT cut the terminal off of circuit #2151 (circled in yellow in the graphic above).

15. Cut off the terminated leads that were in circuits #6030 and #6031 and fold and tape off the ends (circled in red in the graphic above). These circuits will no longer be used.

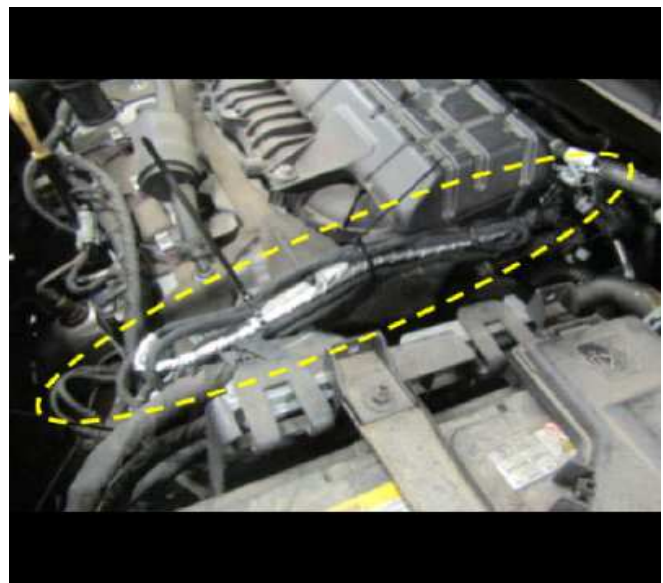
5549633

Note: Graphic shown above is LFY harness routing.
