# Service Bulletin

Bulletin No.: 20-NA-097

**Subject:** Unwanted Radio Volume Ramp Up to Max, Radio Resets, Radio Display Blank, or Non-Responsive to Touch

*This bulletin replaces PIT5722. Please discard PIT5722.*

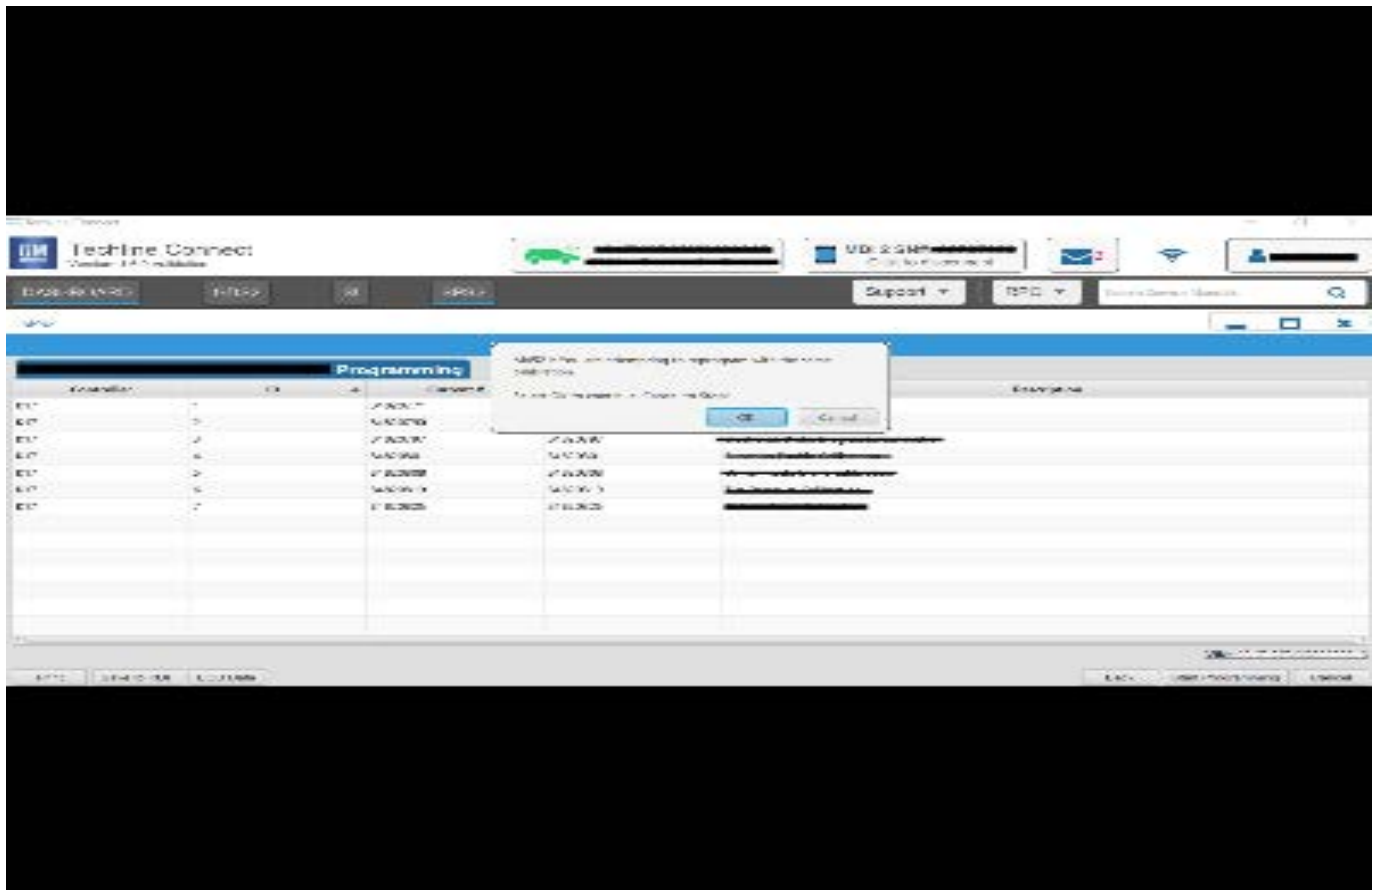
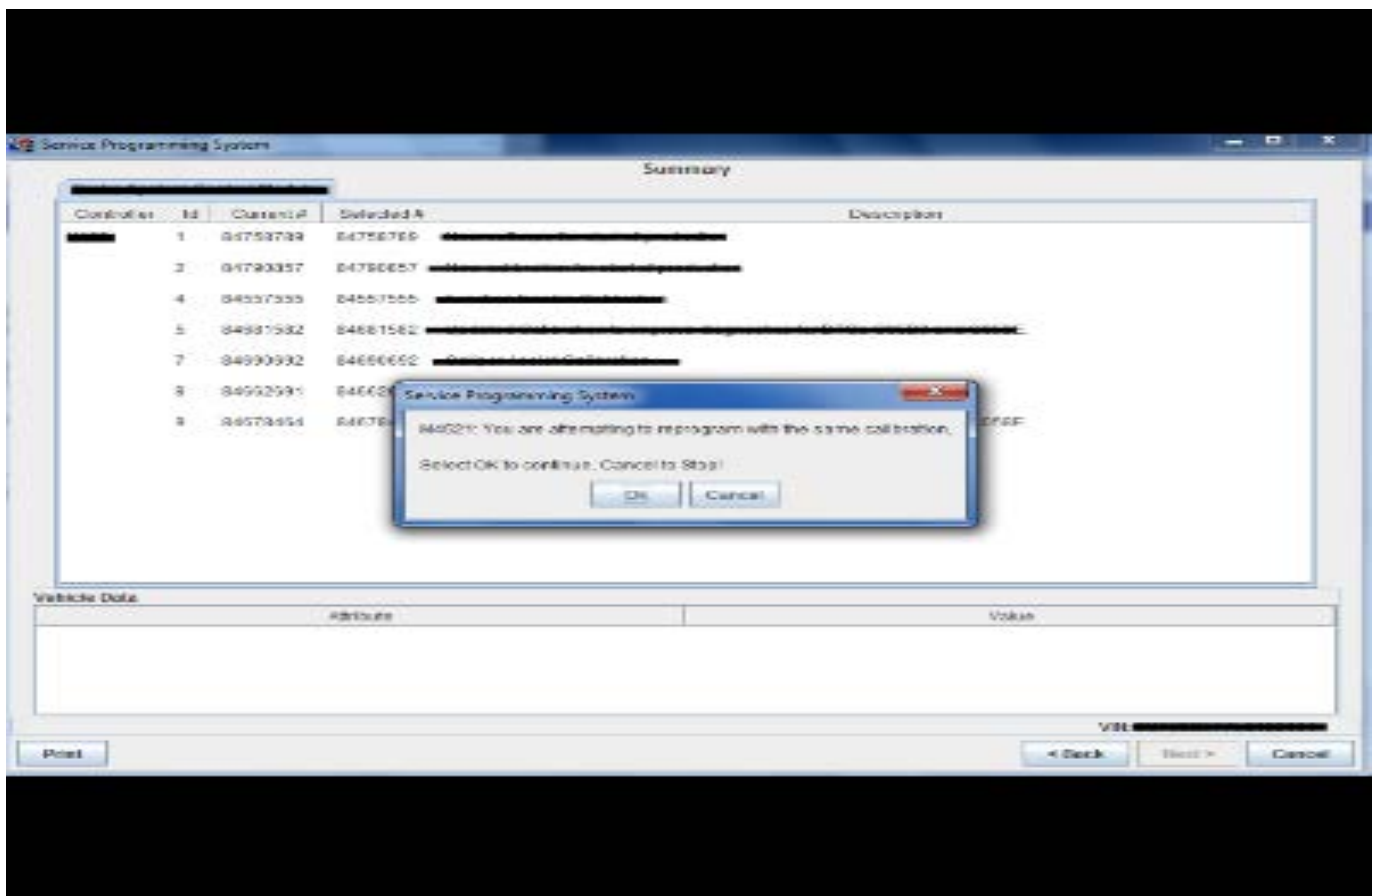
5431207

**Important:** Techline Connect and TIS2WEB screens shown above.

**Important:** If the same calibration/software warning is noted on the TLC or SPS Summary screen, select OK and follow screen instructions. After a successful programming event, the WCC is located in the Service Programming System dialogue box of the SPS Summary screen. No further action is required. Refer to the Warranty Information section of the bulletin.

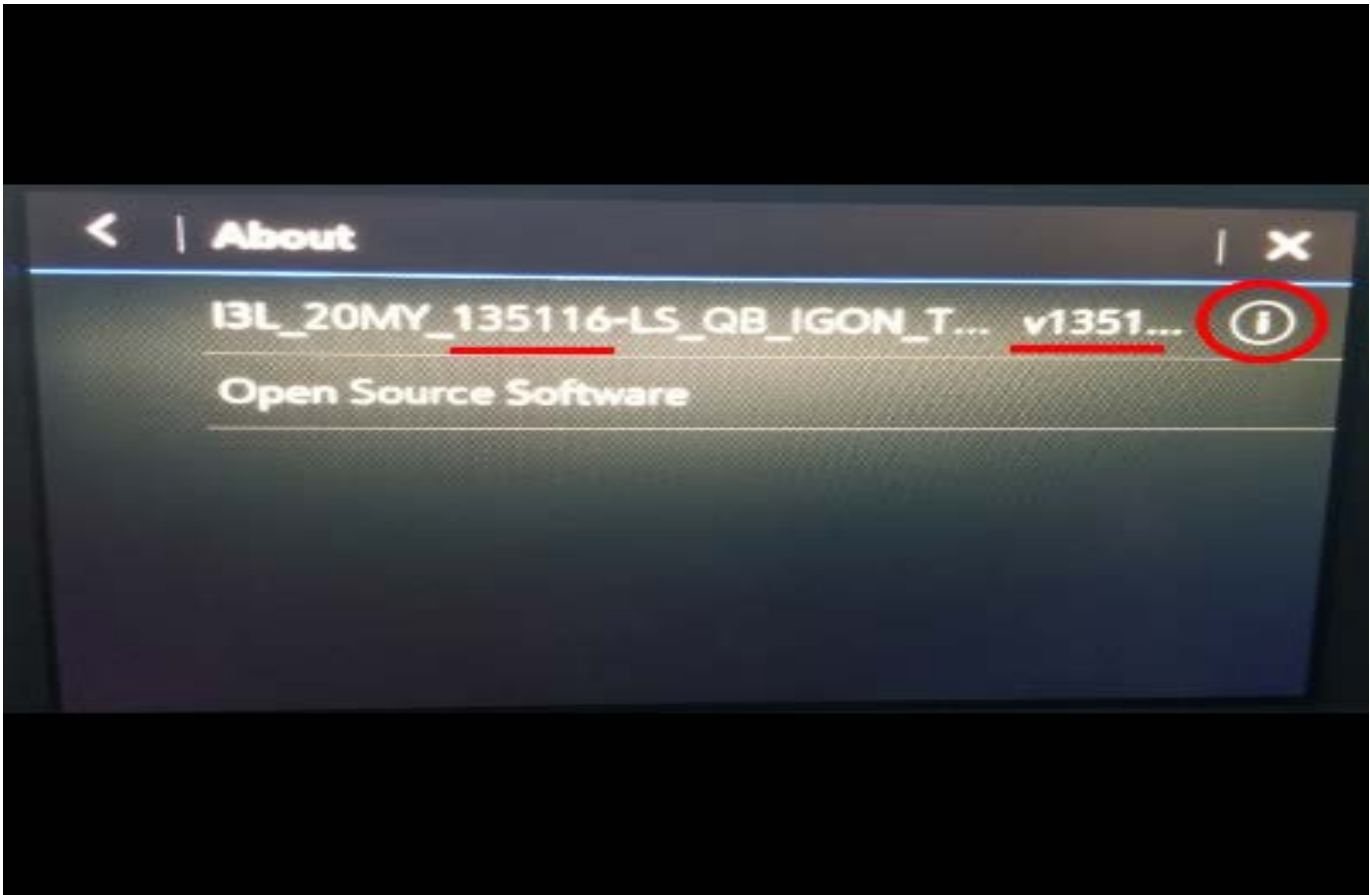
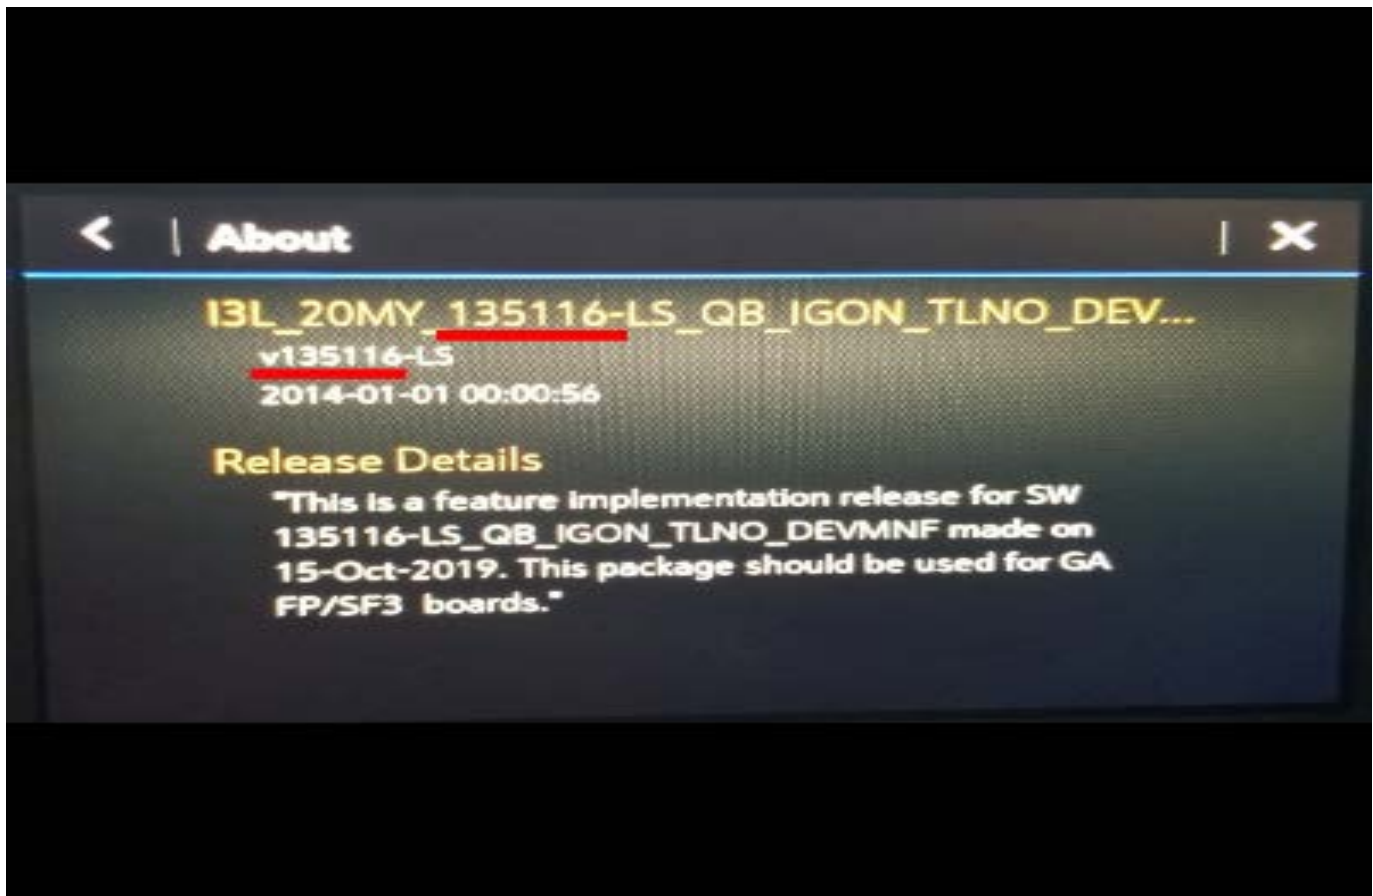
5671247

1. Reprogram the radio software via USB to version V135116 or higher. The software version currently in the radio can be identified by viewing Home, Settings, About, Information icon (circled lower-case i). On the first About screen, you may only see a truncated version number (e.g. v1351...). Select the icon to view the full version number.

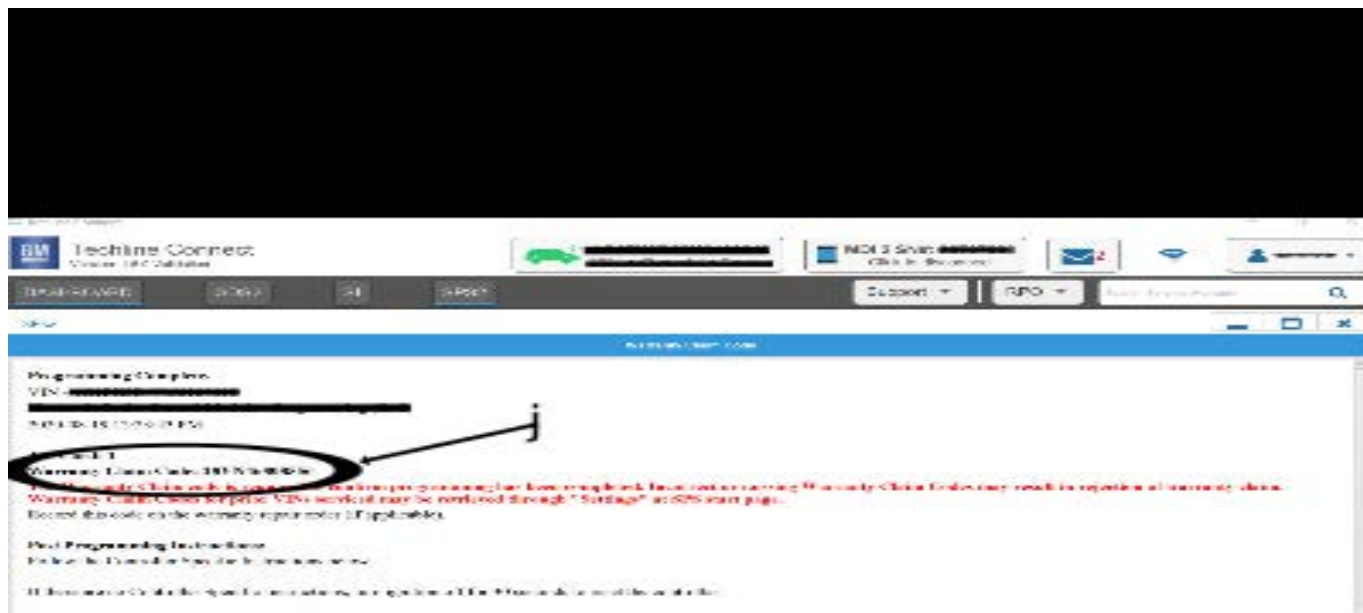
5431209

**Note:** The screenshots above are an example of module programming and may not be indicative of the specific module that is being programmed. Module selection and VIN information have been blacked out.

**Important:** To avoid warranty transaction rejections, you **MUST** record the warranty claim code provided on the Warranty Claim Code (WCC) screen shown above on the job card. Refer to callout 1 above for the location of the WCC on the screen.

6. Record the SPS Warranty Claim Code on the job card for warranty transaction submission.
