Service Bulletin

Bulletin No.: 20-NA-197

Subject: Malfunction Indicator Lamp (MIL) Illuminated - DTC P0087, P0089, P0191, P026C, P026D, P1089, P163A, P163B, P2293, P228A, P228B, P228C, and/or P228D Set

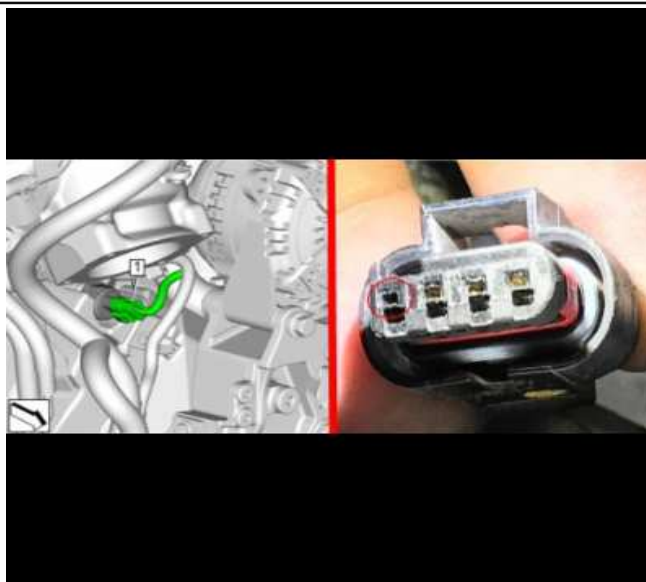
5652222

Cause	This condition may be caused by corrosion or damaged at the fuel pressure sensor electrical connector.

Inspect the fuel pressure sensor electrical connector for corrosion or damage.

⇒ It may be necessary to use the terminal test kit with dielectric grease on it and apply/drag each terminal a few times.
