# Service Bulletin

## PRELIMINARY INFORMATION

**Subject:** Rear and Side Tempered Glass Spots (Quench Marks)

**Models:** 2021 and Prior GM Passenger Cars and Trucks

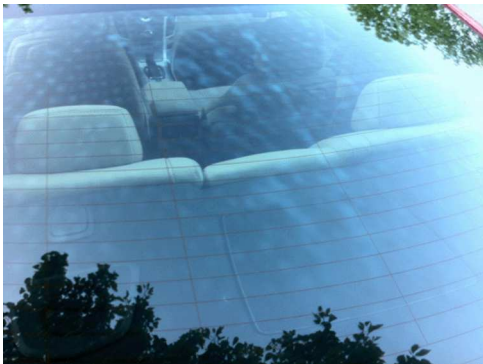
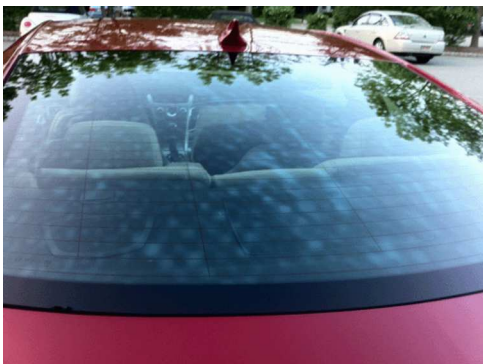
Some customers may comment on spots showing on the rear and side windows when the vehicle is in the sunlight. When wearing polarized glasses/sunglasses, these spots may be more magnified.

The spots are due to the manufacturing process and are “quench marks” in the glass. Quench marks are an unintentional side effect of the tempering process.

Technicians should explain to the customer that this is a normal condition and part of the manufacturing process for tempered glass. Do not replace the window(s) for this condition.
