# Product Emission Recall

## N202310040 Incorrect HVAC Airflow Calibration

**Release Date:** November 2020

Models: 2018 Chevrolet Equinox

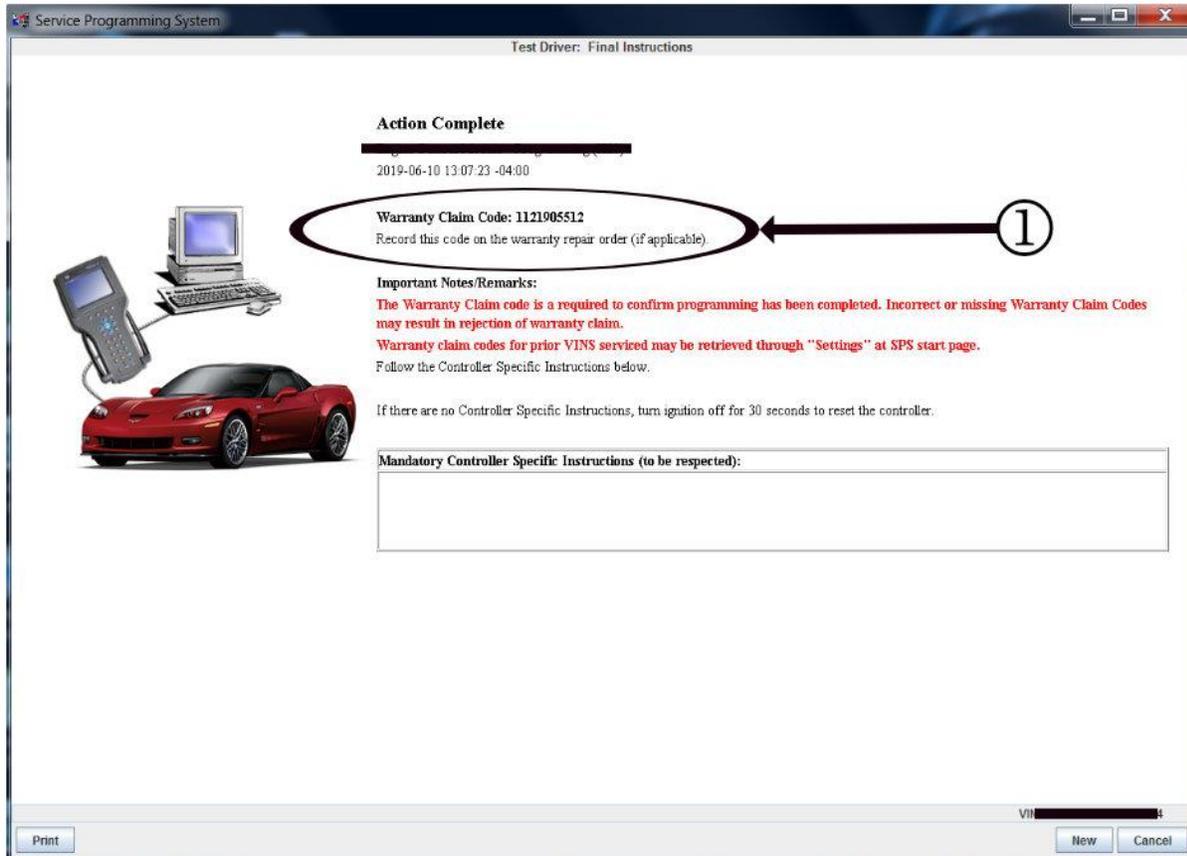
5431209

**Note:** The screenshots above are an example of module reprogramming, and may not be indicative of the specific module you're reprogramming.

**Important:** To avoid warranty transaction rejections, you **MUST** record the warranty claim code provided on the Warranty Claim Code (WCC) screen shown above on the job card. Refer to callout 1 above for the location of the WCC on the screen.

2. Record SPS Warranty Claim Code on job card for warranty transaction submission.
3. CALIFORNIA VEHICLES ONLY: Complete a "Proof of Correction" certificate and provide to the vehicle owner upon recall completion.
