Technical Journal

Seat belt front, may not retract fully

REF NO: TJ 32985.5.0	ISSUING DEPARTMENT: Technical Service	CAR MARKET: United States and Canada	
PARTNER: 3 US 7510 Volvo Car USA		ISSUE DATE: 2020-11-16	STATUS DATE: 2020-11-20
FUNC GROUP: 8841	FUNC DESC: seat belt, front	Page 1 of 4

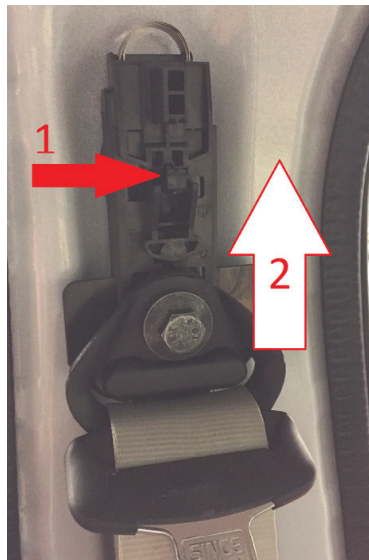
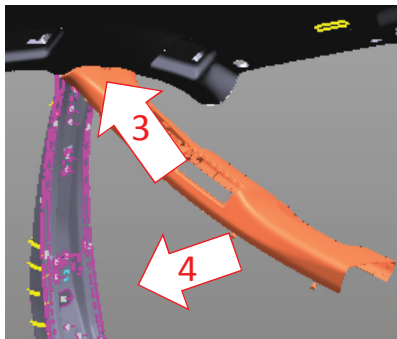
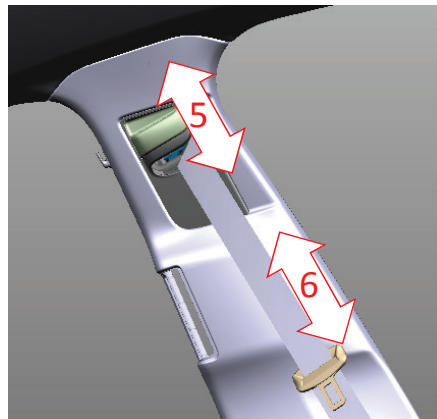
TJ32985

If a front seat belt does not retract normally, please follow the information under “Service”.

Most replaced front seat belt does not have a fault and the warranty claim will not be approved. Make sure to check that the B-panel is correct mounted (follow point 1 to 6 under “Service”) before deciding to replace the seat belt.

1. Inspect the belt adjustment mechanism. If the button is bent, try to straighten it. If it is broken, replace.
2. Push the adjustment to its highest position.
3. Push the panel up under the inner liner as much as possible.
4. Fold down into normal position.
5. Check that height adjustment operates smoothly.
6. Check that the belt rolls out smoothly.
