Technical Journal

Front anti-roll bar link, creaking/knocking noise

REF NO: TJ 35411.2.0	ISSUING DEPARTMENT: Technical Service	CAR MARKET: United States and Canada	
PARTNER: 3 US 7510 Volvo Car USA		ISSUE DATE: 2020-11-16	STATUS DATE: 2020-11-20
FUNC GROUP: 7629	FUNC DESC: miscellaneous	Page 1 of 3

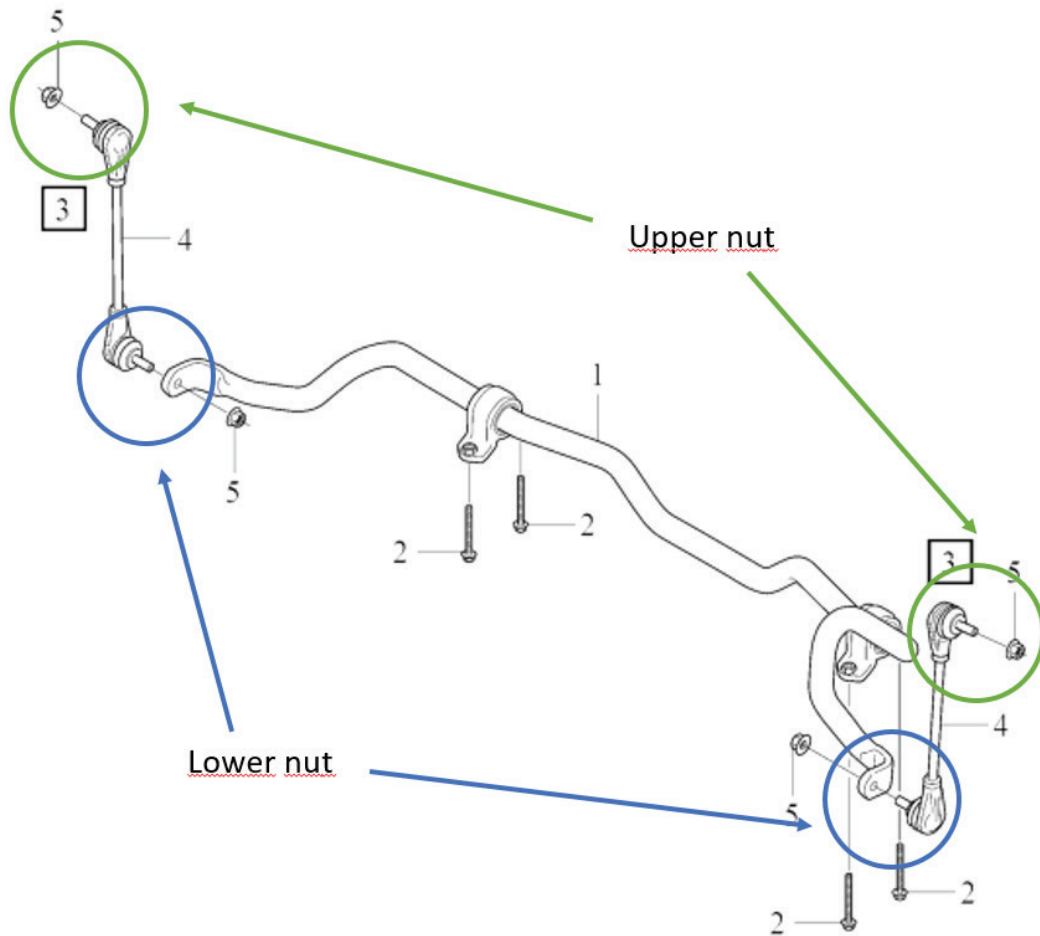
File Name	File Size
Anti roll-bar link.png	0.1055 MB

If the customer is complaining over a creaking or knocking noise from the front suspension mainly when driving on a rough road, turning or over a speed hump, then follow the advice under Service.

Check if the noise is coming from the front anti-roll bar link/links, if needed use a Chassis Ears tool kit during a test drive.

1. Re-torque the upper and lower nut on the front anti-roll bar link to 70Nm.
2. Step 1 will probably solve most of the cases, but if it still is noise replace the faulty anti roll-bar link/links.
