Deformed Wireless Phone Charger Rubber Pad

YEAR(S)	MODEL(S)	ADDITIONAL INFORMATION
2016 - 2021	Tacoma

Some 2016 – 2021 model year Tacoma vehicles may exhibit a condition in which the wireless phone charger assembly rubber pad is deformed. Follow the Repair Procedure in this bulletin to address this condition.

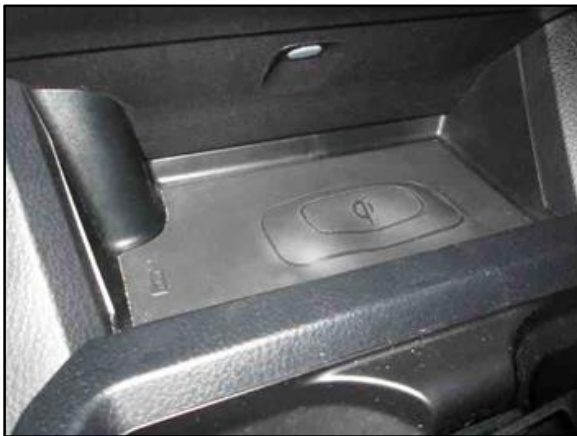
Does the vehicle exhibit a condition in which the wireless phone charger assembly rubber pad is deformed?

Figure 1. Example of a Deformed Wireless Phone Charger Assembly Rubber Pad

PART NUMBER	PART NAME	QTY
861C4-04010	Panel, Mobile Wireless Charger	1

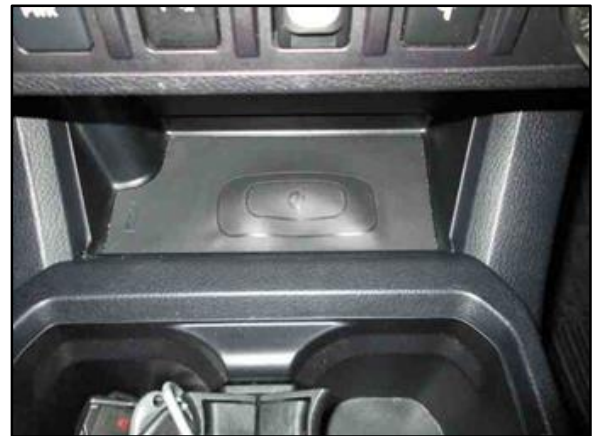
Figure 2. Example of a Deformed Wireless Phone Charger Assembly Rubber Pad

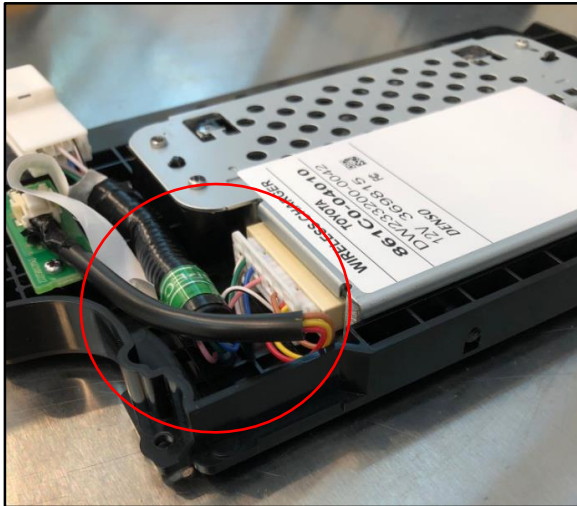
Figure 8. Incorrect Wiring Position

NOTICE
 Ensure the wiring is positioned **ENTIRELY INSIDE** the mobile wireless charger to prevent damage.

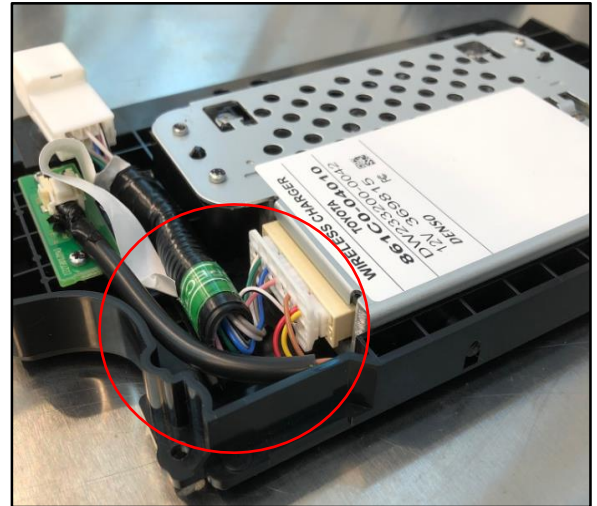
Figure 9. Correct Wiring Position
