SIB 52 09 20

## HEAD RESTRAINT AND/OR BACKREST OF 3RD ROW SEATS CANNOT BE FOLDED DOWN

E-Series	Model Description
G07	X7 Sports Activity Vehicle

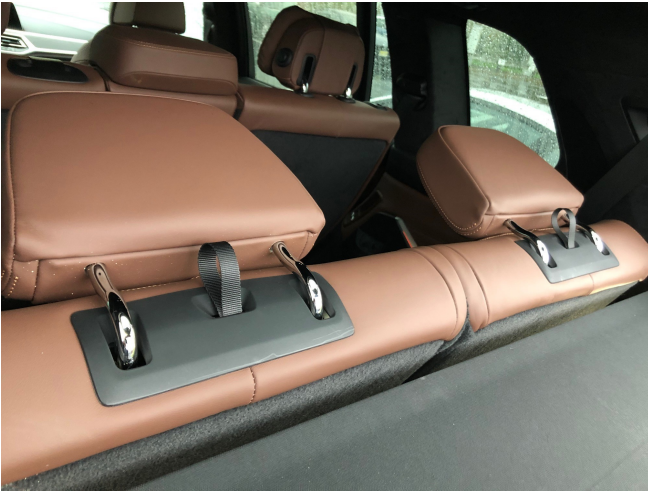
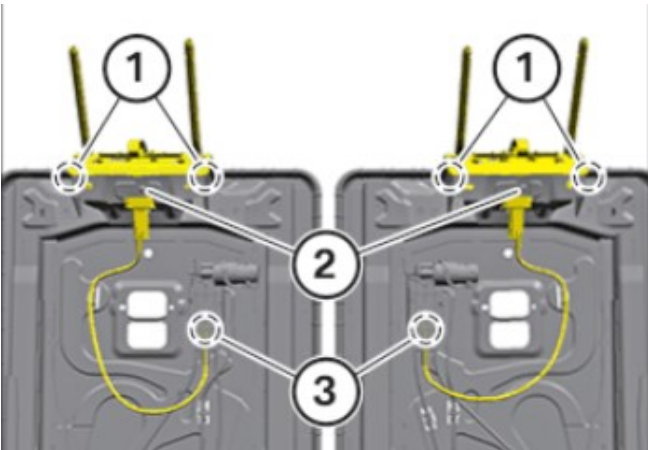
Can the head restraint be manually unlocked using the release loop beneath the headrest (see picture) and thus folded down?

**YES** = Head restraint mechanism is faulty.  
Replace the folding module of the head restraint (#2 in picture).

See REP 52 30 118 Remove and install/replace folding module of left or right head restraint

**NOTE:** The head restraint cannot be removed without destroying the covering material. **A new cover (leather) will be required to perform this repair.**

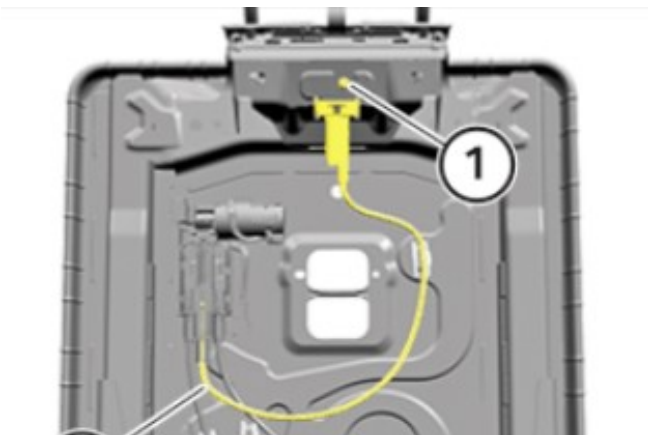
**NO** = Check if the Bowden cable is correctly mounted and properly routed.

If the Bowden cable is mounted and correctly routed, replace the Bowden cable for the headrest (shown in yellow in picture).

See REP 52 30 253 Replace Bowden cable for left or right head restraint (Bowden cable unlocking device for head restraint).

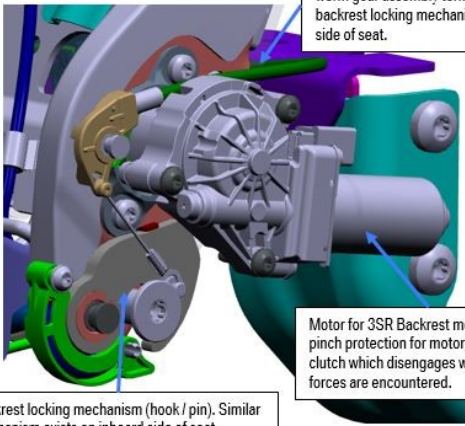
G07 3<sup>rd</sup> Row Seat – Overview Picture.

Bowden cable which originates at motor / worm gear assembly terminating at backrest locking mechanism on outboard side of seat.

Motor for 3SR Backrest movement. No pinch protection for motor, but has clutch which disengages when high forces are encountered.

Backrest locking mechanism (hook / pin). Similar mechanism exists on inboard side of seat.

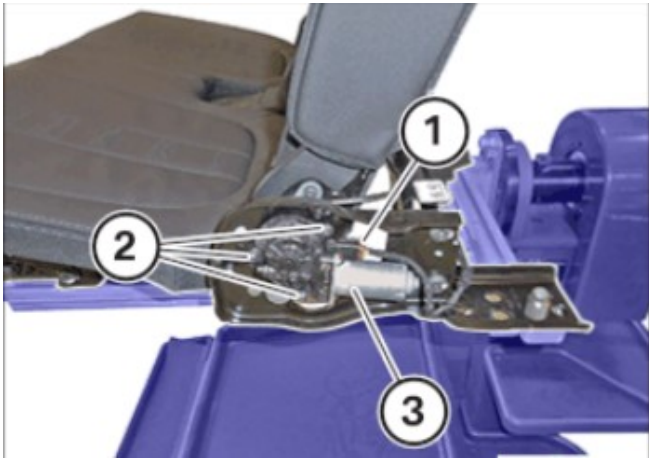
If the head restraint stays in the seat position, the latch is closed.

If the head restraint falls into the folded position again, the latch is open.

**YES** (Latch is open) = Replace drivetrain of backrest tilt adjustment.

See REP 67 31 635 Remove and install/replace drivetrain for backrest tilt adjustment of third-row seating (left or right) (according to vehicle diagnosis)

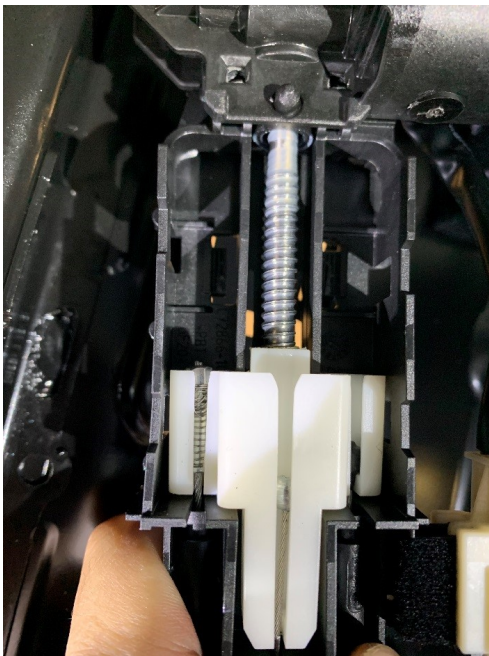
**NO** (Latch is closed) = Check if the drivetrain for backrest release adjustment is broken?

**NOTE:** The 3 Bowden cables are housed in a common housing that moves along a worm gear assembly.

When the electric motor activates, it spins the worm gear to pull up on the housing so that all 3 cables move simultaneously

One of the cables controls the head restraint folding. Once pulled, the headrest will release and pivot downwards. **Raising the headrest back into the upright position must be done by pushing up on it by hand.**

(The other two cables control the latch release at the seat pivot to enable the seat to fold.)

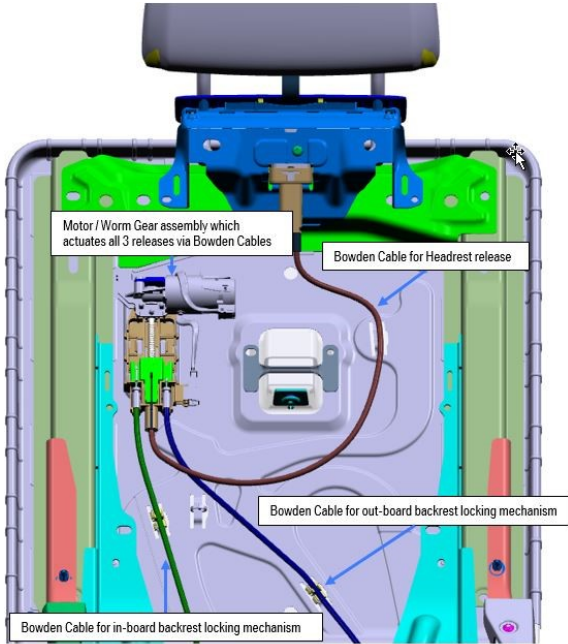
Is the drivetrain for the backrest release (actuator) broken?

**YES** = Replace only the drivetrain for backrest release (actuator).

See REP 67 31 645 Remove and install/replace drivetrain for backrest release of third-row seating (left or right) (according to vehicle diagnosis)

**NO** = Replace BOTH the Bowden cable(s) and drivetrain for backrest release (actuator).

See appropriate repair instruction:  
 REP 52 30 256 Replace Bowden cable for left or right rear seat backrest (Bowden cable for outer backrest release)

REP 52 30 255 Replace Bowden cable for left or right rear seat backrest (Bowden cable for inner backrest release)

REP 67 31 645 Remove and install/replace drivetrain for backrest release of third-row seating (left or right) (according to vehicle diagnosis)
