SIB 54 08 19

SUNROOF REVERSES WHEN CLOSING

This Service Information Bulletin (Revision 5) replaces SI B54 08 19 **dated November 2020**.

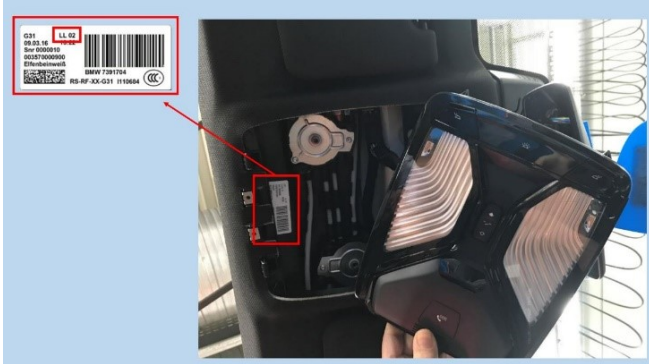
4. With the FZD Removed, inspect the “LL” number as shown to the left.

Is the LL number 25, 44, or 45?

Yes: Continue to step 5.

No: Continue to step 6.

5. Replace the wind deflector following repair instructions **REP 54 13 090 “Removing and installing/replacing wind deflector”**.
