SIB 64 04 16

2020-11-04

Water Ingress In Footwell Area From A/C Condensate Drain

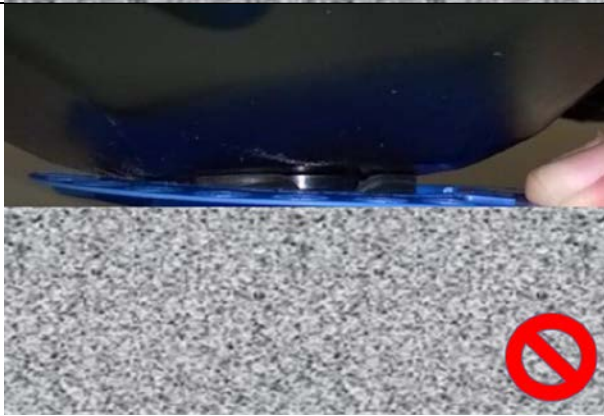
<p>3. This close up shows drain incorrectly installed.</p>

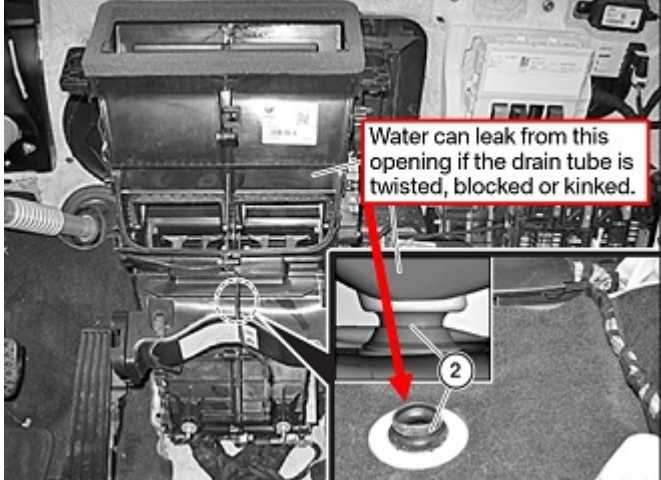
<p>4. Water leaks can occur in these areas causing the molding smell from carpet.</p>

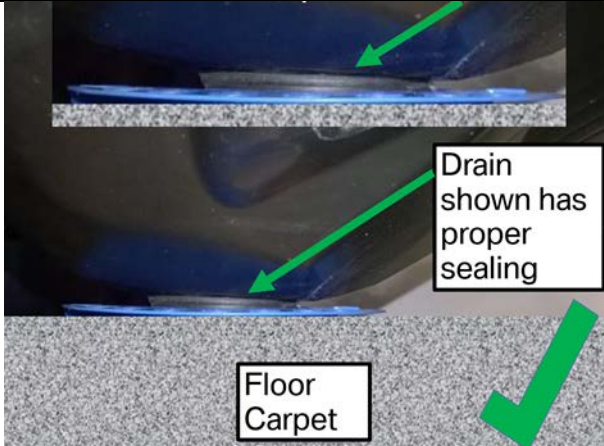
<p>Drain shown has proper sealing</p> <p>Floor Carpet</p>	<p>7. A correct drain installation is shown.</p> <p>8. Install all removed parts.</p>
---	---
