SIB 66 16 20

PARKING ASSISTANCE SYSTEM FAILED

E-Series	Model Description	Production Date
G20	3 Series Sedan	Up to May 28, 2020

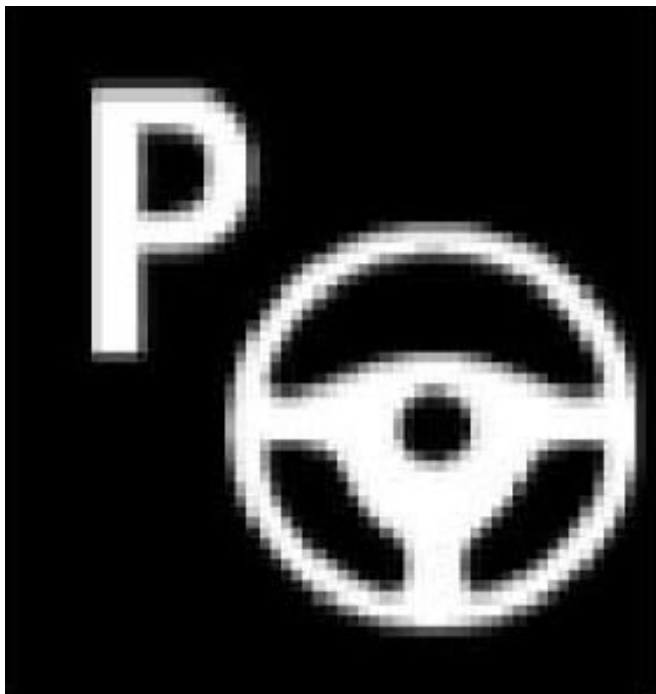
CCM ID 451 – Park Assist
Assume vehicle control. Park Assist failed.
Parking maneuver was interrupted. If this occurs repeatedly, have it checked by the Service Center.

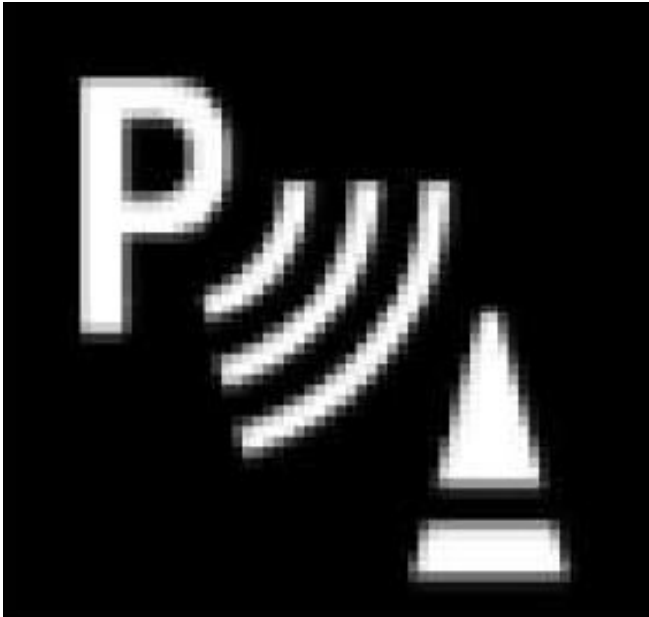
CCM ID 918 – Parking Assistance failure
Parking Assistance failure, park yourself*.
Have it checked by your Service Center.

CCM ID 977 - Lateral Parking Aid

Lateral Parking Aid failure, park autonomously. Drive to your Service Center at your convenience.
