SIB 66 17 20

SURROUND VIEW: PARKING VIEW IMAGES DISPLAYED INCORRECTLY

SURROUNDING VIEW: PARKING VIEW IMAGES DISPLAYED INCORRECTLY

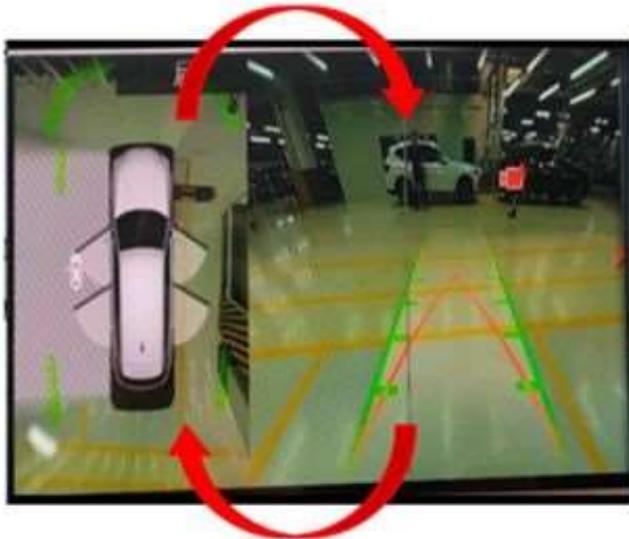
Bad

- This picture shows the top view and rearview images are **incorrectly displayed** in the wrong position (swapped) on the CID for vehicle with option code 6U3 (Live Cockpit Pro – incl. navi).
- Also, the camera icon and vertical gray line is seen in the rearview camera image.

Note: Both images still provide accurate depictions of the vehicle environment.

Encode the ICAM control unit again after programming with ISTA 4.25.4x (released October 8, 2020) or higher. Multiple encoding of the ICAM control unit may be required.

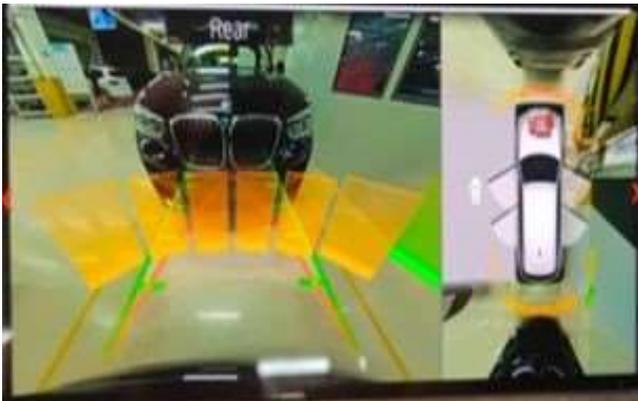
Good

- Here the images are displayed in the **correct image position** on the CID for vehicles equipped with option code 6U3 (Live Cockpit Pro - incl. Navi).

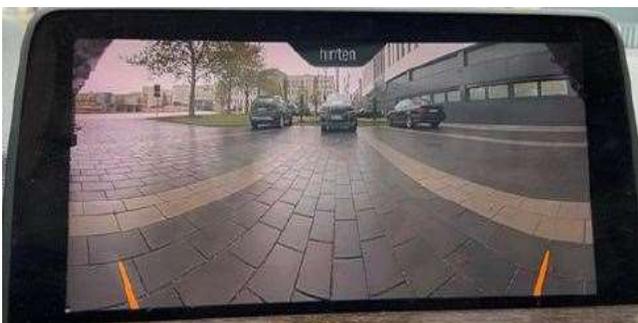
Good

- Rearview image

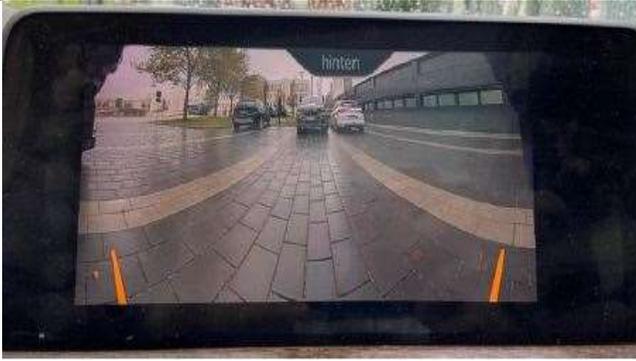
Bad

- Rearview image

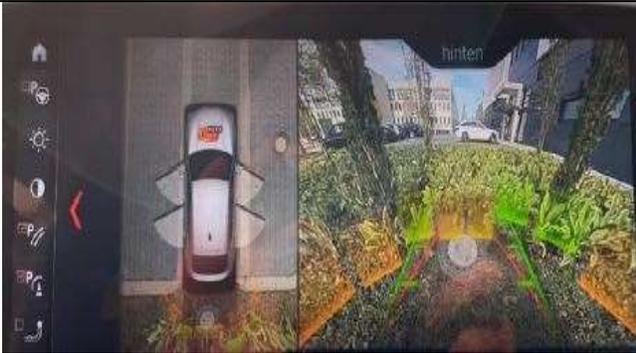
Good

- Rearview and top view image for vehicle without option 6U3 (Live cockpit Pro – incl navi)

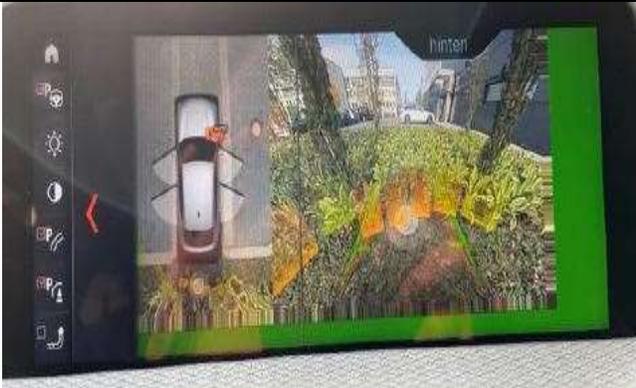
Bad

- Rearview and top view image for vehicle without option 6U3
- Green border along right side and bottom of the picture
- Top view image does not fill designated area
- Camera icon seems out of position when compared to the good image above

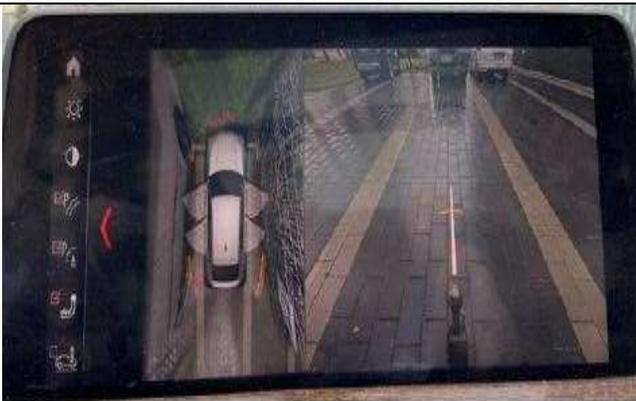
Good

- Rearview and top view image for vehicle without option 6U3
- Top view image fills designated area
- Trailer hitch alignment line (white) is aligned

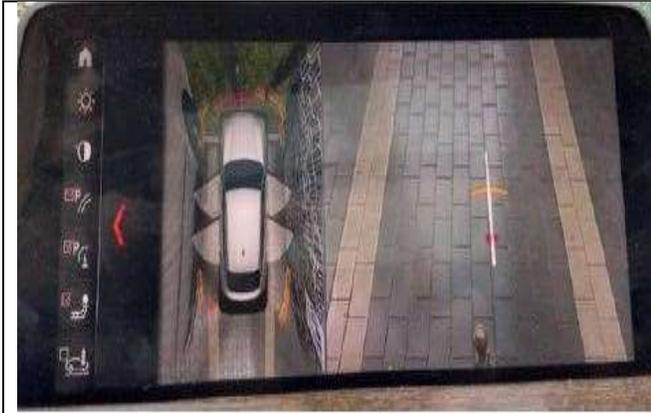
Bad

- Top view image seems good, but an **inaccurate** rearview image for vehicle without option 6U3
- Trailer hitch alignment line (white) is misaligned (offset)
